February 18, 2003

File: 15-76-11

**NORTH CENTRAL REGION LANDSLIDE ASSESSMENT
HWY 43:16 WHITECOURT EAST HILL (NC1)
2002 ANNUAL INSPECTION REPORT**

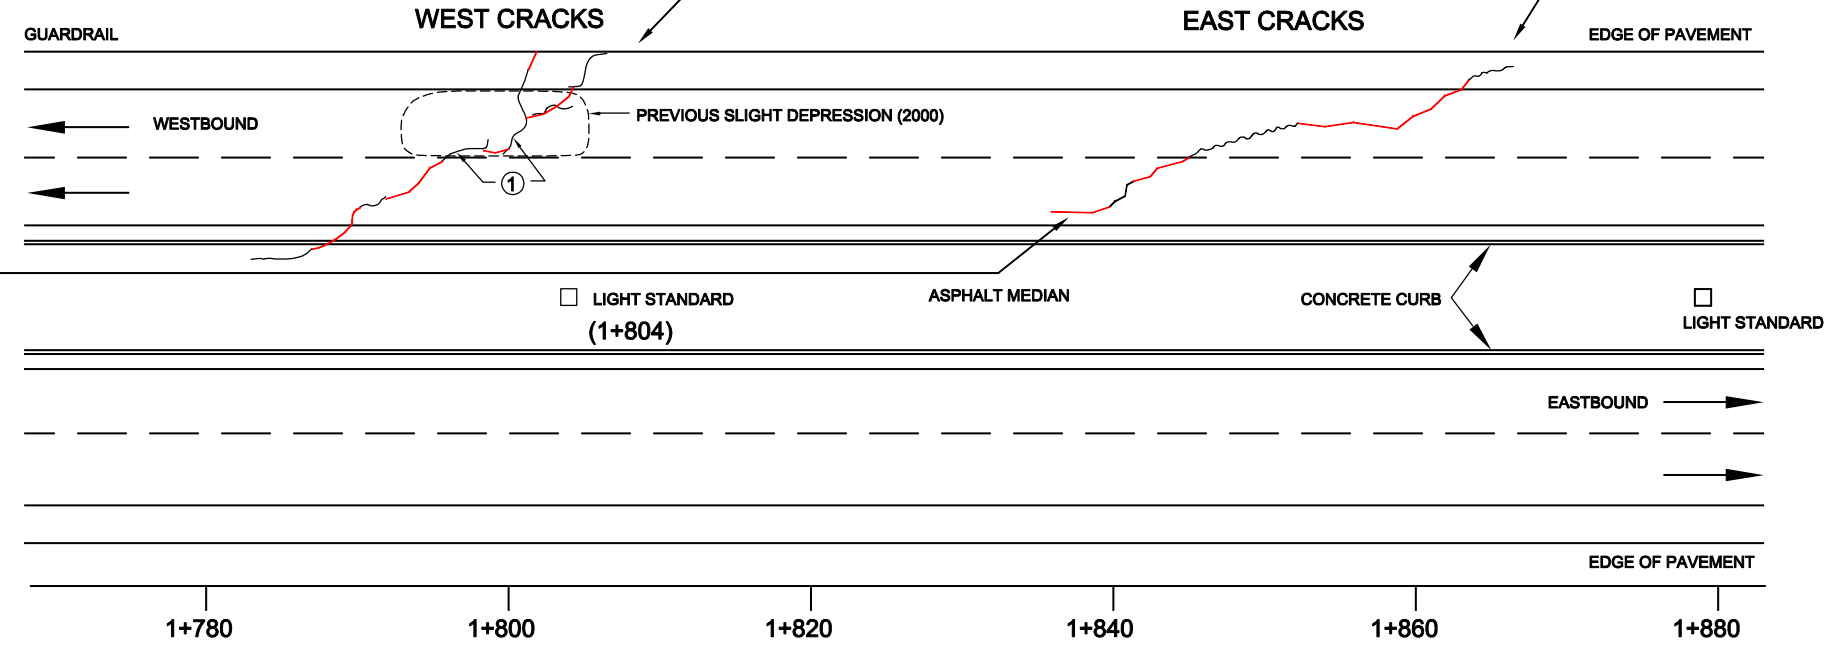
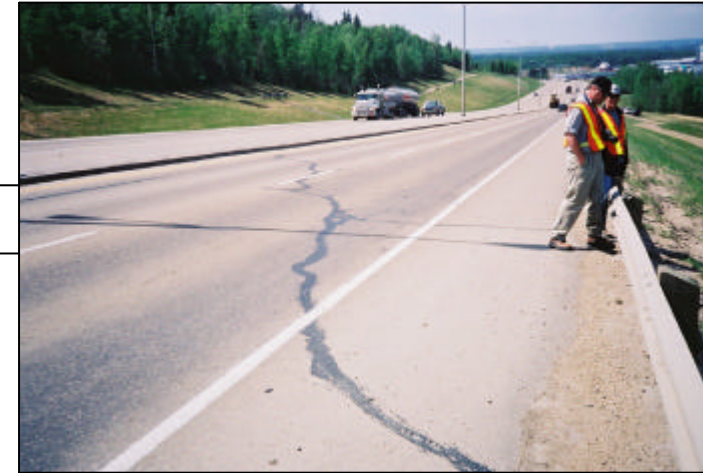
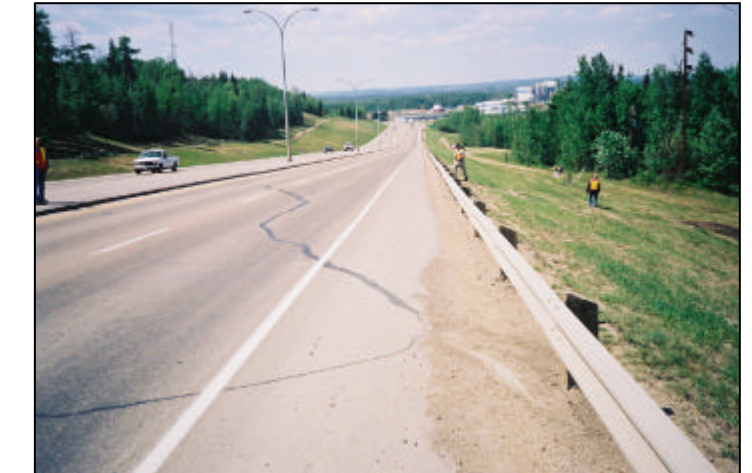
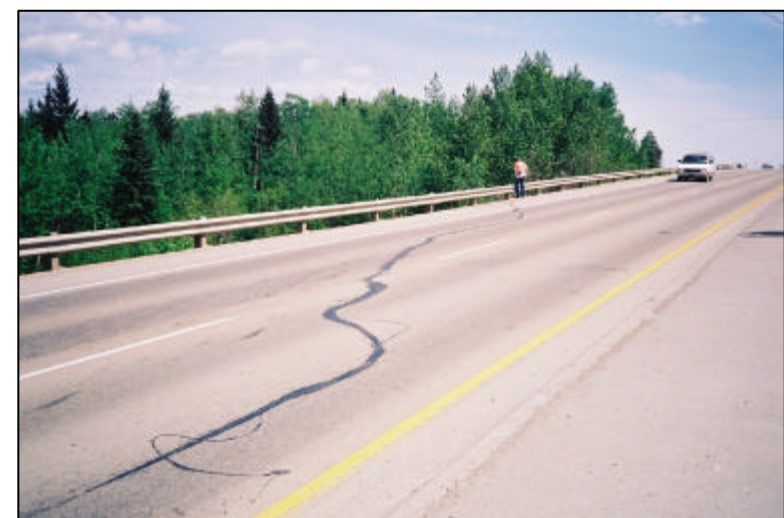
DRAWING No.
FIGURE NC1-2

The roadway surface was inspected during the reconnaissance along the full length of the hill. As in previous years, no distress to the pavement surface was noted except for some cracking noted in the vicinity of Station 1+800 to 1+900. This pavement distress was first observed in 1998.

The crack pattern is shown on the site plan, Figure NC1-2 (Section F), which has been updated with the information from the 2002 site visit. The crack pattern is also shown in photographs taken of the area (Section F). The development of the cracking over the past year consisted of extension of the existing cracks such that a more continuous pattern is evident this year. No significant differential height was noted across the cracks, other than on the west crack where 3 to 5 mm of differential height was observed in the west bound (travelling) lane. This location of differential height across the crack was similar to that noted during the 2001 site visit.

The ongoing development of the roadway surface cracking in the vicinity of Station 1+800 to 1+900 appears to have accelerated somewhat since that observed between the 2000 and 2001 site visits, however differential movement across the crack has not increased. In addition, slope movement rates measured in the inclinometers in the area have reduced since the last site reconnaissance. The crack development is not affecting the trafficability of the roadway surface at the present time. Ongoing movements in this area may however be expected, and may coincide with heavy or prolonged precipitation events. Continued visual monitoring of this area is recommended.

A risk level of 18 is considered applicable to the area of distress on the roadway in the upper portion of the hill (Stations 1+800 to 1+900), based on a Probability Factor of 6 (active but slow, indeterminate movement pattern) and a Consequence Factor of 3. This risk level is the same as that applied for the 2001 site visit. Other areas of the site are considered to have a lower risk rating.

A separate study is currently underway to assess potential remedial measures should the slope movements in the vicinity of Station 1+800 to 1+900 develop such that they impact the roadway surface. Field work including test holes and standpipe piezometers is recommended to determine the soil and groundwater conditions in the vicinity of the slide, which will allow for design of potential dewatering measures if appropriate. Additional slope inclinometers are also recommended to better delineate the slide zone.
