December 12, 2001

File: 15-76-11

**NORTH CENTRAL REGION LANDSLIDE ASSESSMENT  
HWY 43:16 WHITECOURT EAST HILL (NC1)  
2001 ANNUAL INSPECTION REPORT**

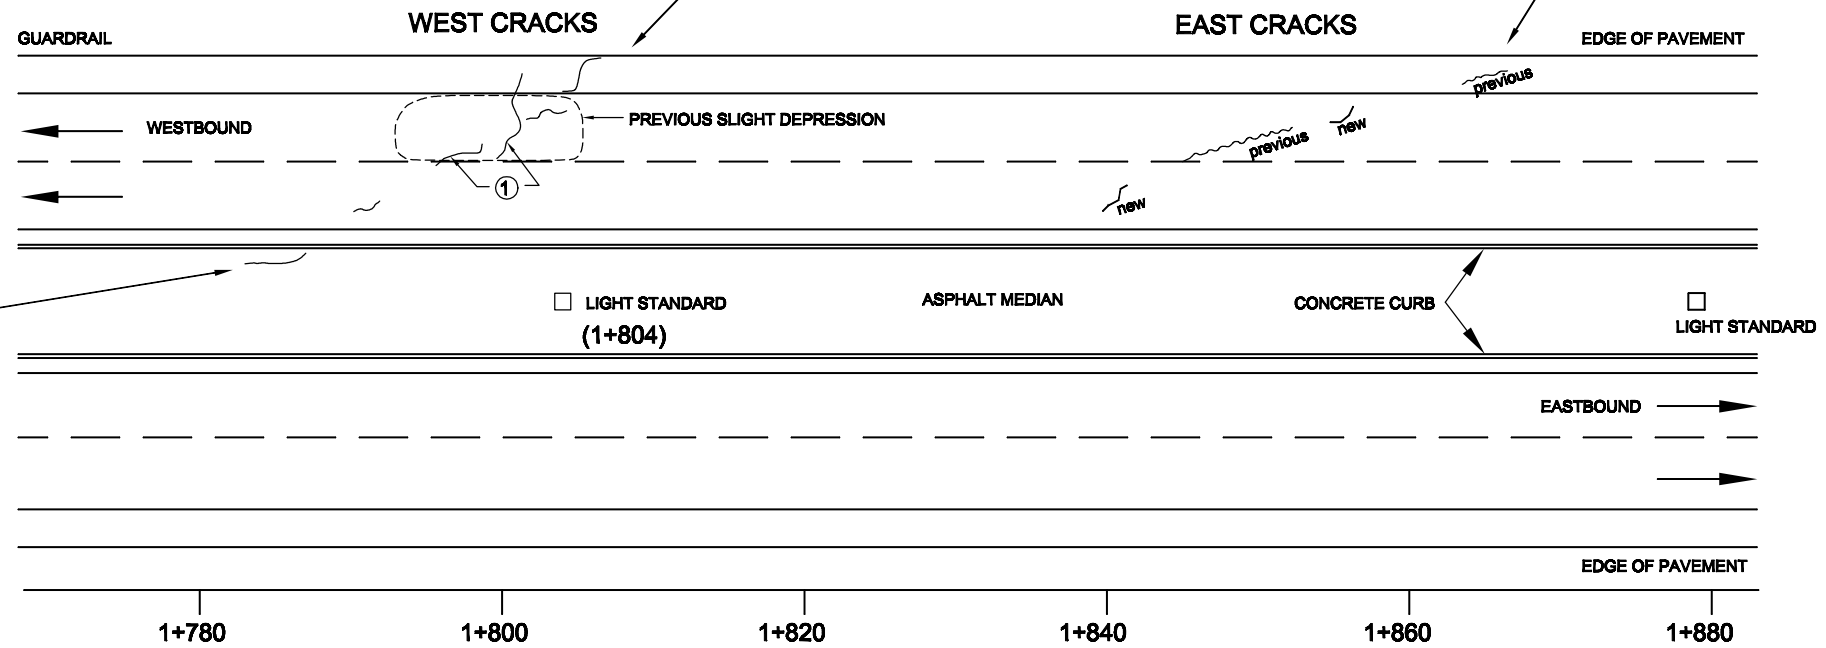
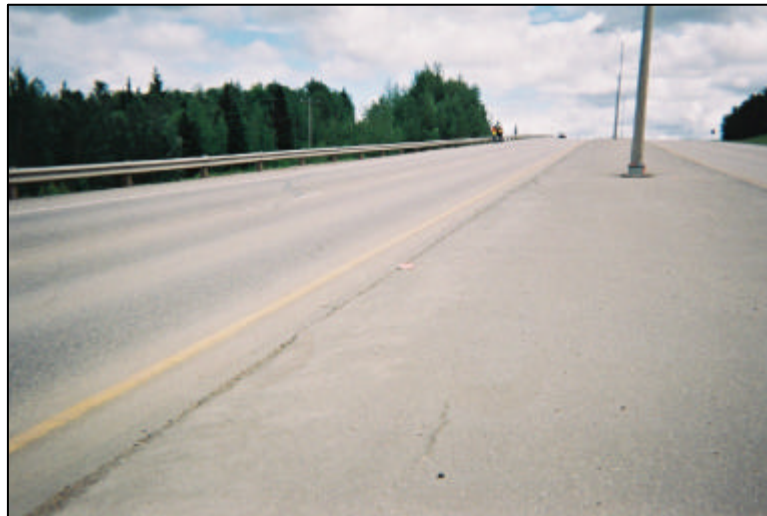
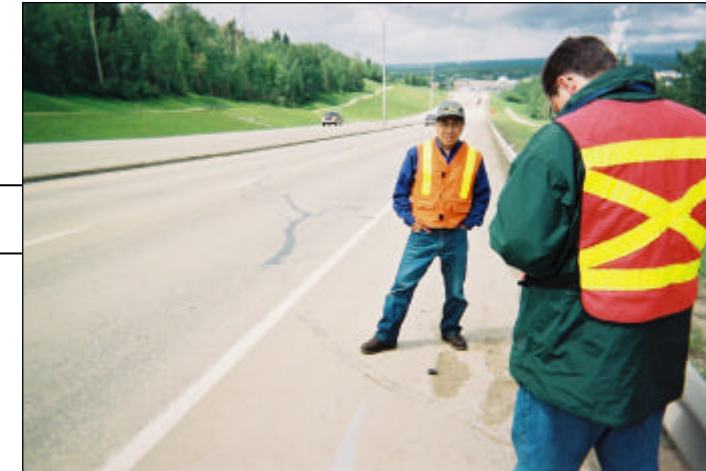
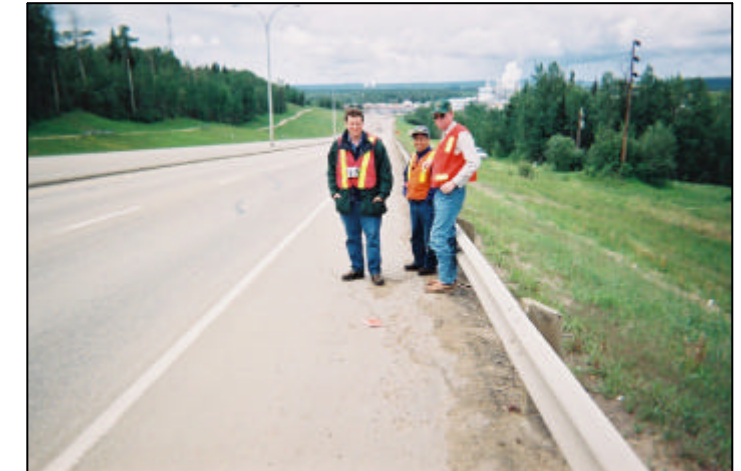
DRAWING No. **FIGURE NC1-2**

The highway roadway surface was inspected during the reconnaissance along the full length of the hill. As in previous years, no distress to the pavement surface was noted except for some cracking noted in the vicinity of Station 1+800 to 1+900. This distress was first observed in 1998.

The crack pattern is shown on the site plan, Figure NC1-2 (Section F) which has been updated with the information from the 2001 site visit. The crack pattern is also shown in photographs taken of the area (Section F). No difference in the west crack pattern or differential height across the cracks was noted from that observed in 2000. The slight depression noted in 2000 was not as noticeable in 2001. Some minor crack development was noted in the east crack area. The locations of the new cracks are shown on the site plan. The new cracks have not opened up and no differential height was noted across them.

**CRACK PATTERN IN PAVEMENT  
STATIONS 1+780 TO 1+880**

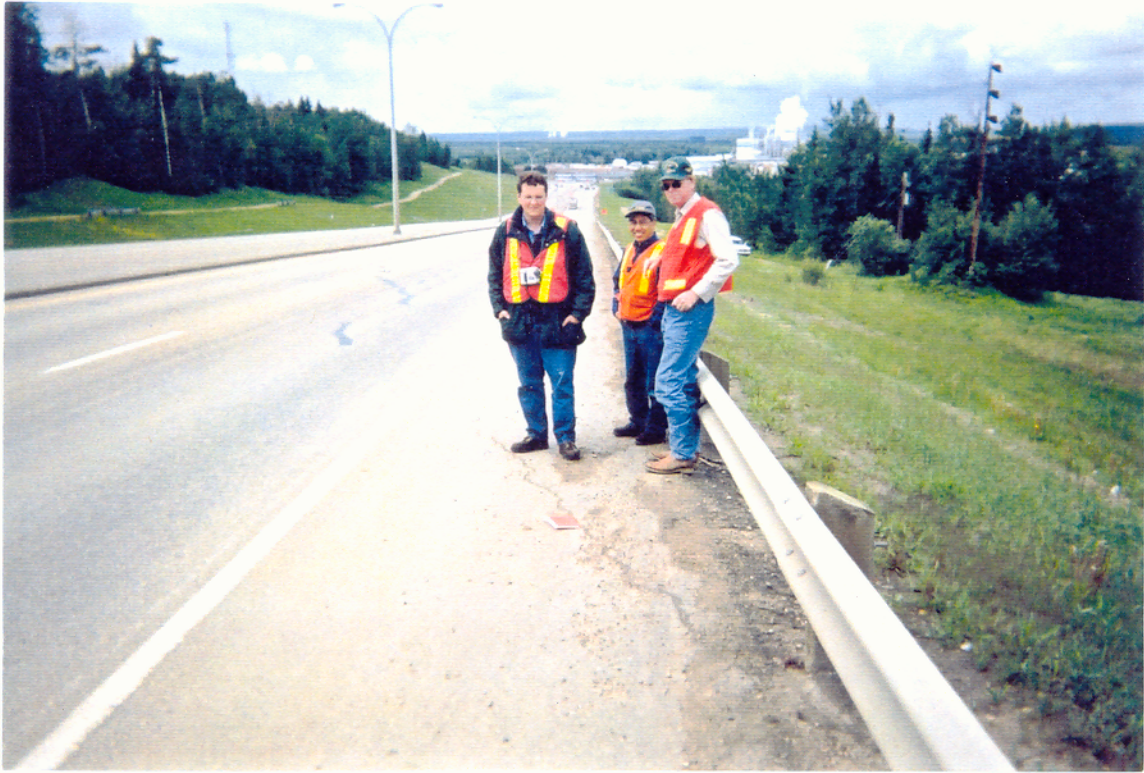
The ongoing development of the roadway surface cracking in the vicinity of Station 1+800 to 1+900 appears to have slowed down since that observed between the 1999 and 2000 site visits. The crack development is not affecting the trafficability of the roadway surface at the present time. Ongoing movements in this area may however be expected, and hence continued visual monitoring of this area is recommended.

LOOKING WEST AT EAST CRACKS NEAR STATION 1+860

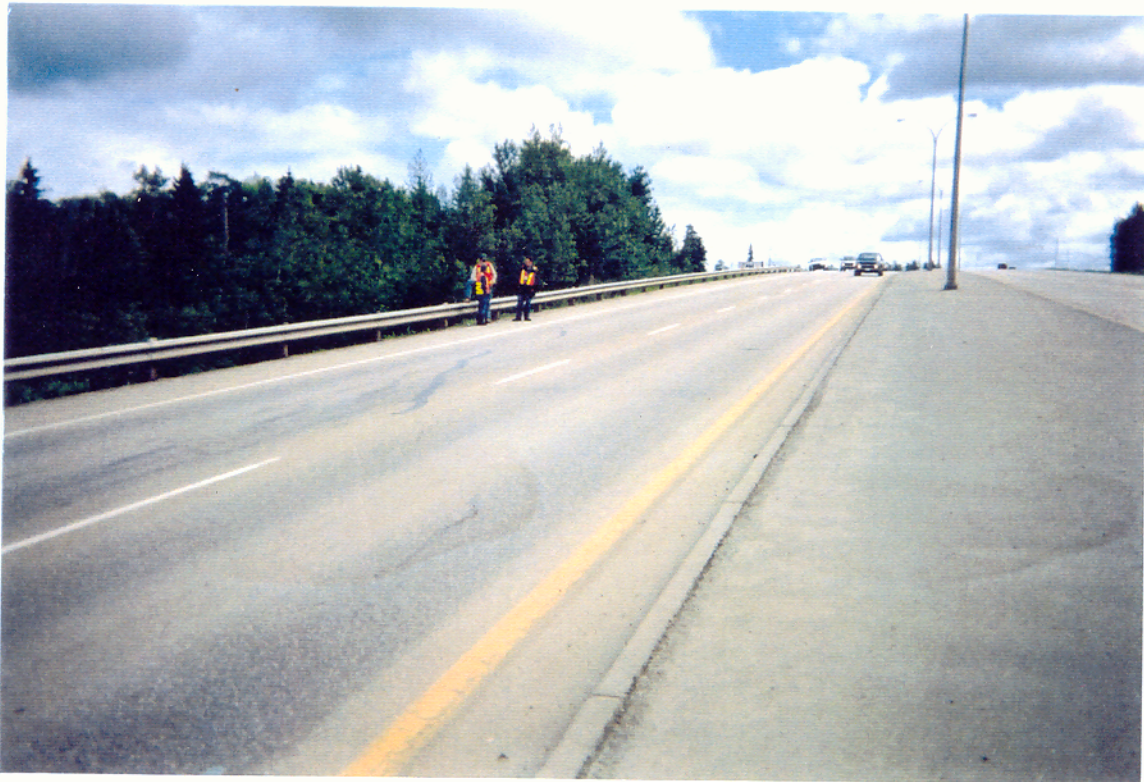
LOOKING NORTHEAST AT EAST CRACKS NEAR STATION 1+860

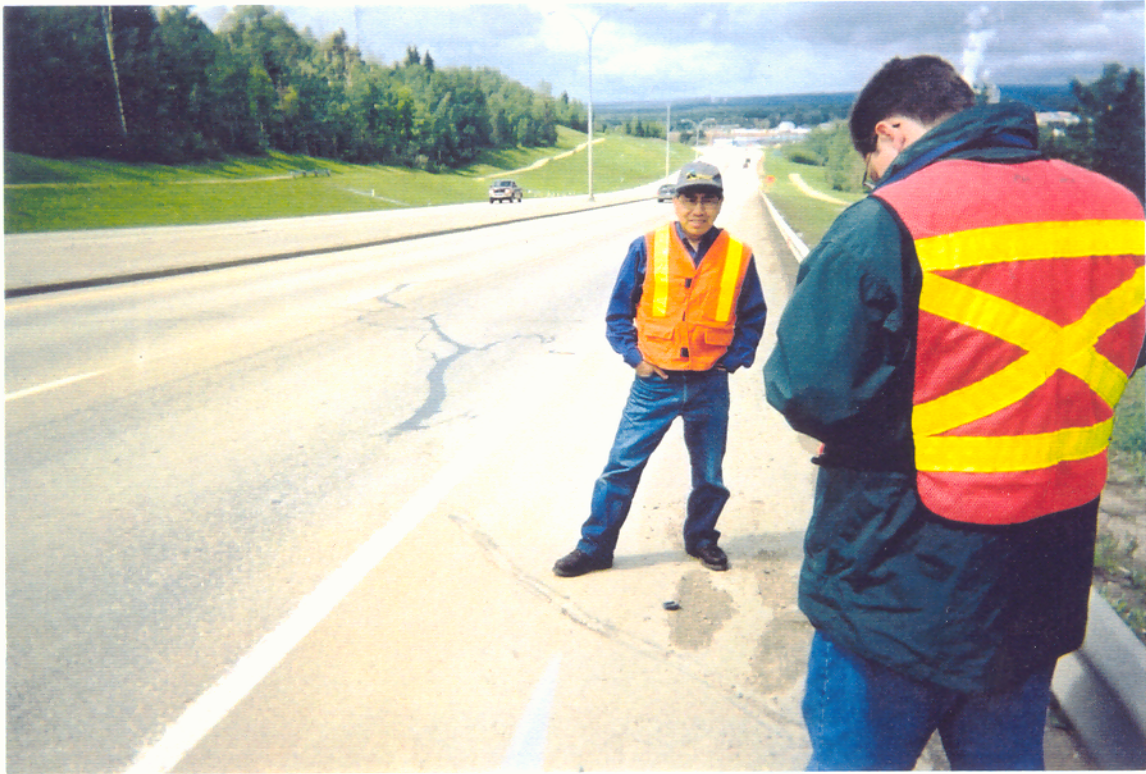
LOOKING WEST AT WEST CRACKS NEAR STATION 1+800

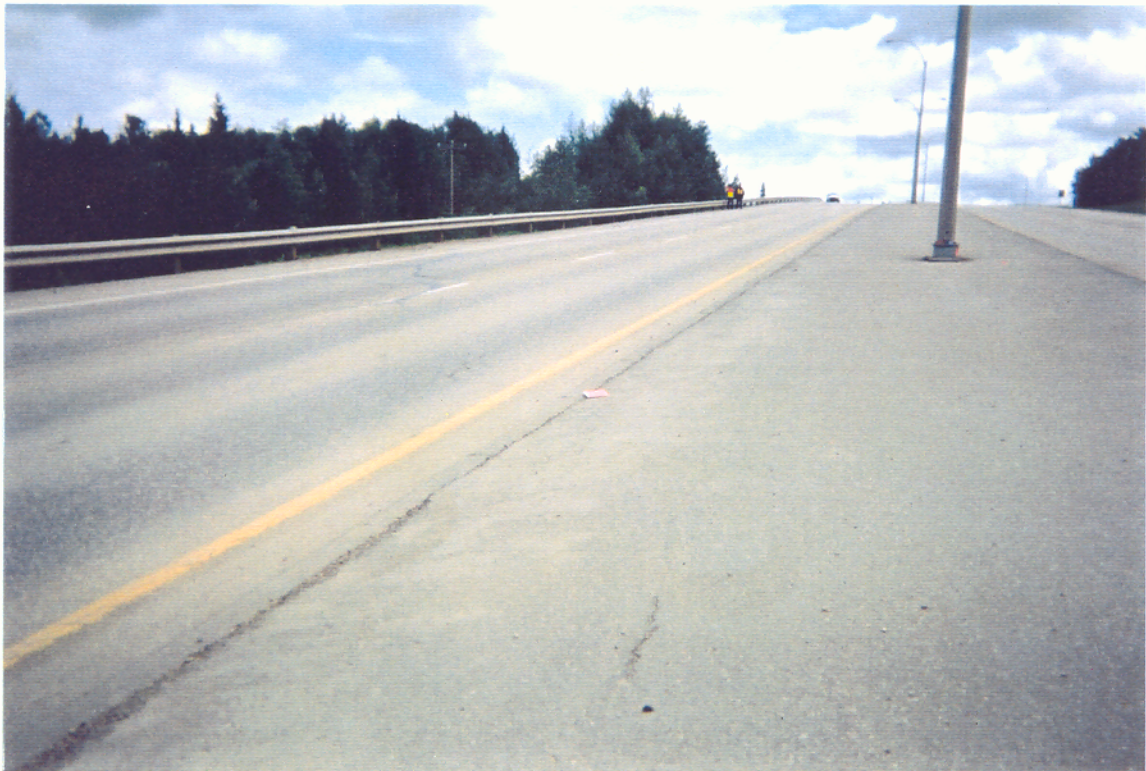
LOOKING NORTHEAST AT WEST CRACKS NEAR STATION 1+800

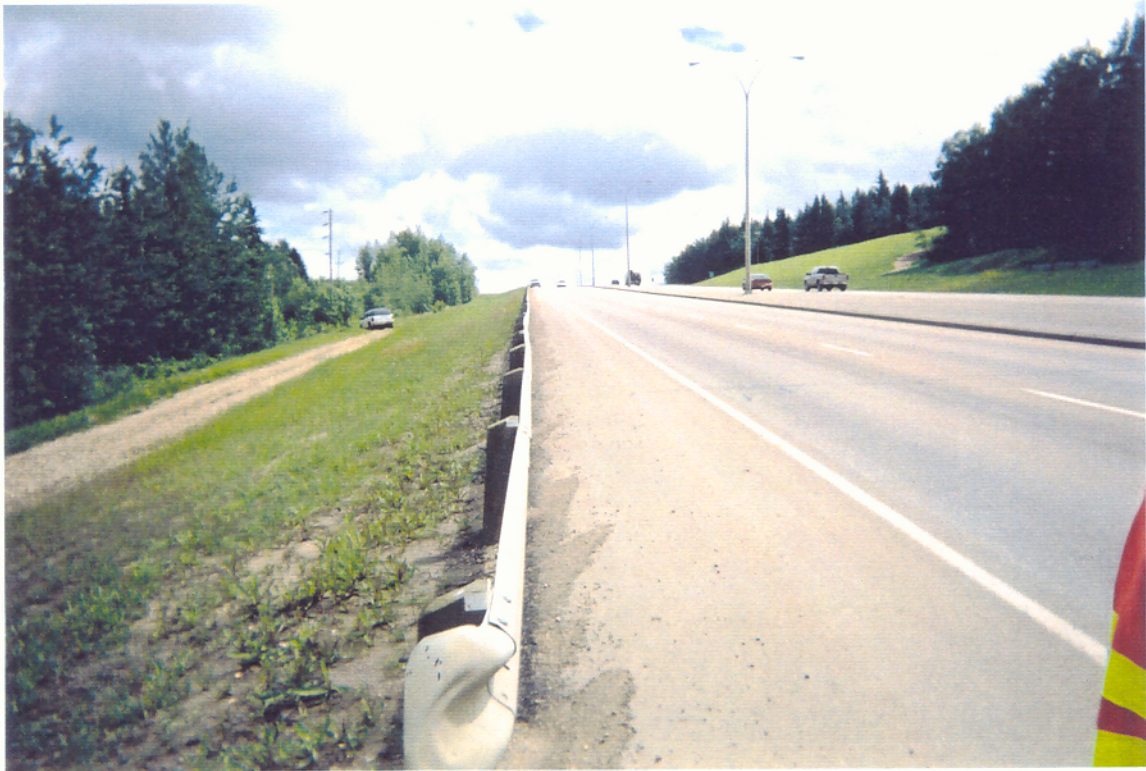
No other significant cracking was noted in the asphalt surface along the length of the hill. The guardrails appeared straight at the time of the site visit, indicating that no gross slope movement is occurring at the guardrail locations.

LOOKING EAST AT UPPER GUARDRAIL

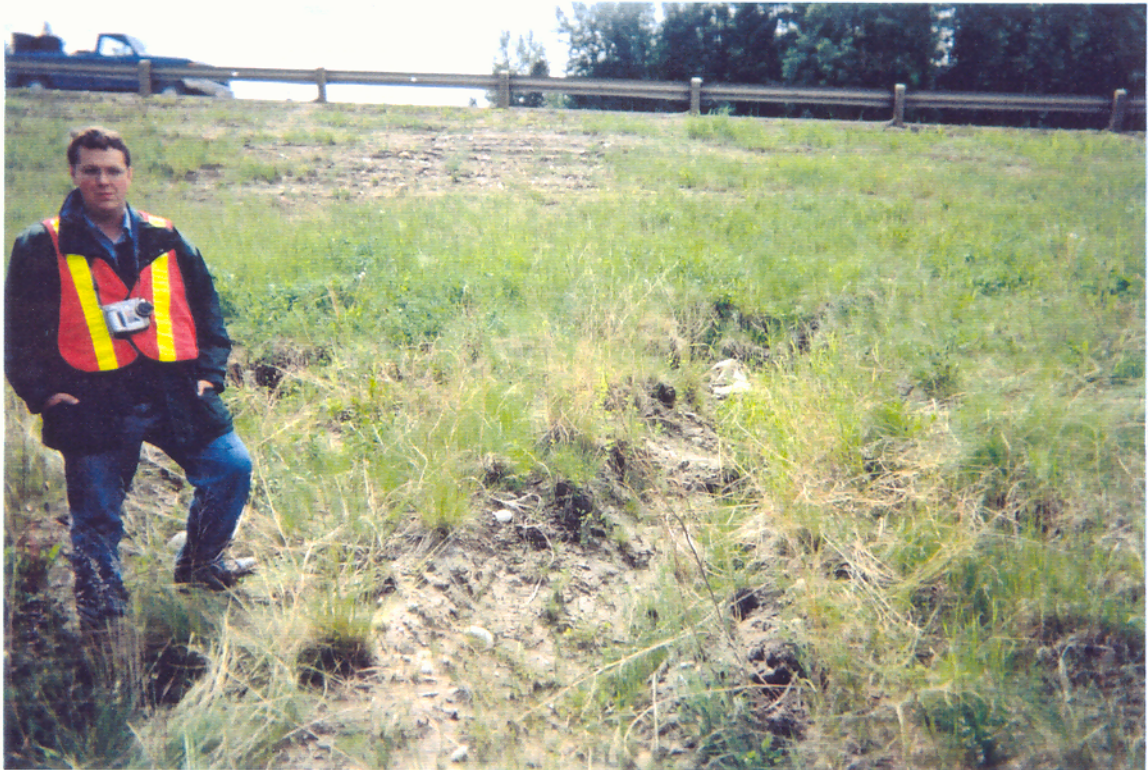
Local erosion (gulying) was noted in the side slope approximately 5 m to 10 m north of the edge of pavement of the west bound lanes, at a location adjacent to the eastern edge of the utility corridor in the vicinity of Station 1+920. This erosion feature was first noted during the 2000 site reconnaissance. A photograph is included in Section F.

EROSION GULLIES NEAR STATION 1+920

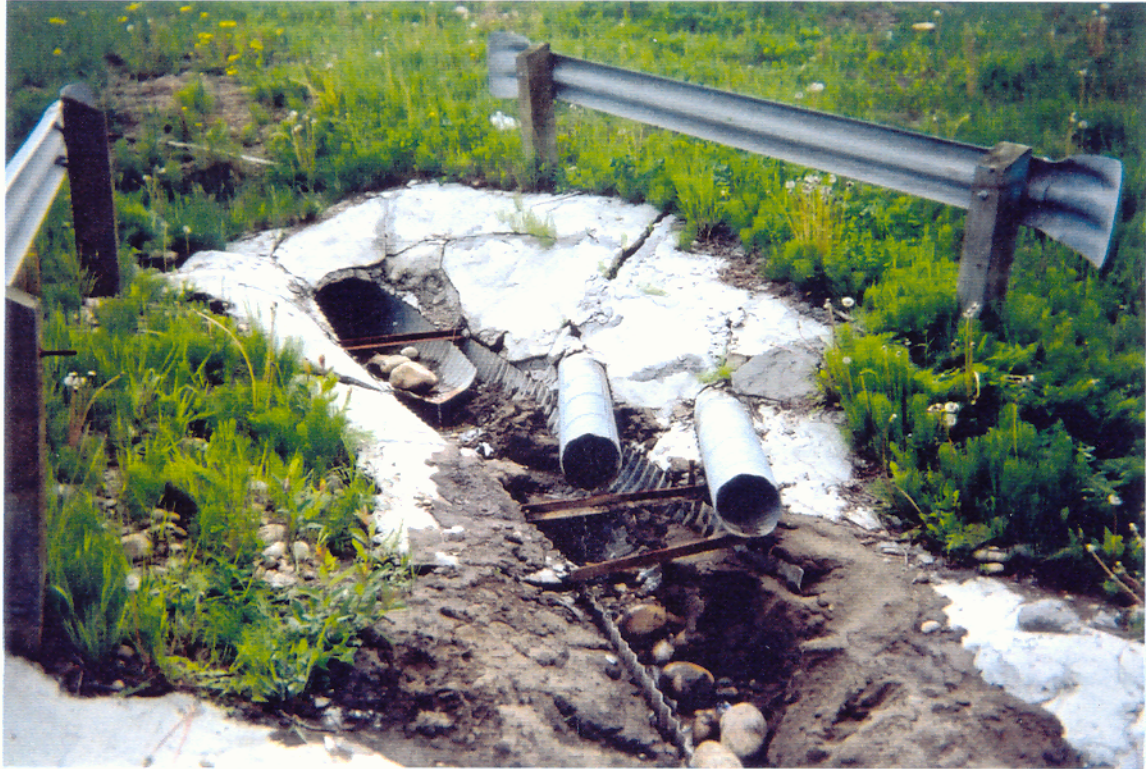
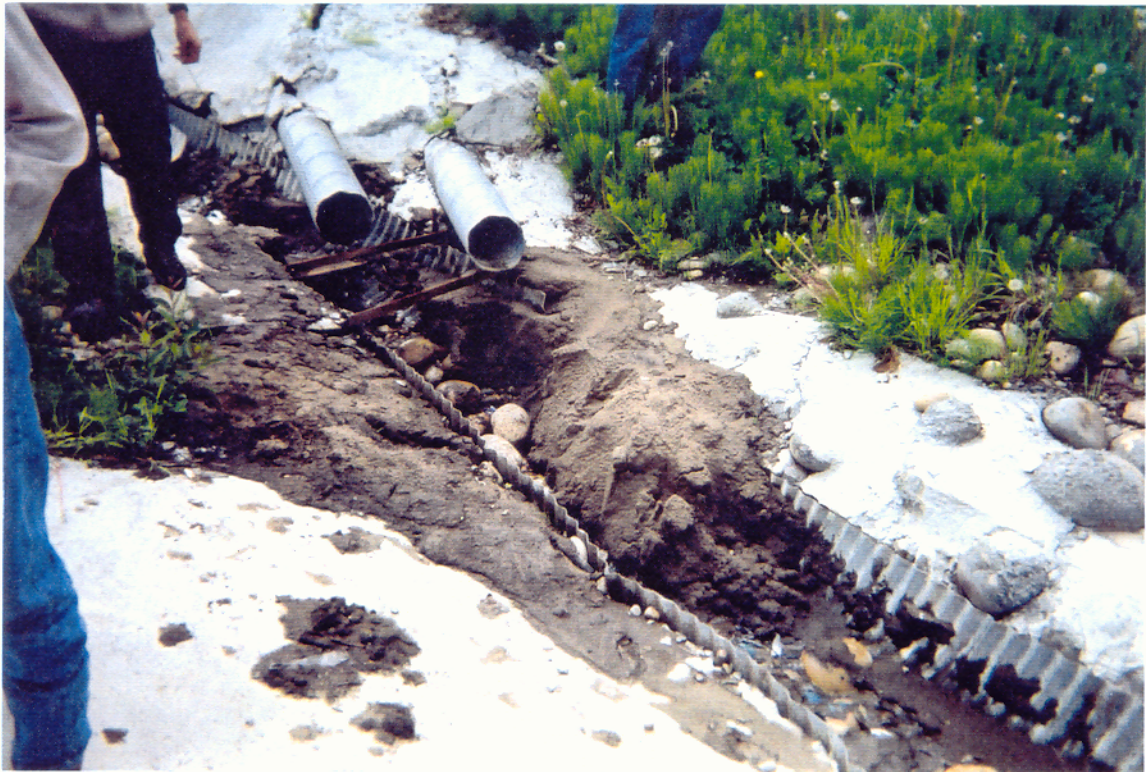
As noted initially during the 2000 site visit, the concrete work has dropped and separated from the half round pipe located between the two culverts. Photographs of the culvert from the 2001 visit are included in Section F. Water from the south ditch upslope of the area still appears to be entering under the half round pipe, creating the potential for water to travel on the outside of the centreline culvert. In addition, washout of sand from behind the concrete work has occurred which has partially blocked the half round culvert (see photographs).

SUBDRAIN AND CULVERT OUTLETS NEAR STATION 1+680  
(SOUTH OF HIGHWAY)

Recommendations for maintenance at the Whitecourt East Hill site were provided on site to Mr. Yagos and were outlined in a fax document to Mr. Terry Carter, P.Eng. of AT (Edson) dated July 11, 2001 (attached). The maintenance consisted of repair of the concrete areas around the subdrainage outlet and culvert inlet at Station 1+680, and repair of the erosion gullies in the highway sideslope near Station 1+920. In addition, recommendations were provided to extend and armour the culvert outlet located on the north side of the highway between approximate Stations 1+700 and 1+750 (actual chainage not known). It is understood from Mr. Yagos that this work was to have been undertaken during the week of November 19, 2001.

As noted in the 2000 report, it is expected that frost action will continue to have a negative effect on the concrete and half round culvert in the vicinity of Station 1+680. Hence ongoing maintenance will be required to maintain flow of water into the lower culvert at this location. Alternatively, a buried (and possibly insulated) piping solution may be considered for the intersection of these water sources to reduce the likelihood of piping occurring around the lower culvert inlet.

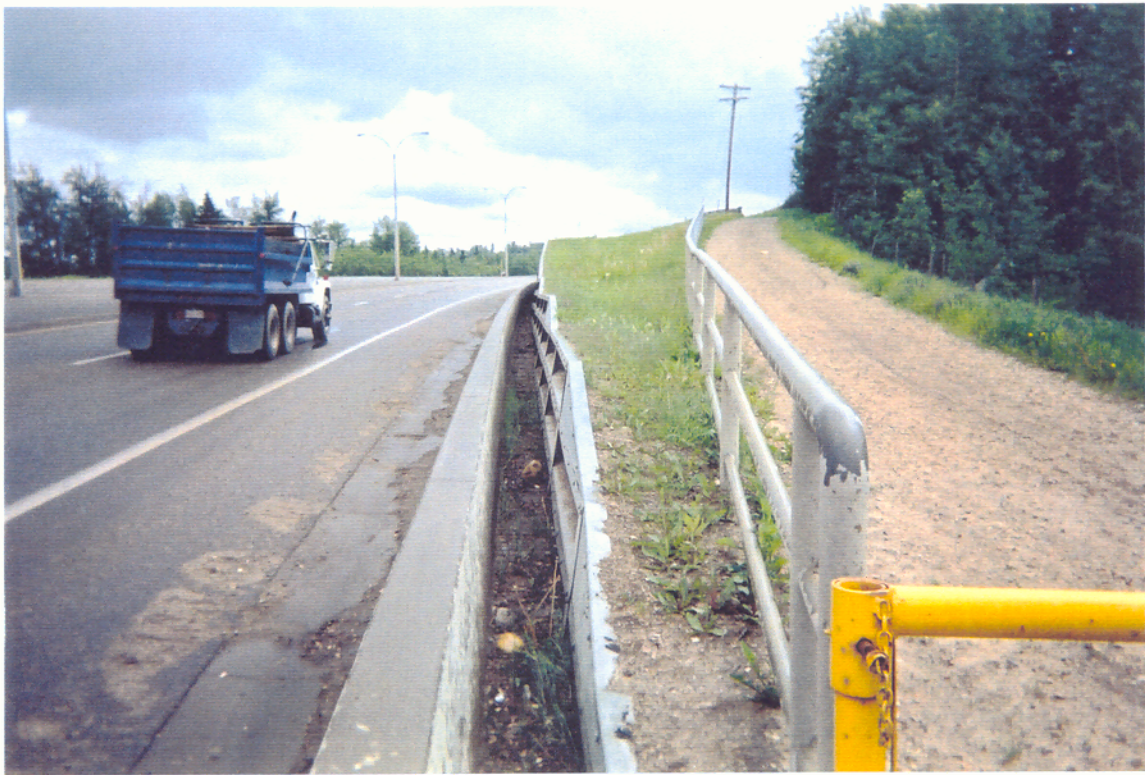
The bin wall and backslope area above the bin wall near the bottom of the east hill were inspected. The bin wall is located between the access road to the McConnell property and the highway, near Station 1+200 at the bottom of the hill. The bin wall profile appears relatively uniform; no significant bulging or deformation was observed (see photos in Section F).

BIN WALL, STATION 1+200 LOOKING NORTHEAST

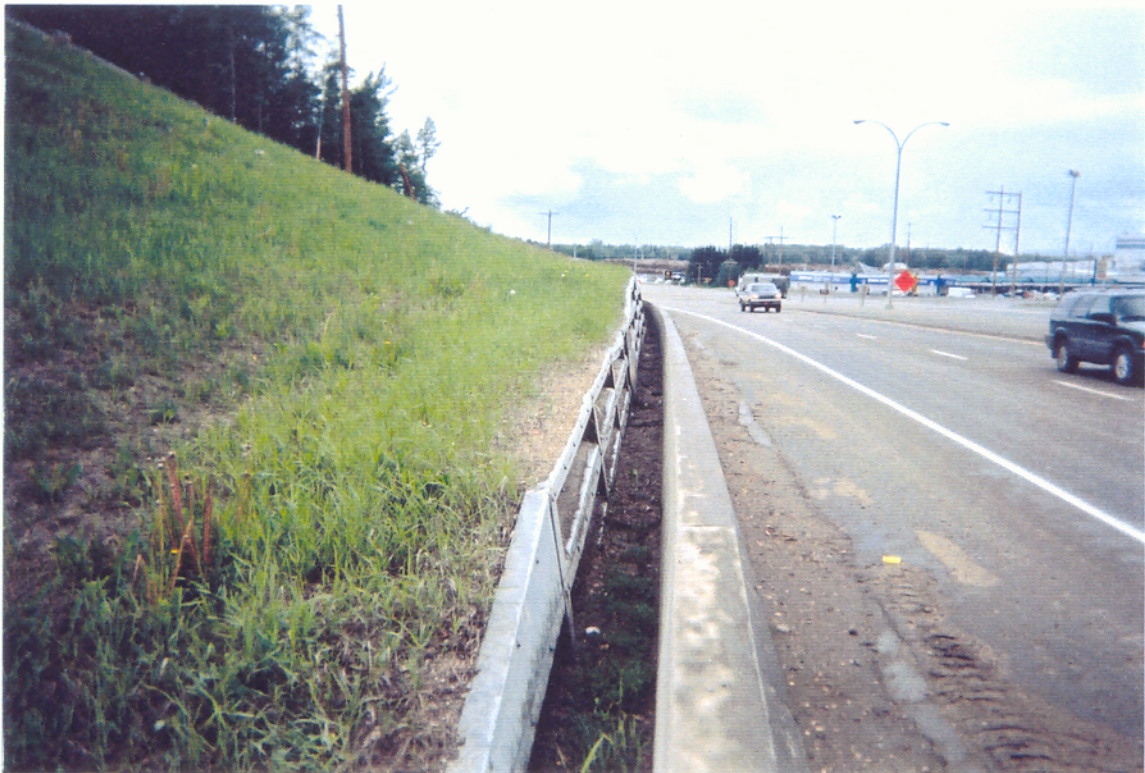
BIN WALL, STATION 1+200 LOOKING WEST
