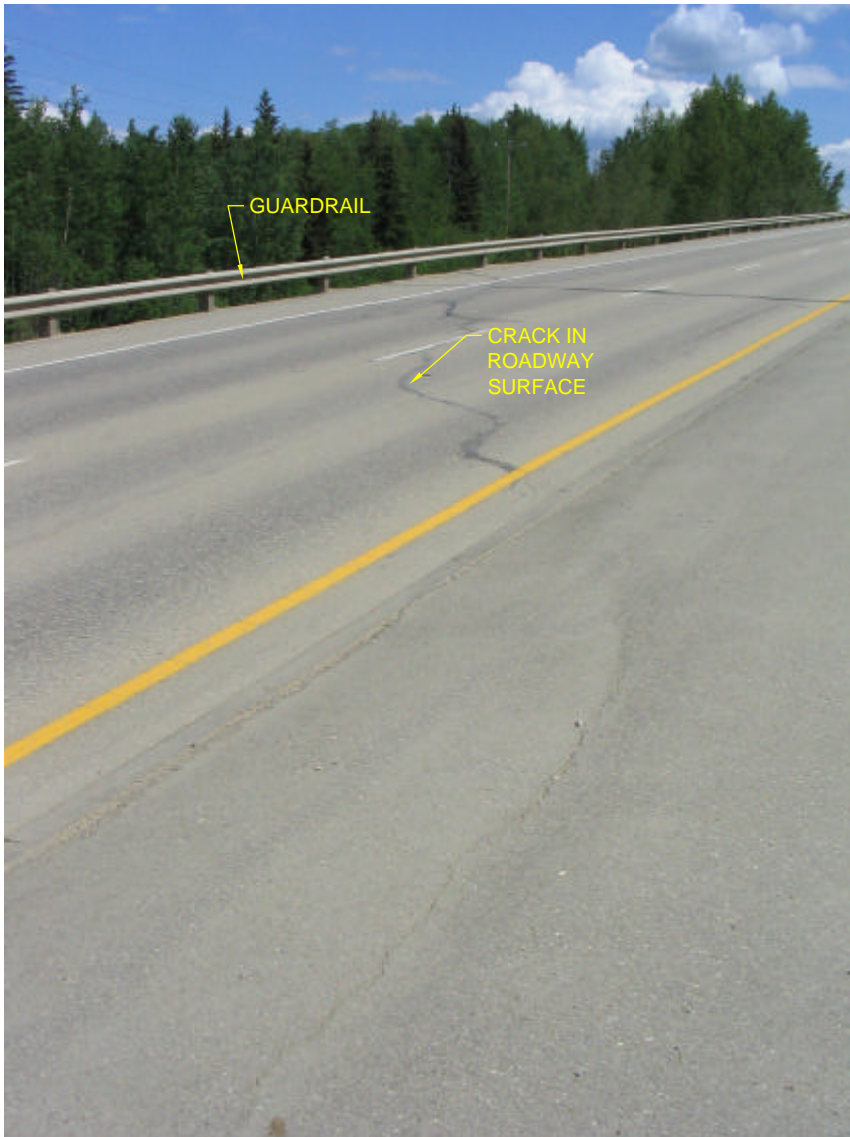
PHOTO 1 LOOKING EAST ON WESTBOUND LANES AT THE LOCATION OF ROADWAY WEST CRACK

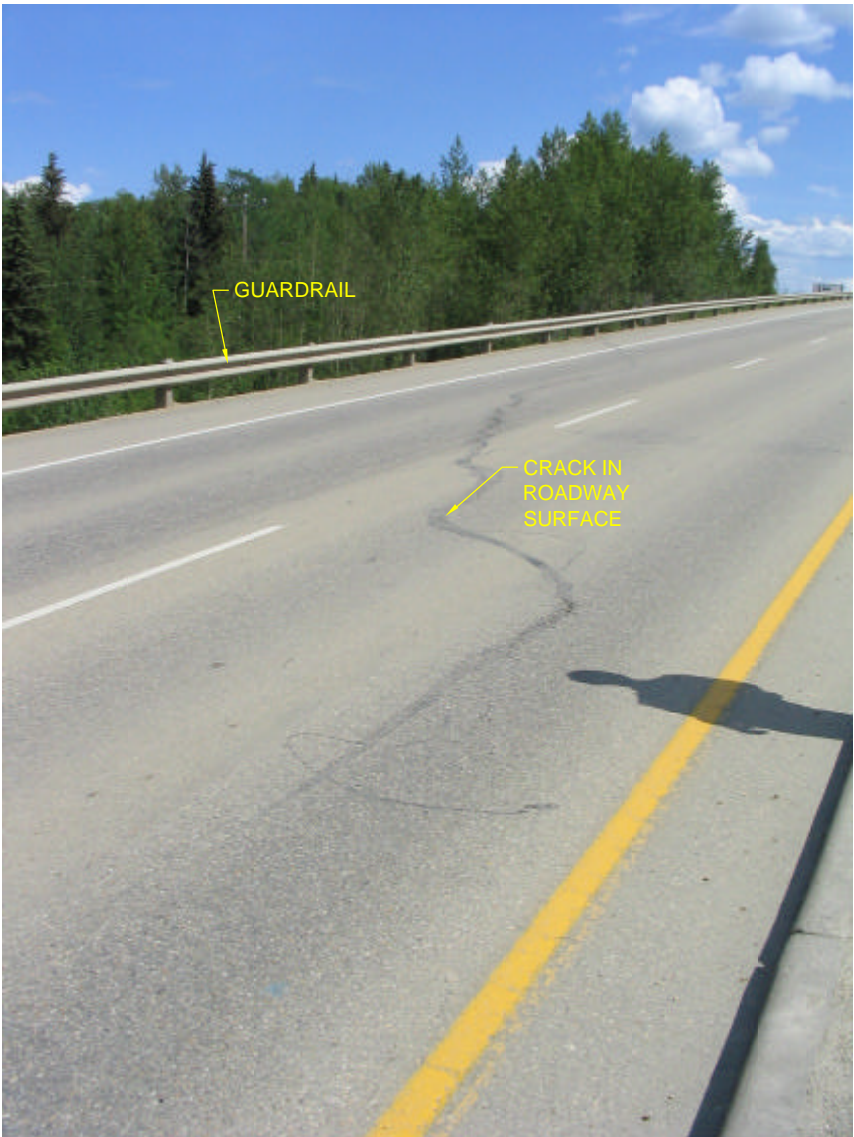
PHOTO 2 LOOKING EAST ON WESTBOUND LANES AT THE LOCATION OF ROADWAY EAST CRACK

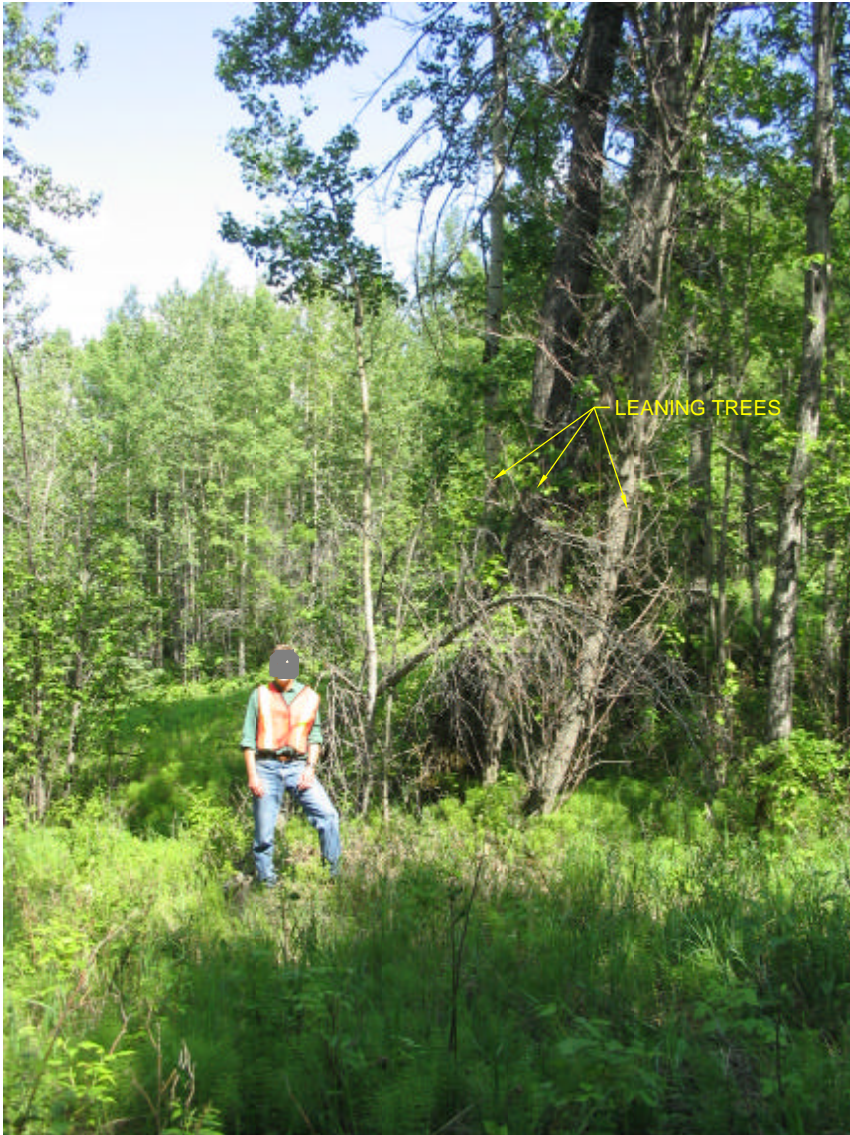
PHOTO 3 LOOKING WEST AT POTENTIALLY UNSTABLE AREA DOWNSLOPE OF THE ROADWAY

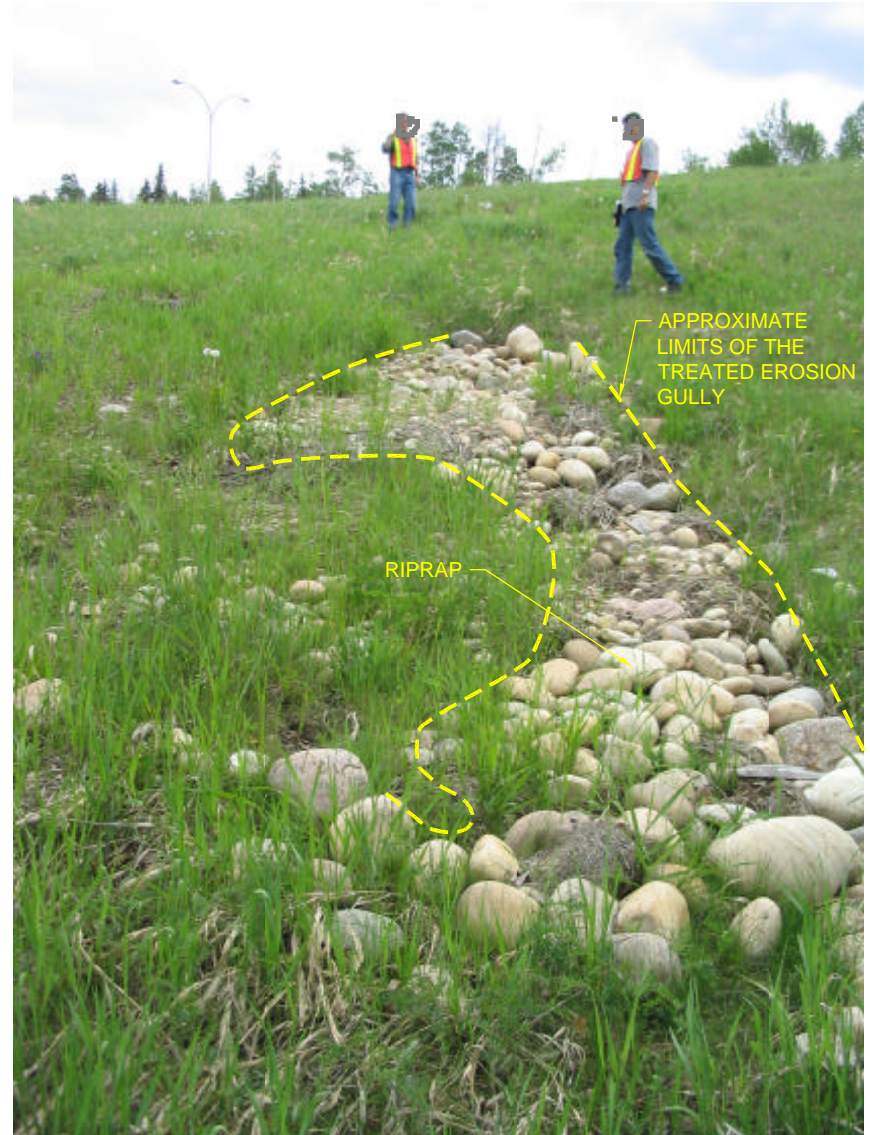
PHOTO 4 AN EROSION GULLY ON THE ROADWAY DOWNSLOPE TREATED WITH RIPRAP

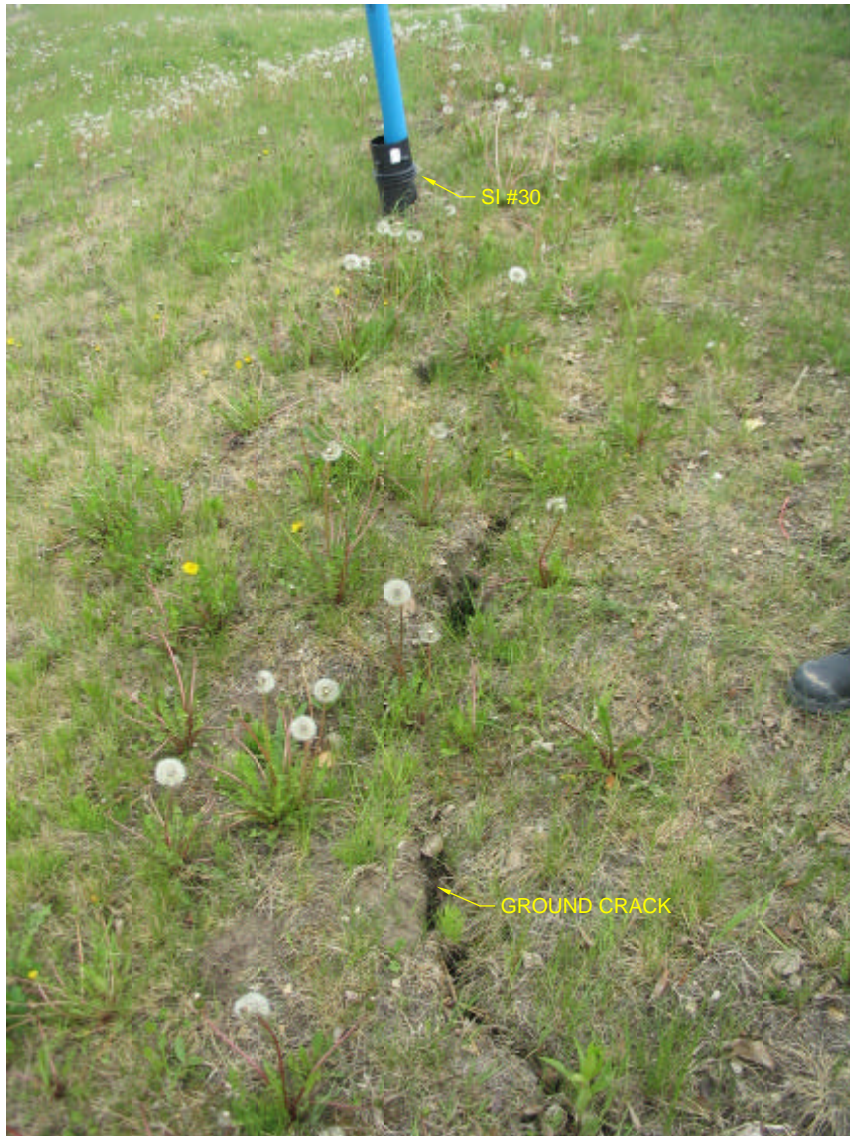
PHOTO 5 CRACK IN THE BACKSLOPE ABOVE THE BIN WALL

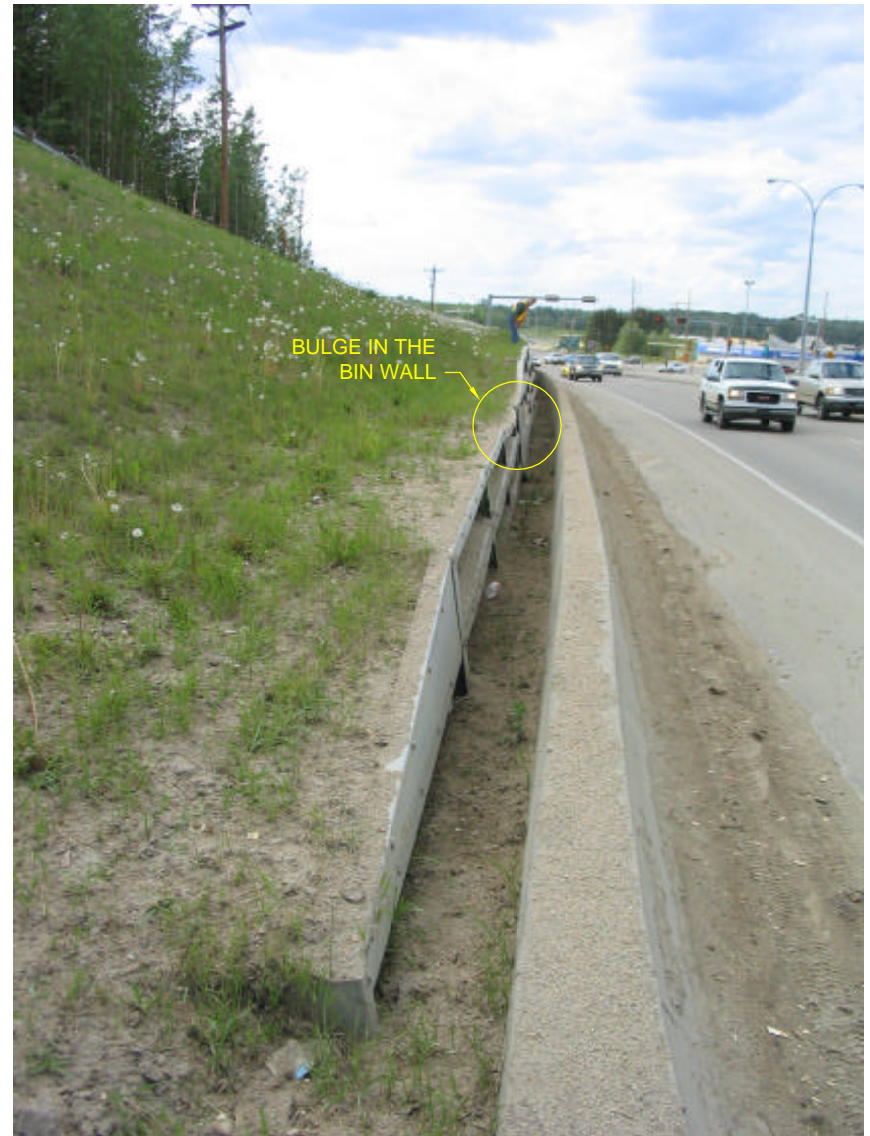
PHOTO 6 BULGE IN THE EAST SECTION OF THE BIN WALL
