January 29, 2003

File: 15-76-11

**NORTH CENTRAL REGION LANDSLIDE ASSESSMENT  
SH 748:02 NORTH OF EDSON RIVER BRIDGE (NC15)  
2002 ANNUAL INSPECTION REPORT**

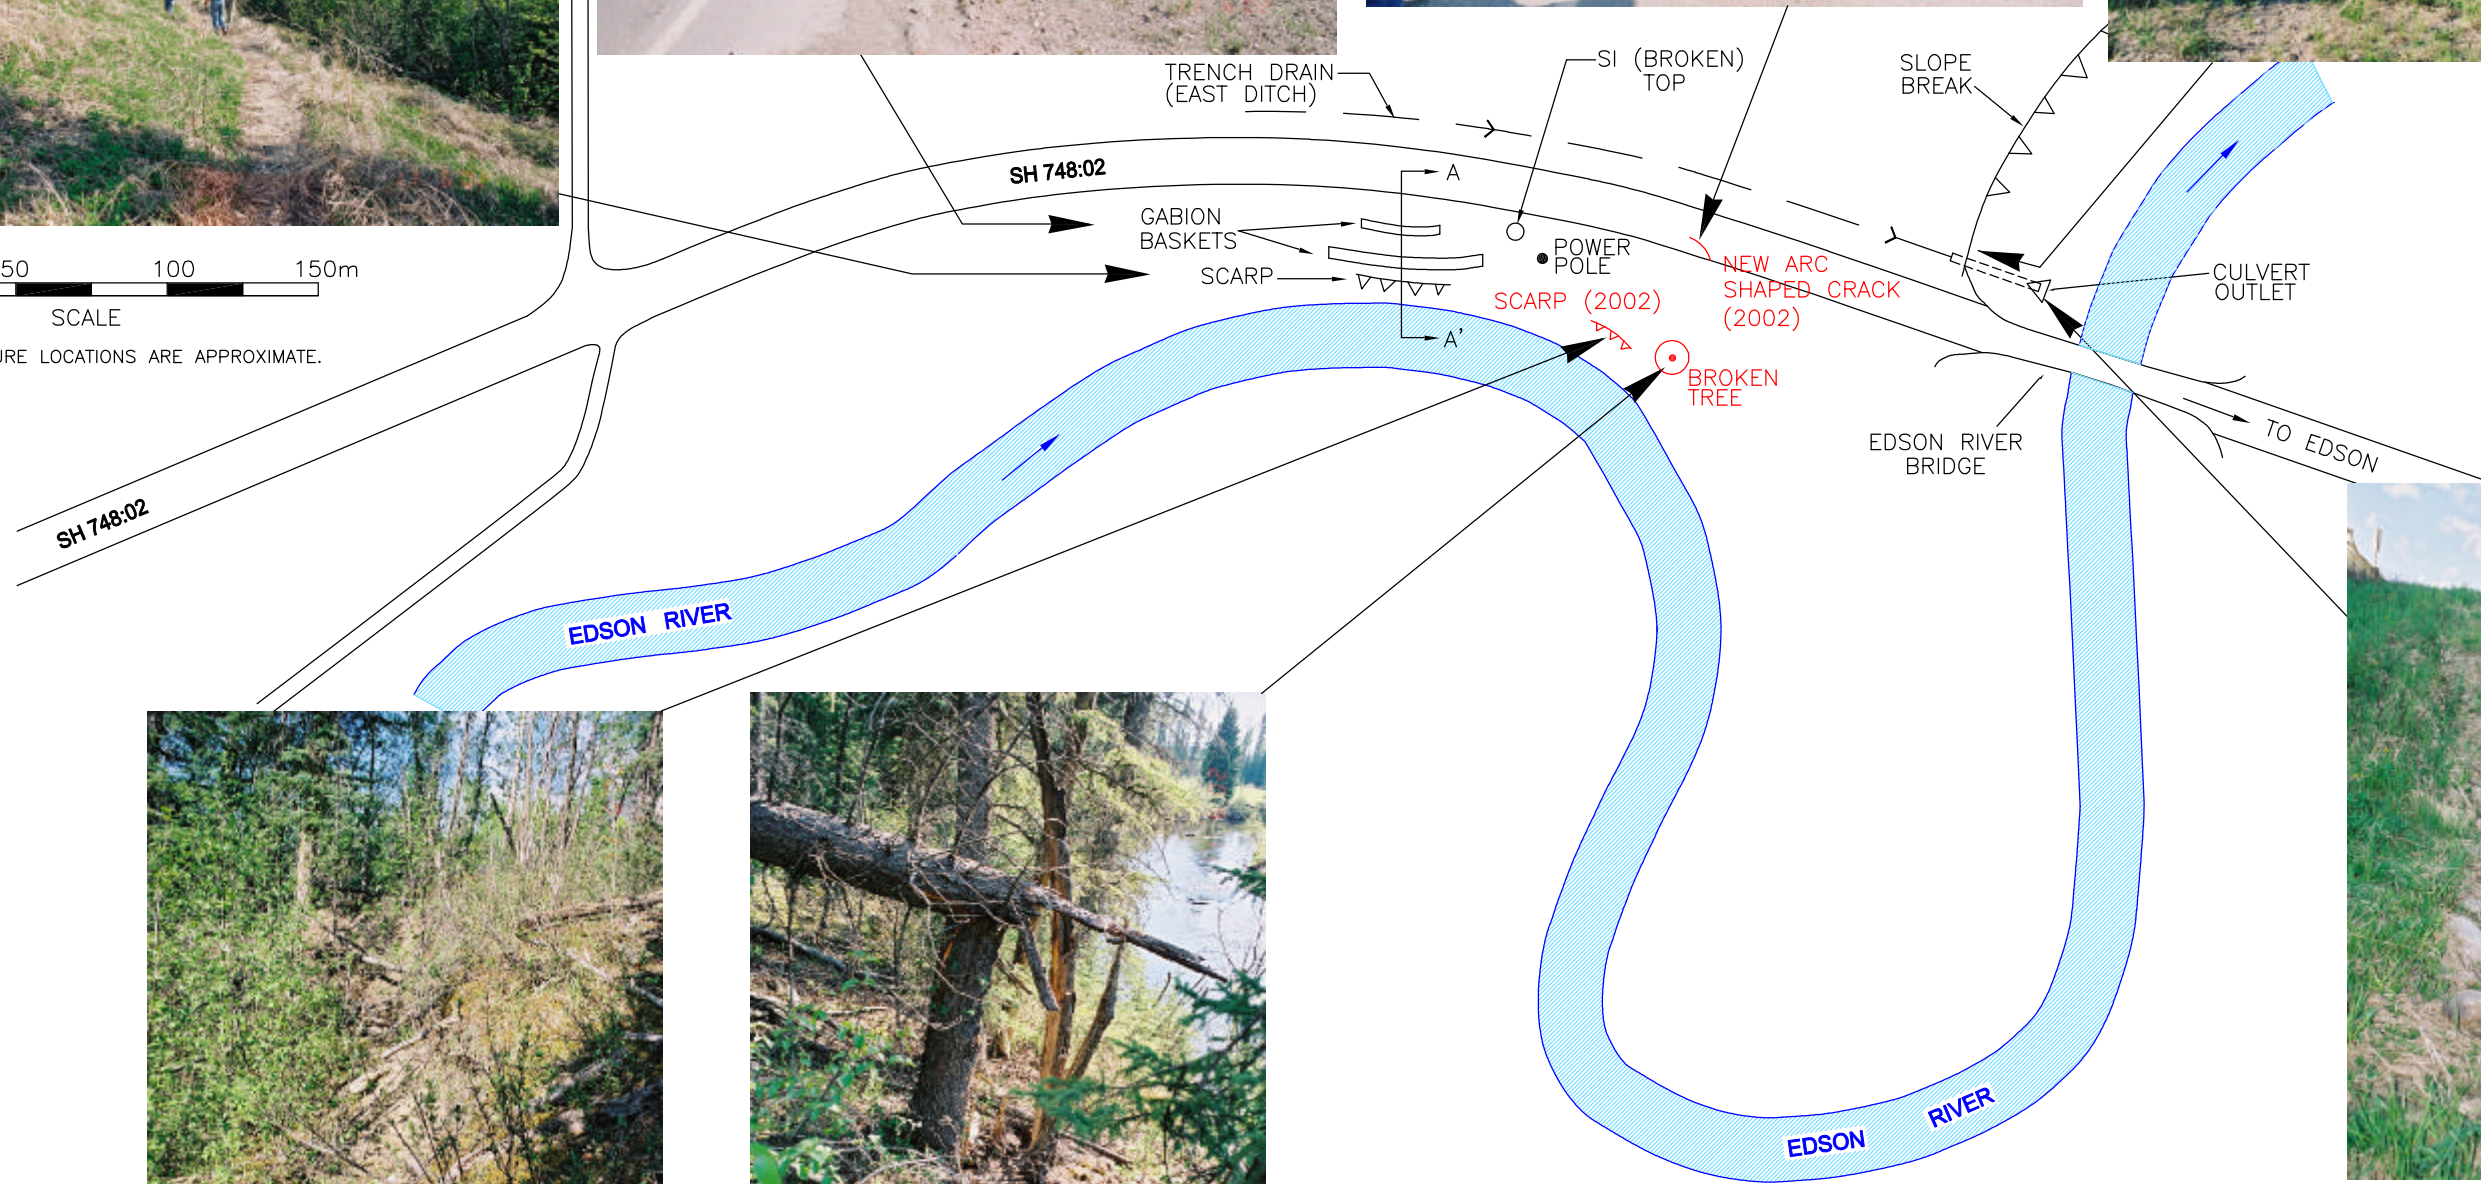
FIGURE NC15-1 (2002)

- An arc shaped crack approximately 2 metres long was noted in the roadway surface, located about 40 metres south of the retaining wall area approximately as shown on the site plan. There was no differential height across the crack at the time of the site reconnaissance.
- Slope movement was observed in the side slope at this location. A 15 m to 20 m long scarp feature was noted close to the river, splitting a tree. Photos of the pavement crack and scarp are provided in Section F.

Continued visual monitoring of the area south of the repair should be undertaken. If further crack development occurs, consideration should be given to installation of slope monitoring instrumentation (inclinometers and piezometers) to gather geotechnical data to allow for design of remedial measures.
