**NORTH CENTRAL REGION LANDSLIDE ASSESSMENT  
H39:06 – SLIDE NEAR GREENWOOD LAKE ROAD (NC23)  
2002 ANNUAL INSPECTION REPORT**

This letter documents the 2002 annual site inspection of a portion of Highway 39:02 located at km 12.6. The work was undertaken by Thurber Engineering Ltd. (Thurber) in partial fulfillment of our Geotechnical Services, Monitoring and Assessment of Instrumentation and Landslides contract with Alberta Transportation (AT).

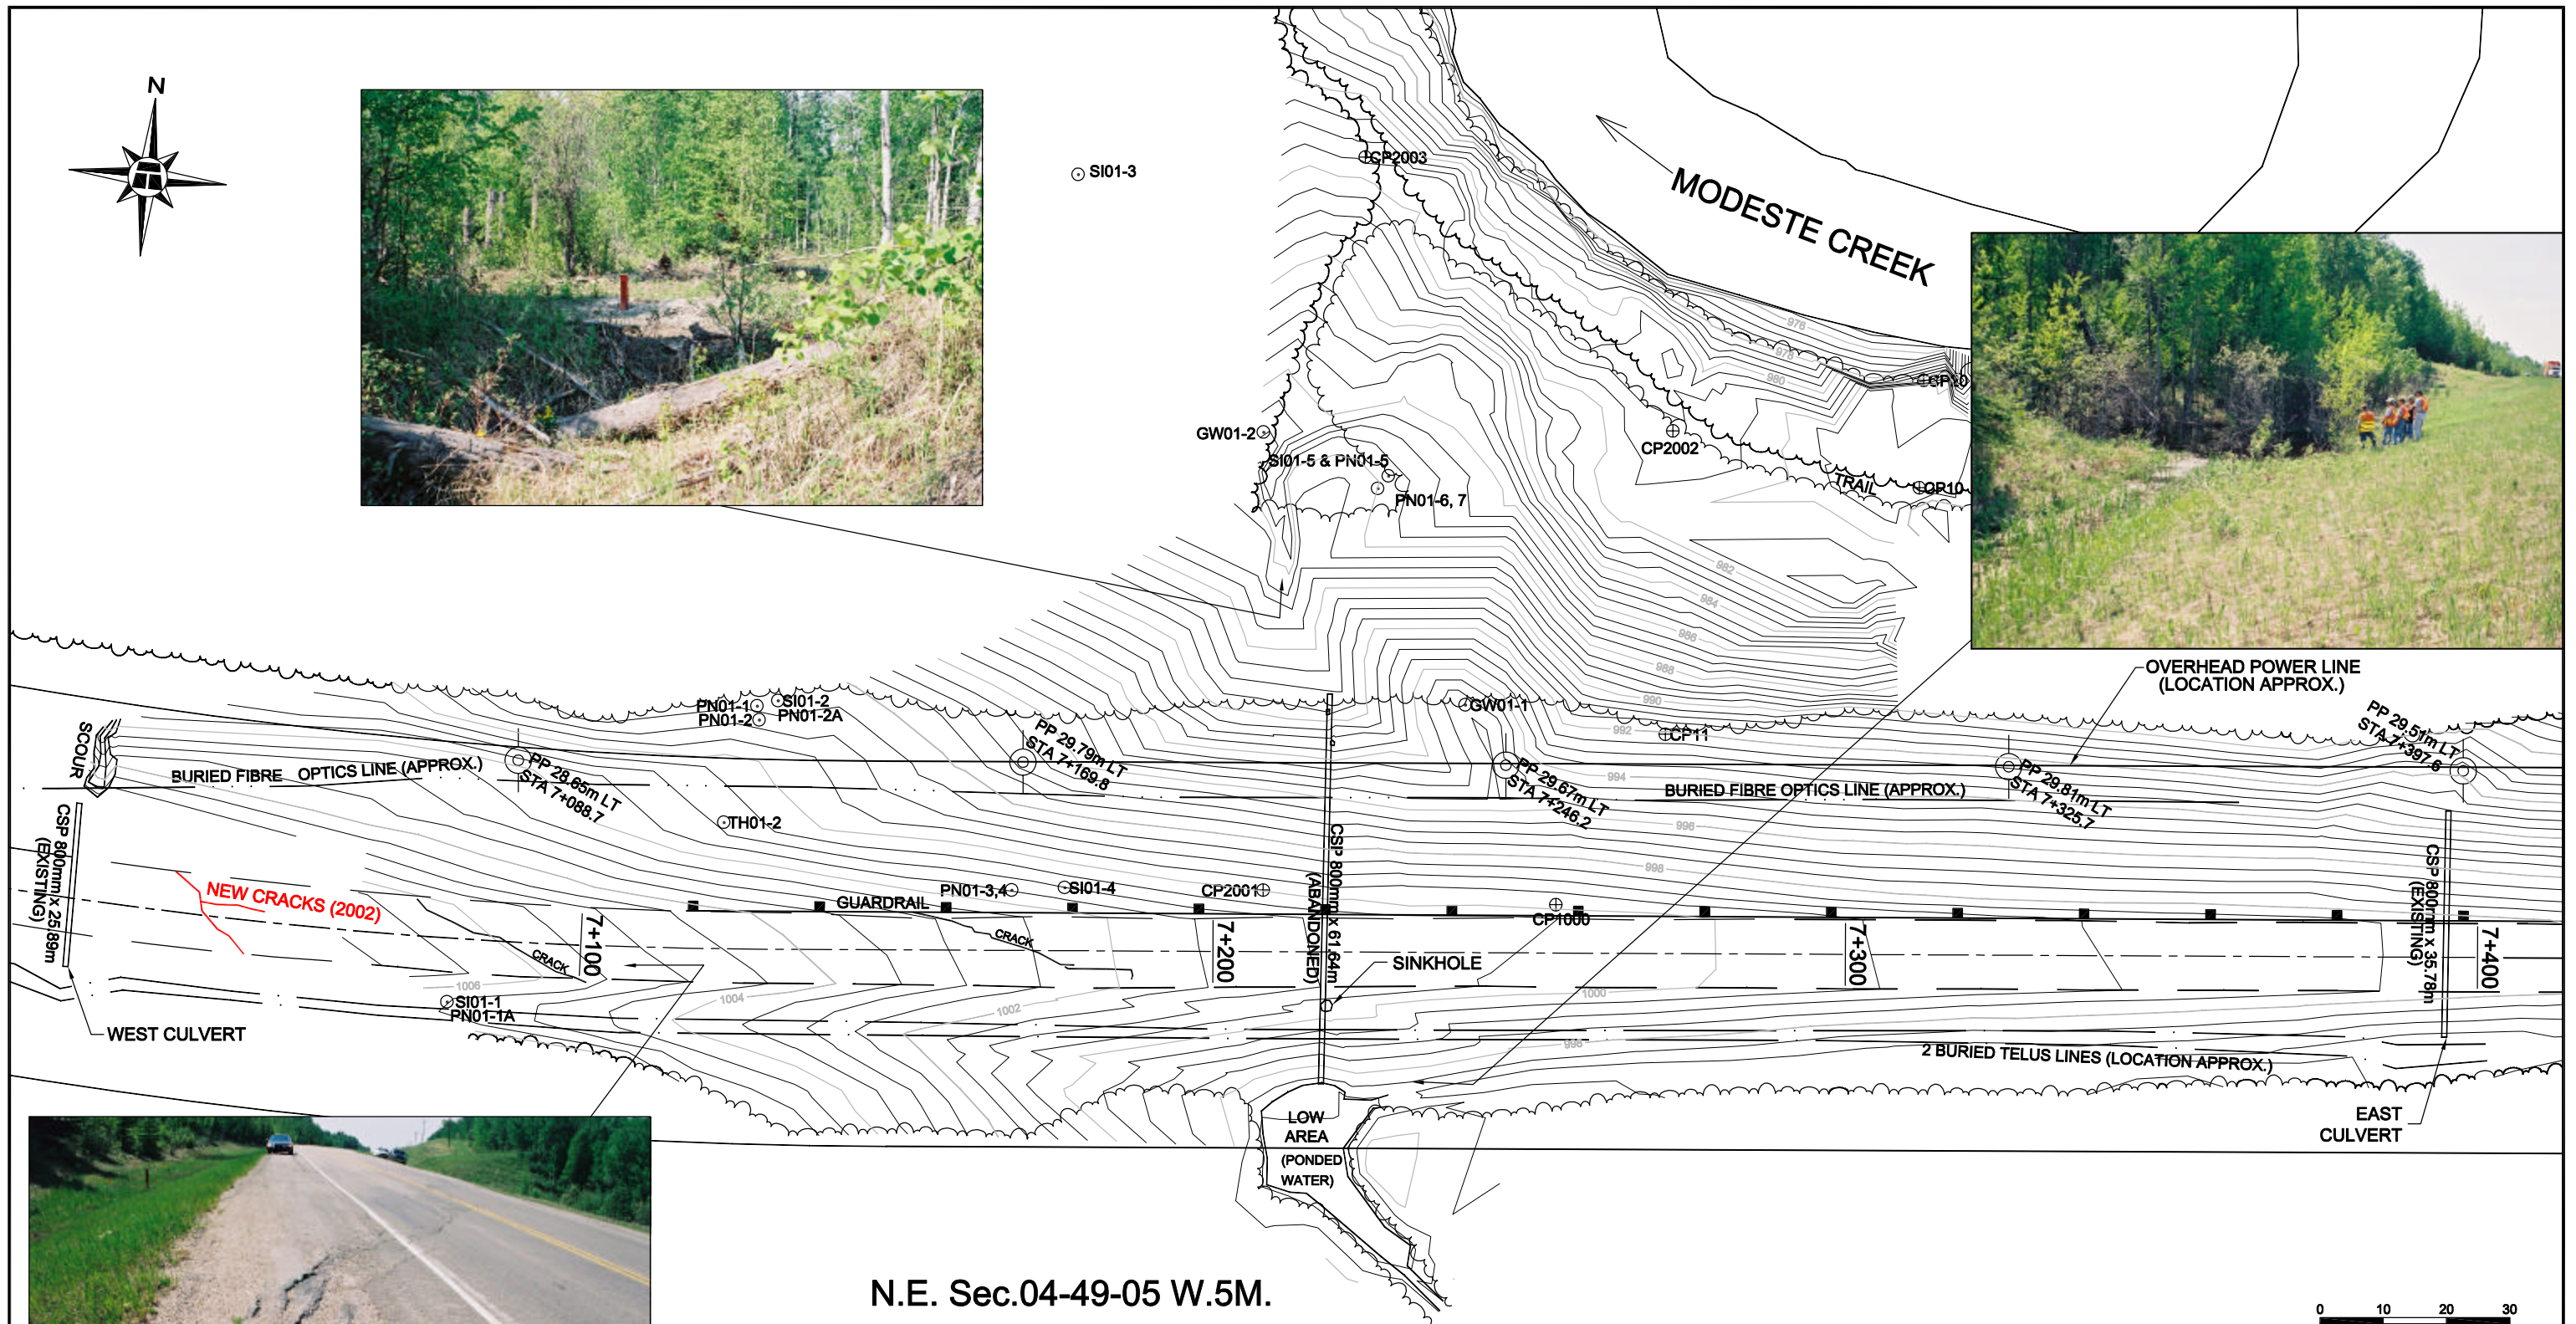
DRAWING No.  
FIGURE NC23-1 (2002)

- Tension cracking within the pavement surface was noted in three locations along the highway, located as shown on the site plan between the west culvert and the center (abandoned) culvert. The two easternmost cracks were present during the first site visit in 2001 and have some sections with crack widths of up to 25 mm and differential heights of up to 20 mm. The western most crack was new (i.e. not observed in 2001) and had no significant differential height across it.

- No signs of slope movement were observed on the back slope (south of the highway). A low area fed by an intermittent creek located south of the abandoned culvert inlet was filled with water at the time of the site reconnaissance. Drainage via the east ditch from the culvert inlet area is not effective at removing the water from this area. A sink hole exists above the abandoned culvert adjacent to the south pavement edge, with a diameter of about 0.6 m and a depth of approximately 0.4 m.

- A scour located below the west culvert outlet is slowly progressing towards the north-east along the tree line. This scour crosses a fibre optic line.

- No signs of slope instability were observed along the side slope north of the highway. An old scour feature was observed in the treed area north of the abandoned culvert outlet, resulting from previous water flow through the culvert.

Based on the observation of a new pavement crack made during the reconnaissance and the results of the slope inclinometer readings, slope movements are continuing to occur at this site. The slope movement is likely sustained by high pore water pressures on the failure plane from within fractured bedrock layers that are fed over the local watershed. These pressures and hence movement rates may rise higher with additional precipitation. A supplementary source of water to the slope is the ponded water at the abandoned culvert inlet.

Design work and tender preparation has been completed for this site, which includes regrading of the ponded water area south of the abandoned culvert, installation of a new culvert adjacent to the abandoned culvert, and installation of horizontal wells into the bedrock to relieve pore water pressures on the failure plane. Construction is recommended in 2003 to reduce further movements.
