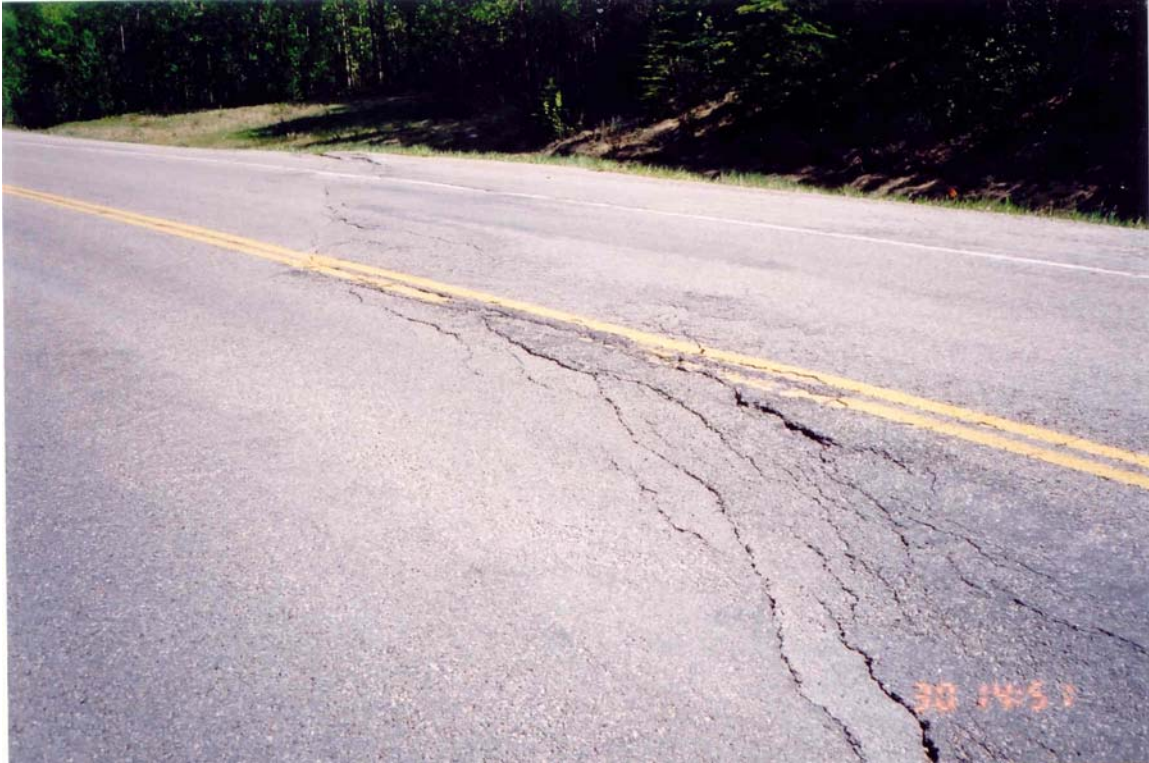
Pavement crack west side looking southeast

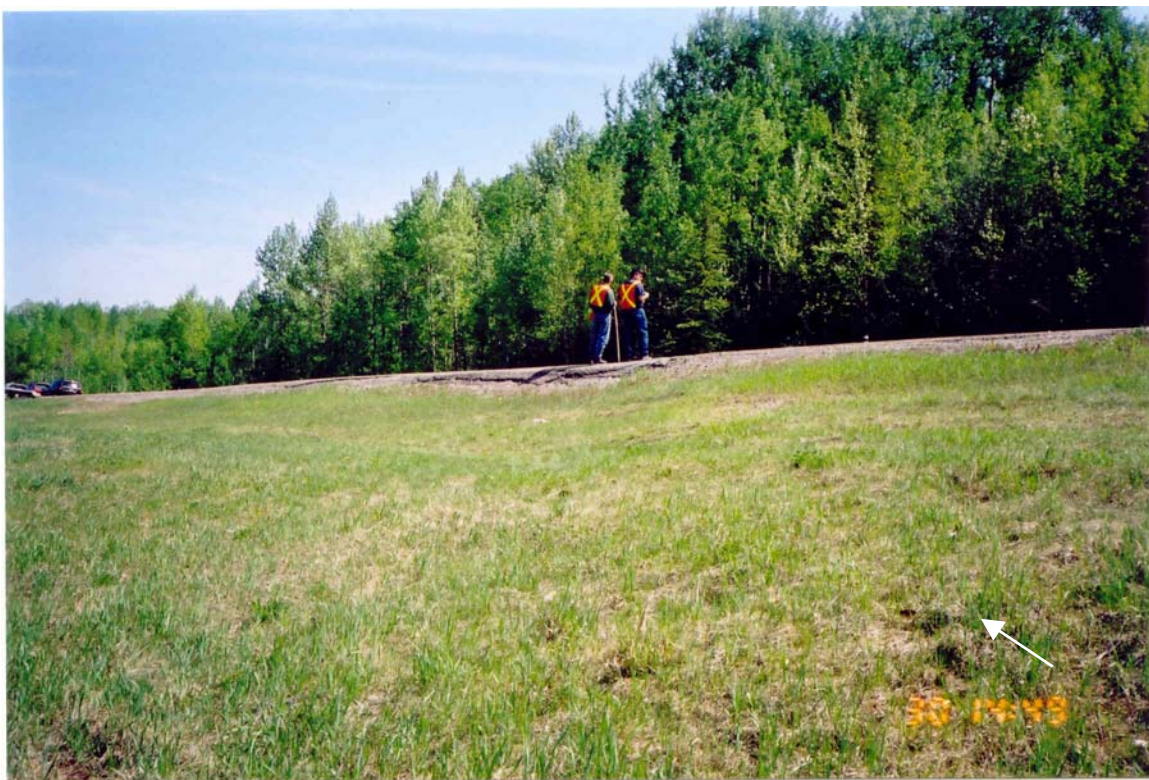
Light scarp forming

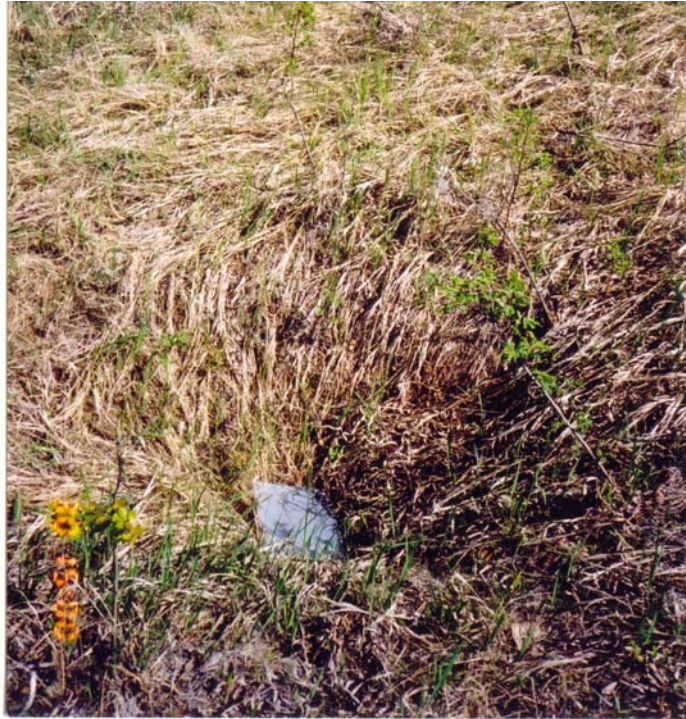
Northeast sink hole

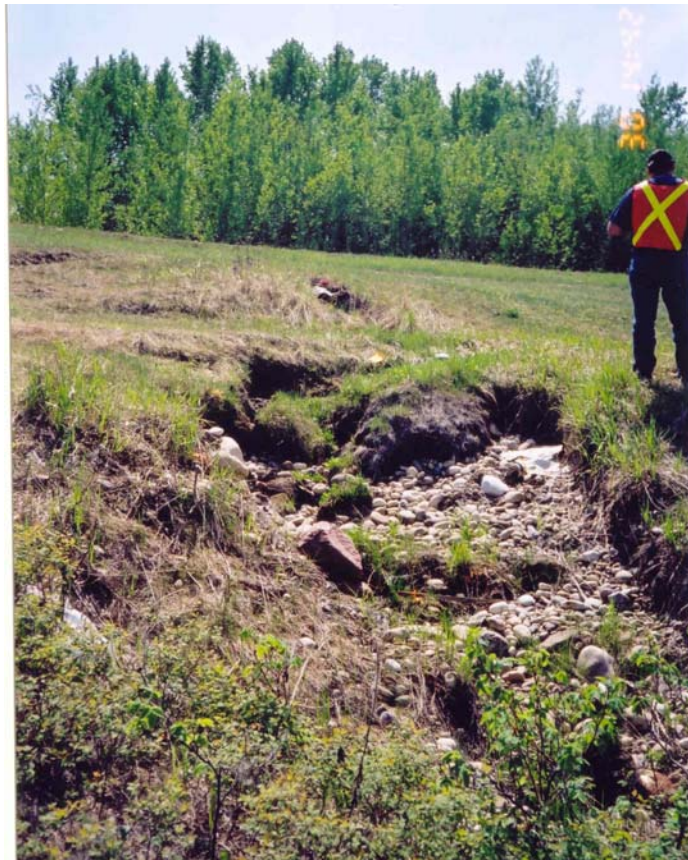
West culvert outlet scour.

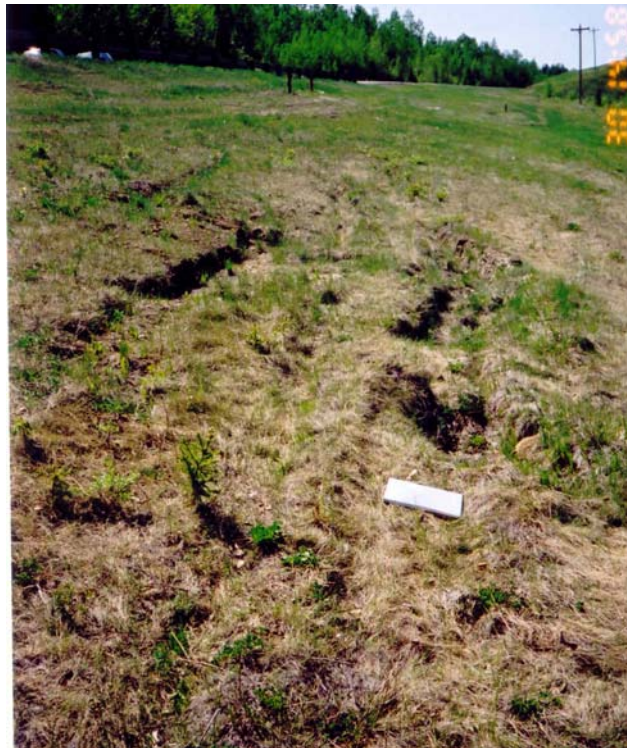
Surface disturbance by track equipment.

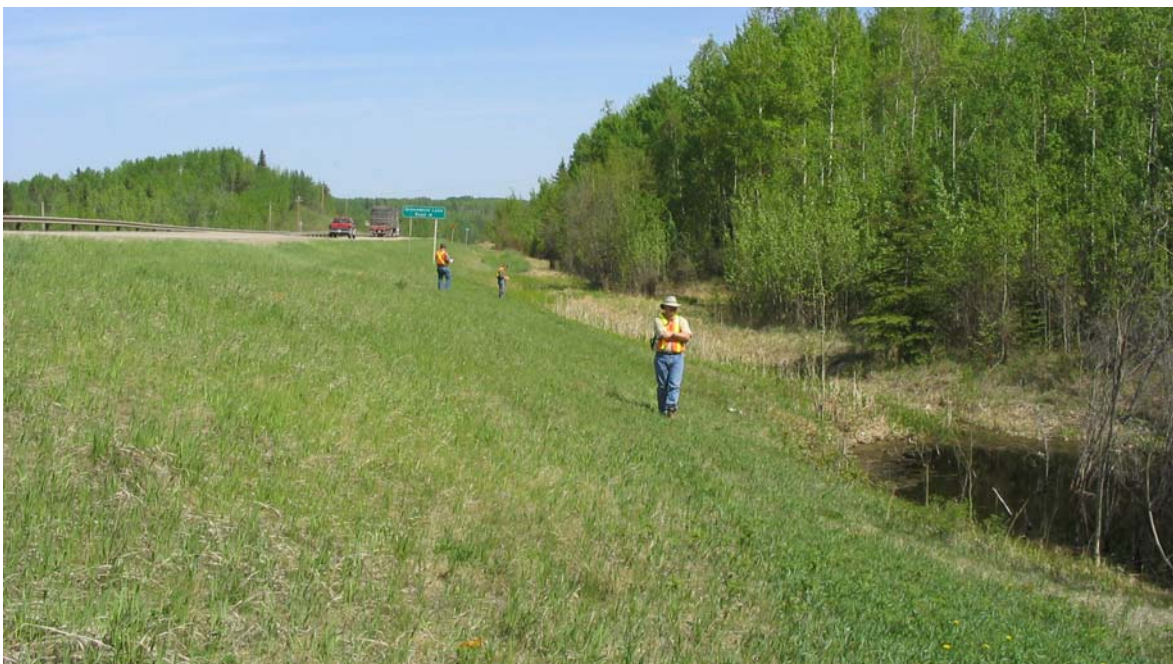
South ditch – water accumulation

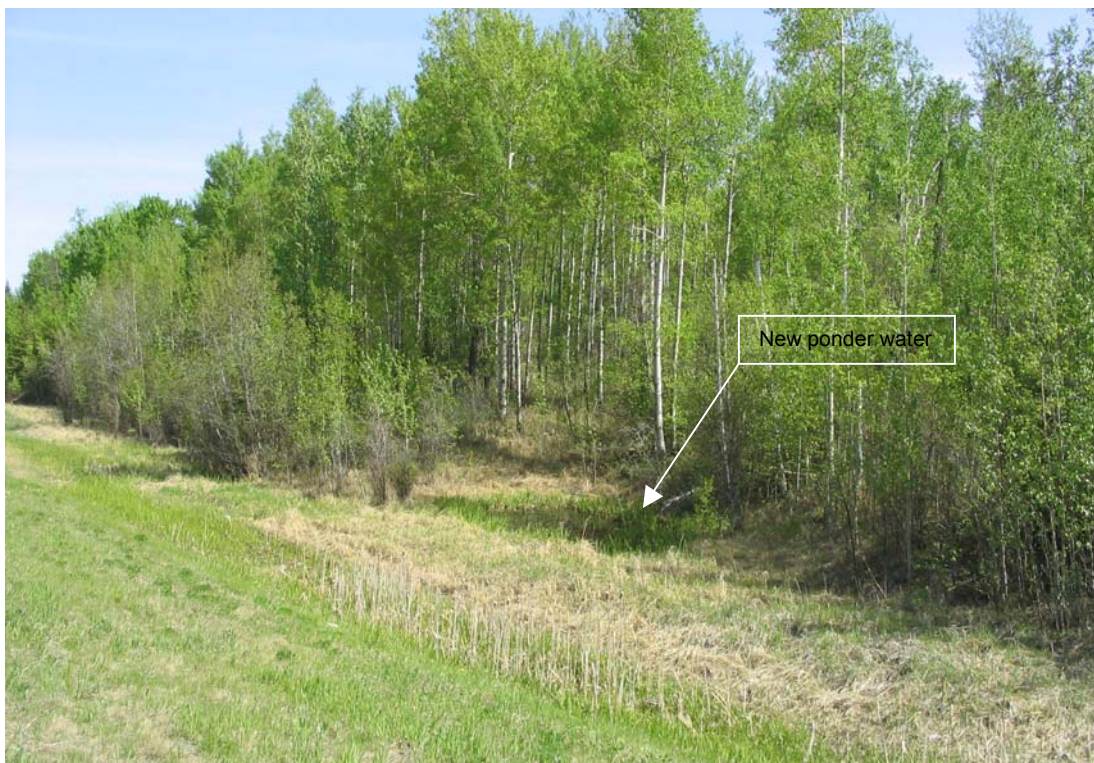
New ponded water east of the abandoned culvert

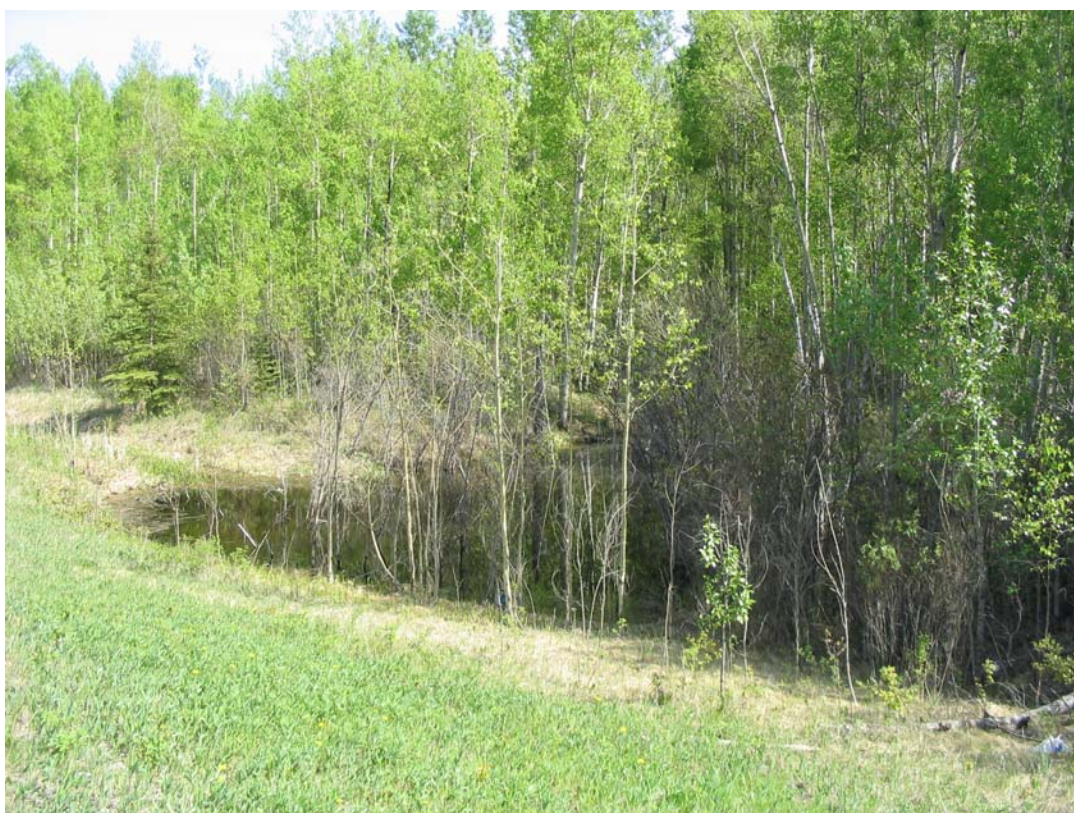
Ponded water at the abandoned culvert inlet area
