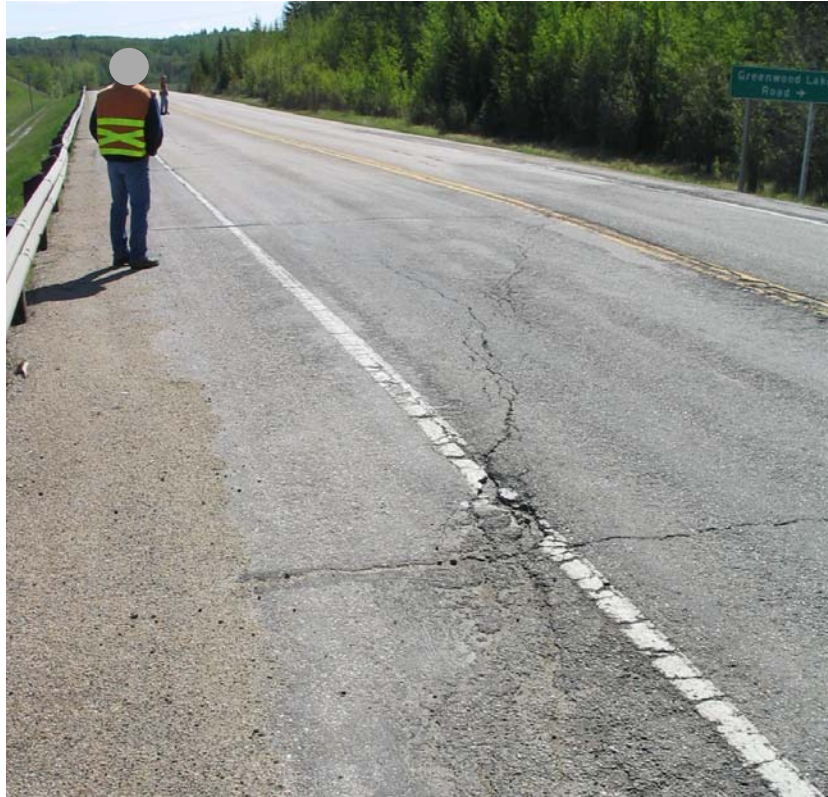
Pavement crack west side looking southeast

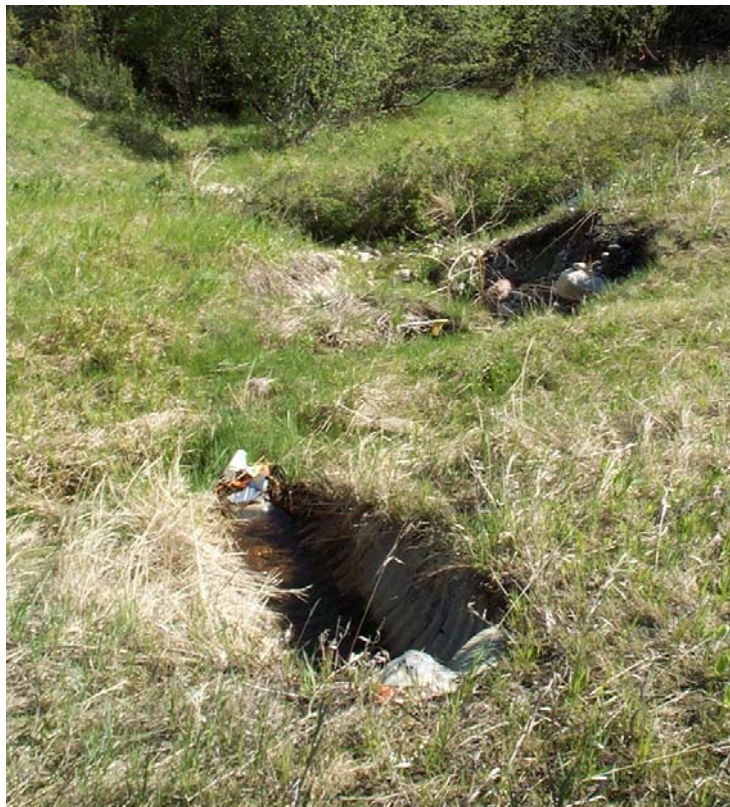
West culvert outlet scour.

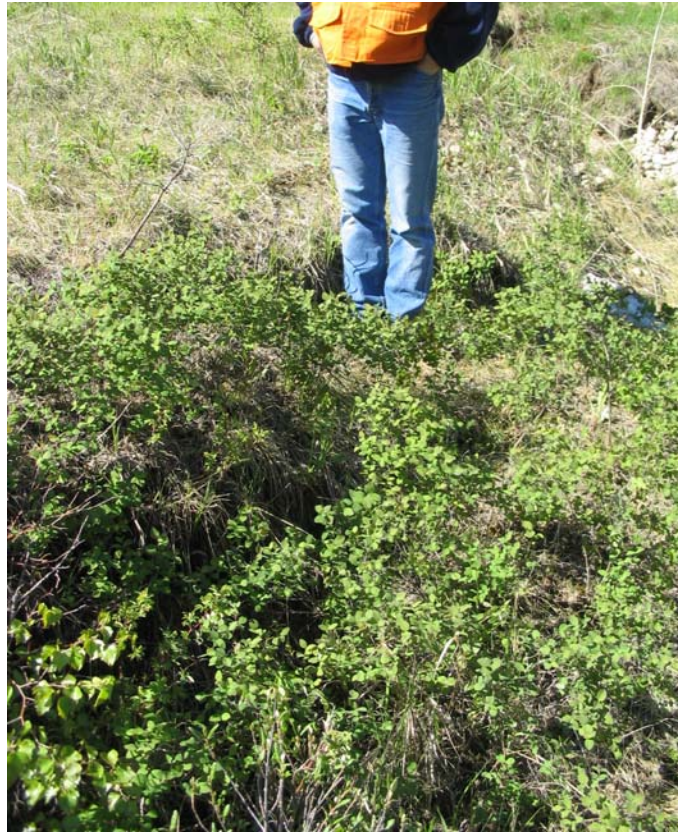
Slump scarp forming down slope of the west culvert.

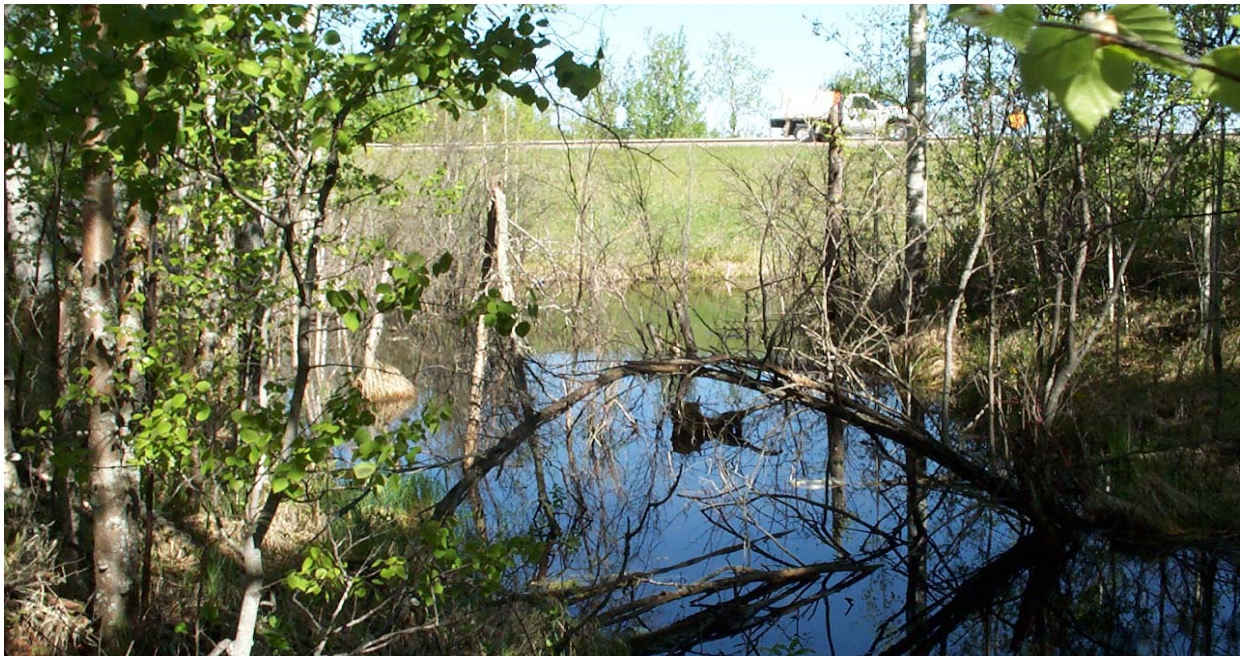
Main ponded water location looking north.

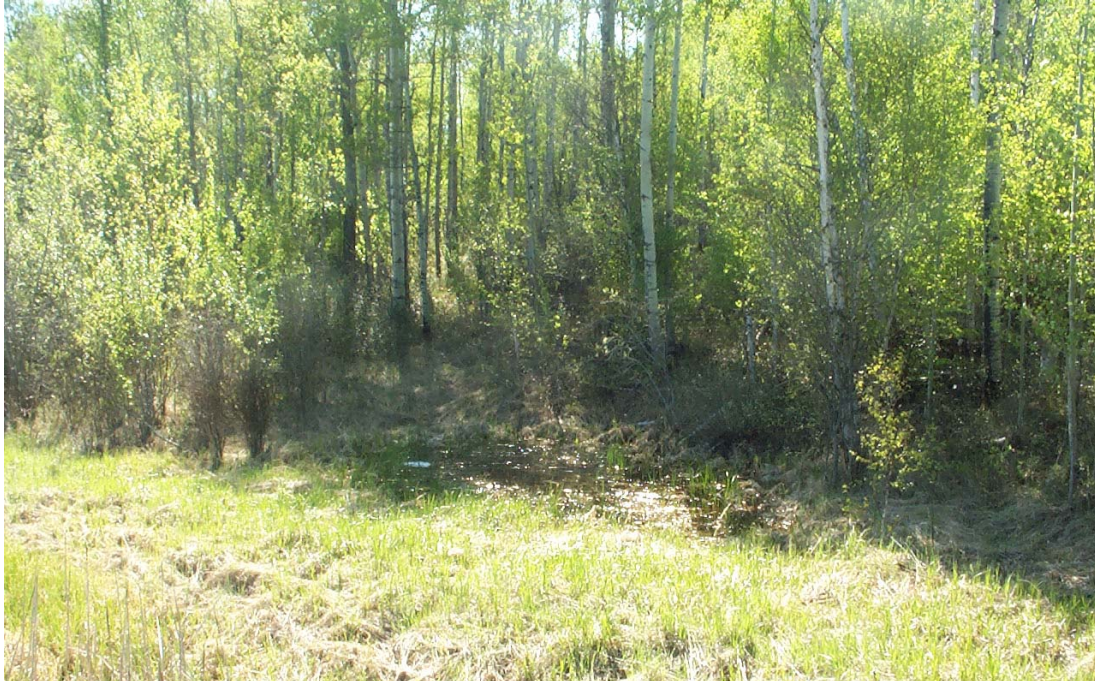
Ponded water east of the abandoned culvert

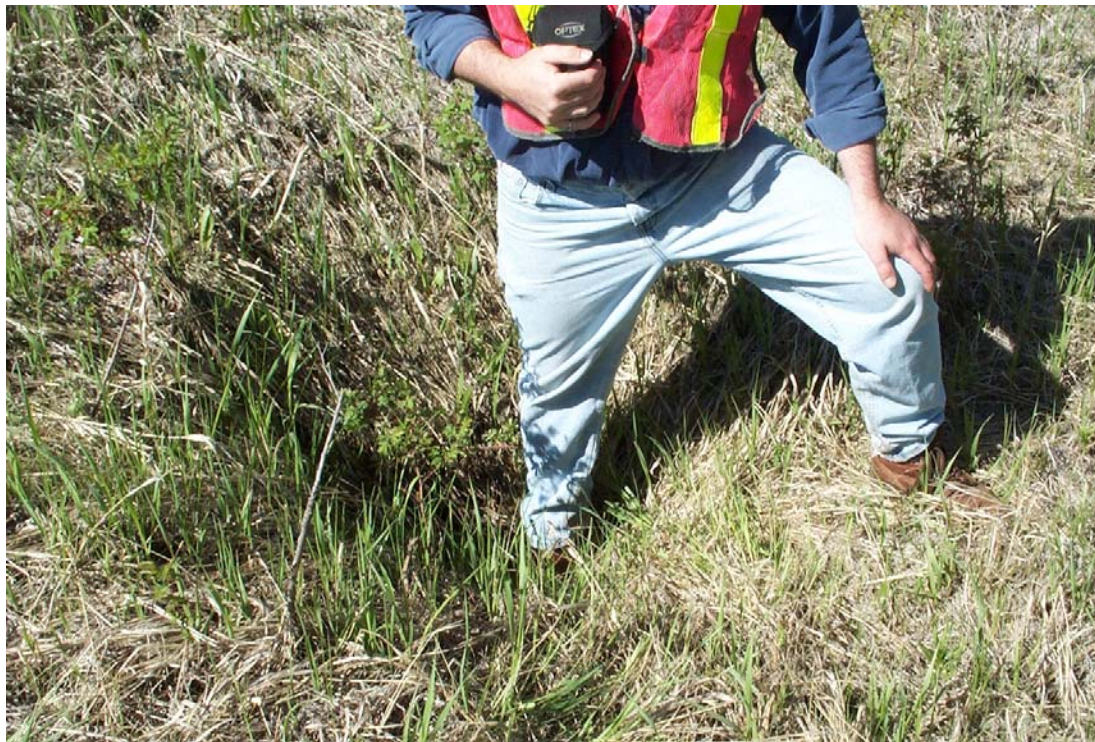
North side sinkhole.
