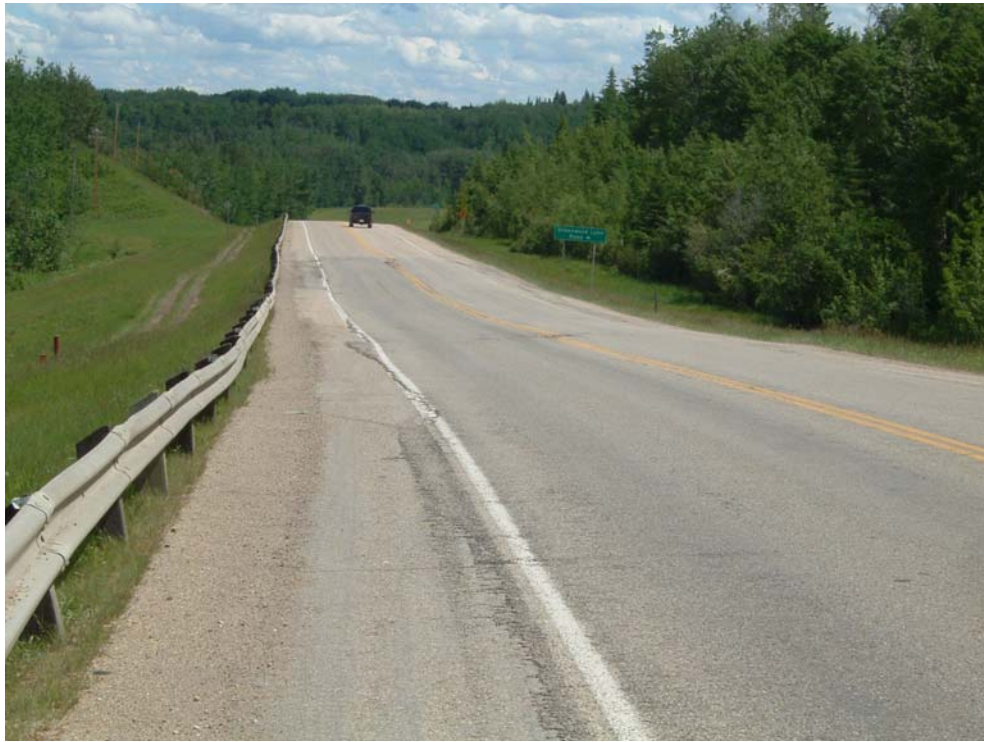
Photo 1. Pavement distress area (looking east), note pavement dips at the centre (2005).

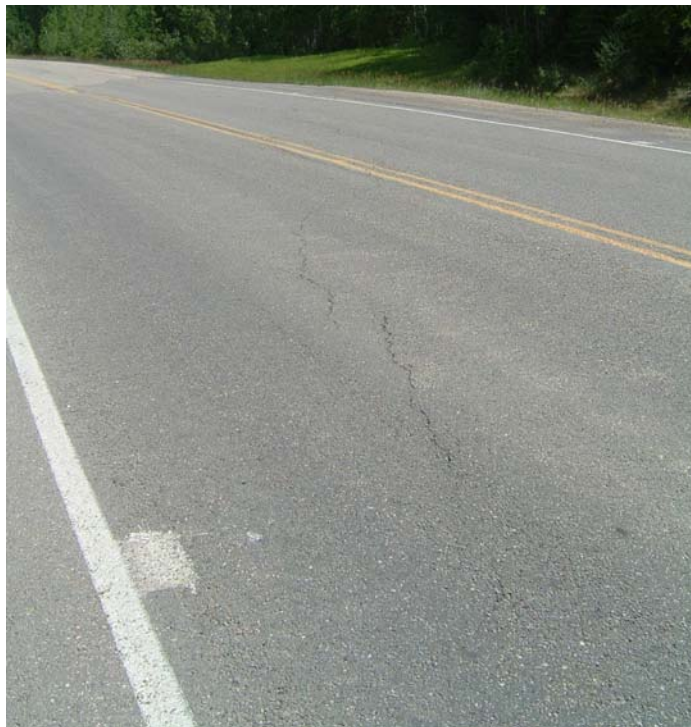
Photo 2 – Pavement cracks (2005).

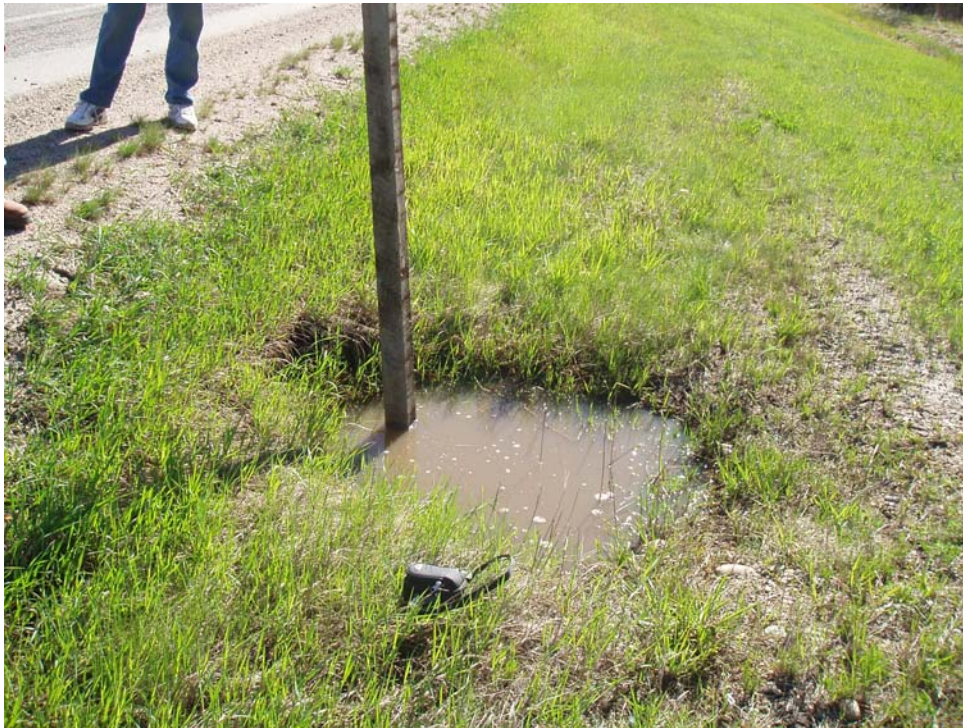
Photo 3 – South side sinkhole (2005).

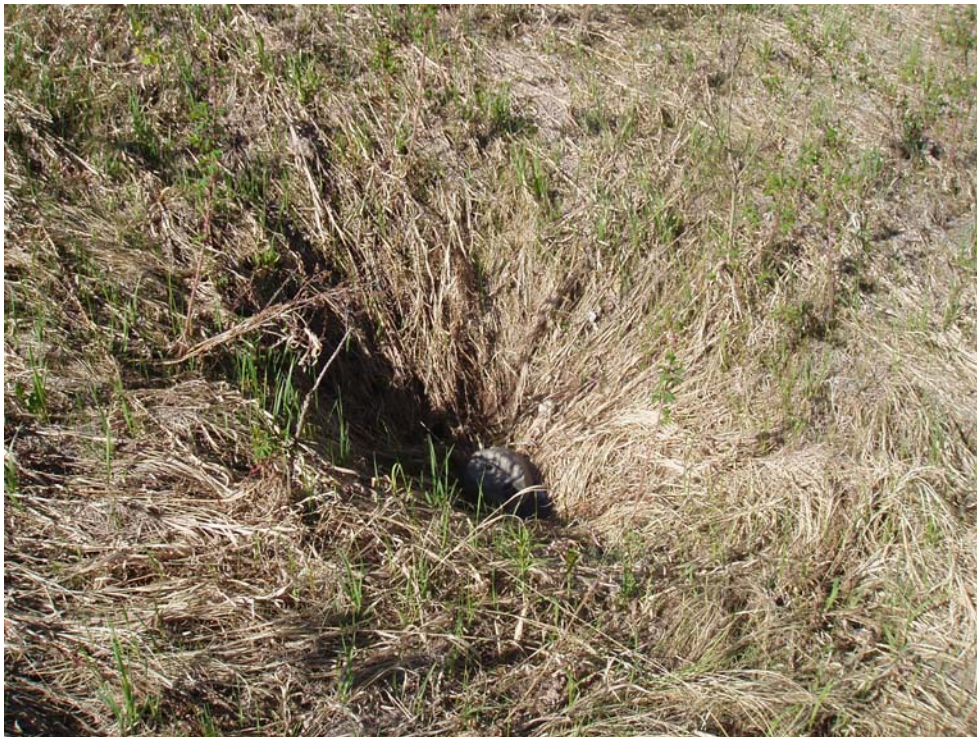
Photo 4 – North side sinkhole (2005).

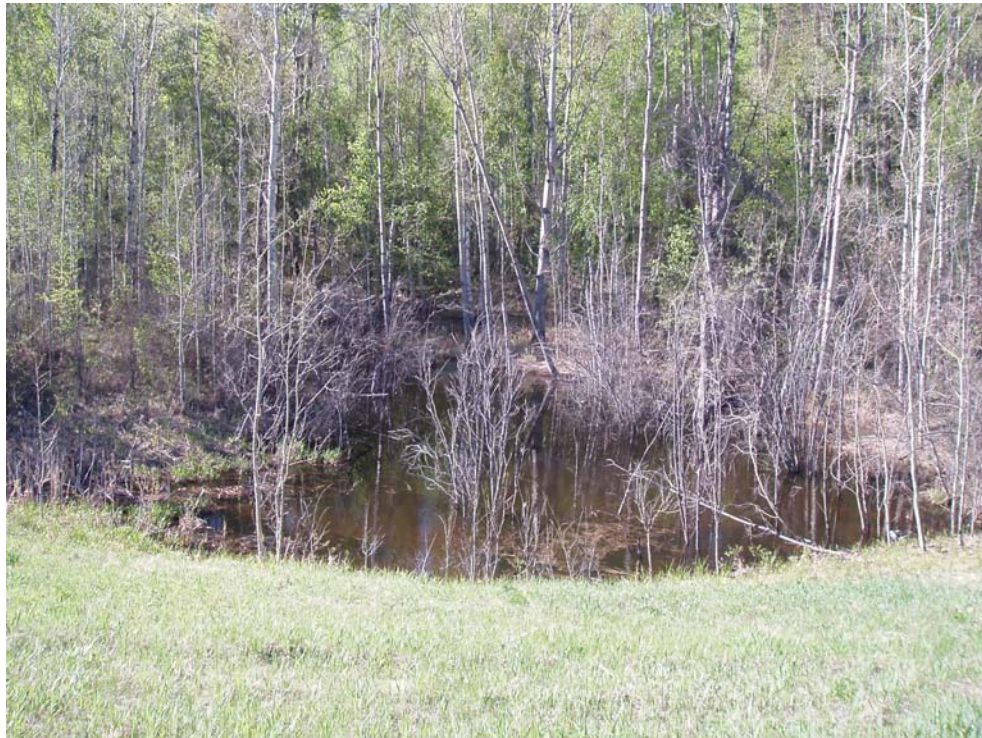
Photo 5 – Pond water at the blocked culvert inlet location (2005).

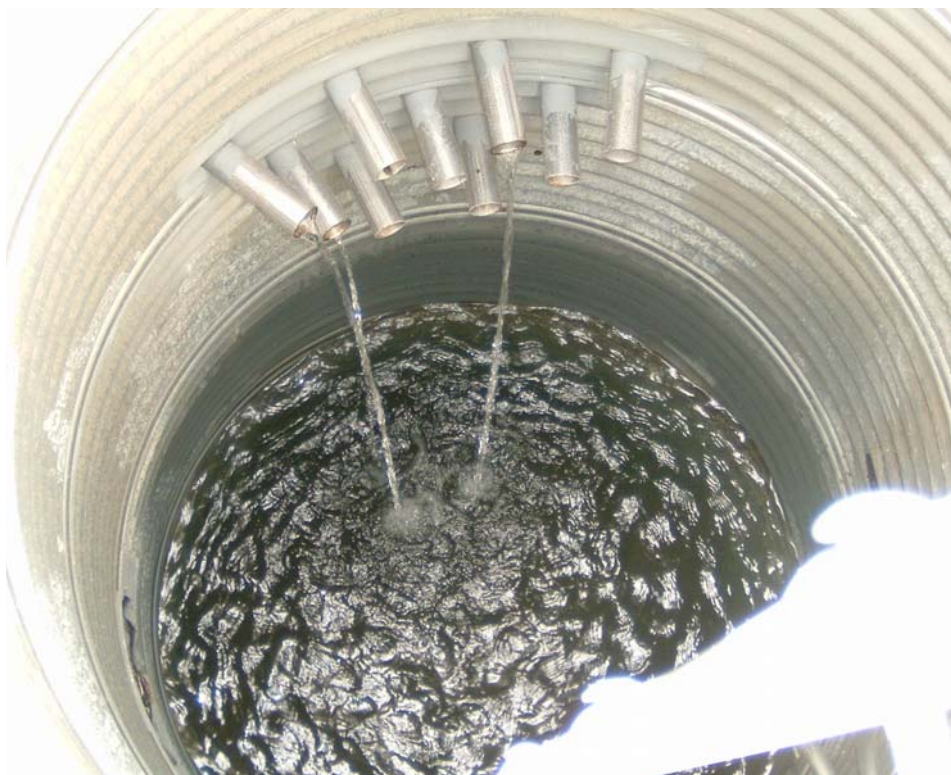
Photo 6 – Subhorizontal drains manhole
(photo taken two month after the site visit) (2005).

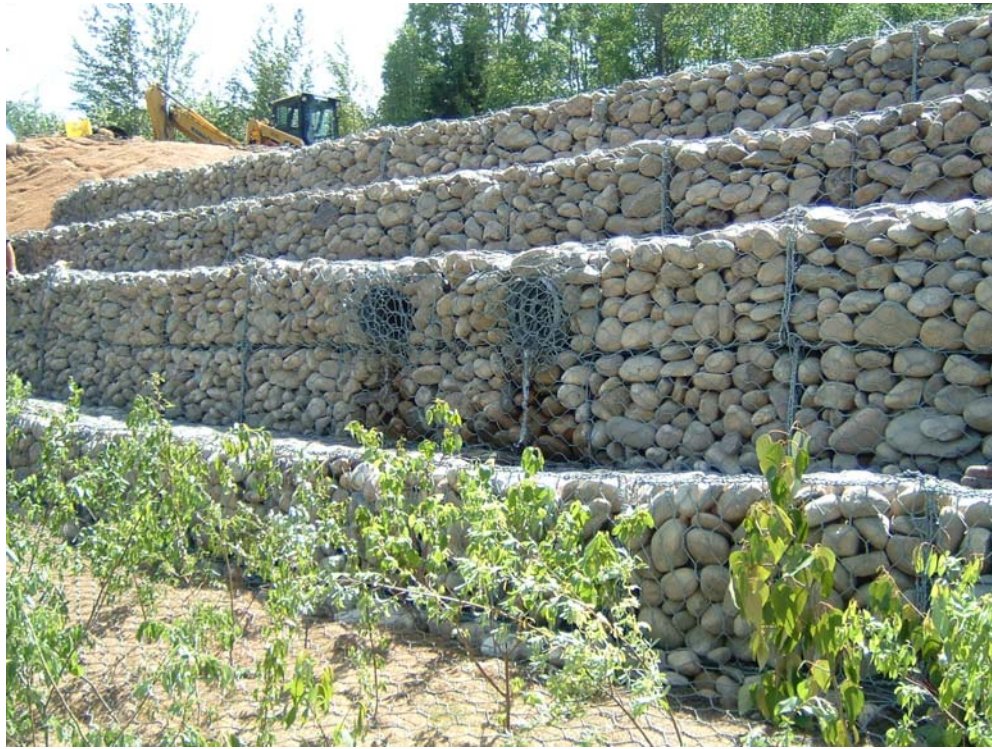
Photo 7 – Gabion outfall structure
(photo taken two month after the site visit) (2005).
