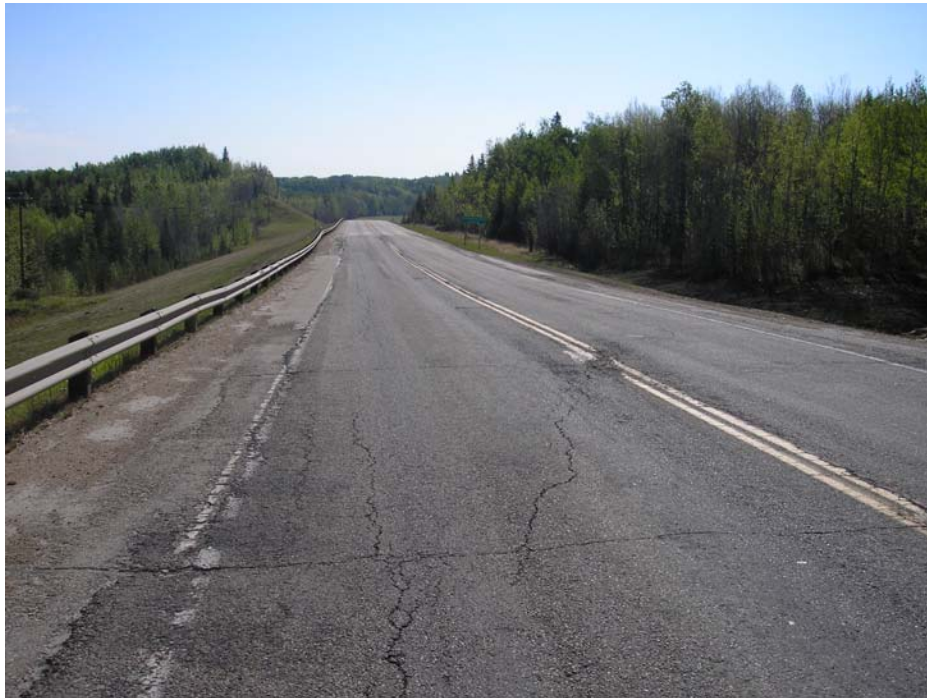
Photo 1. Pavement distress area (looking east), May 18, 2006.

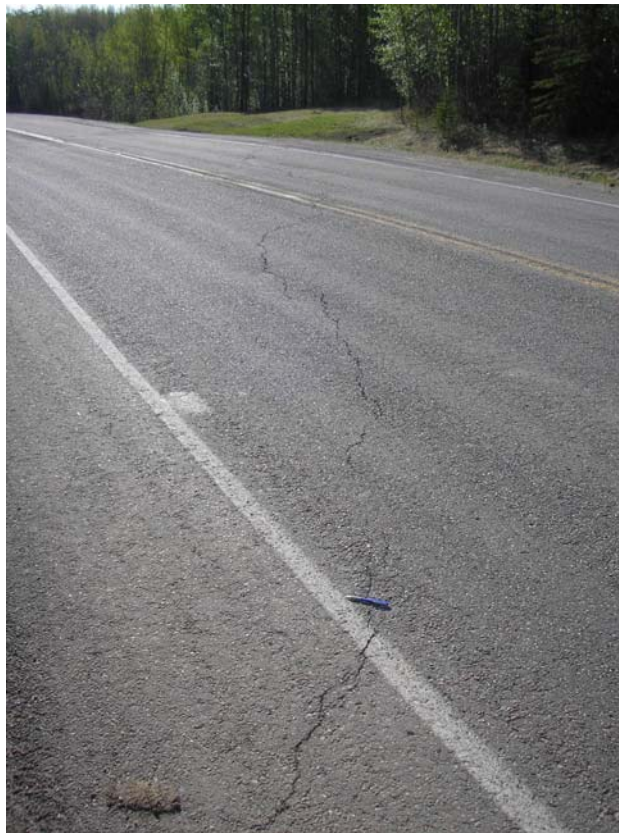
Photo 2 – Closer view of a pavement crack, May 18, 2006.

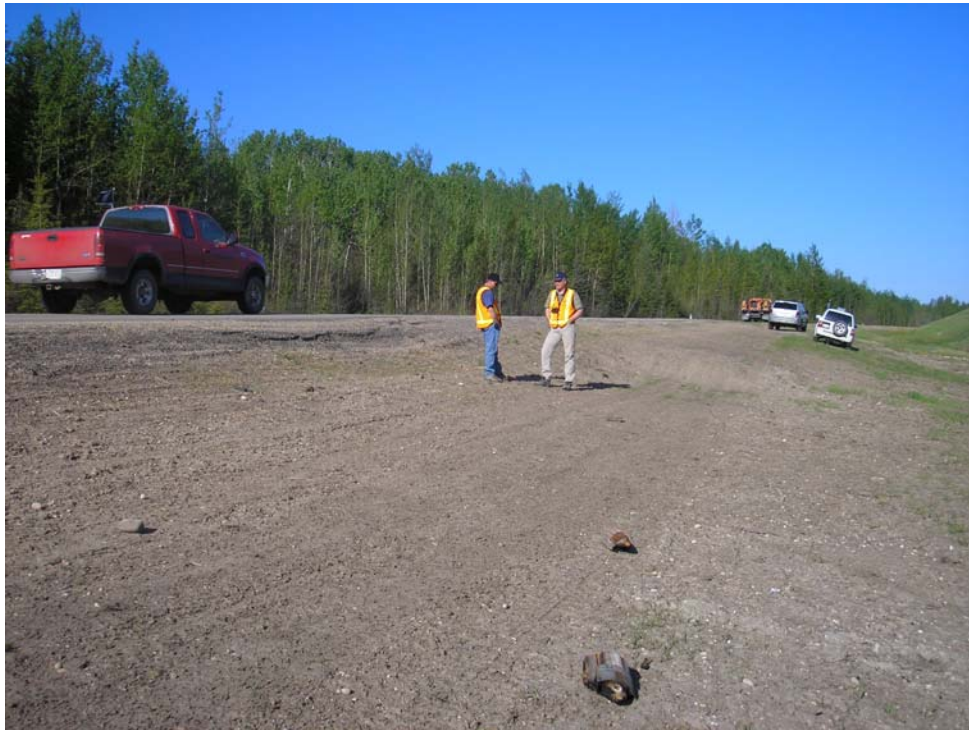
Photo 3 – Dip section on the north side slope (west end of site), May 18, 2006.

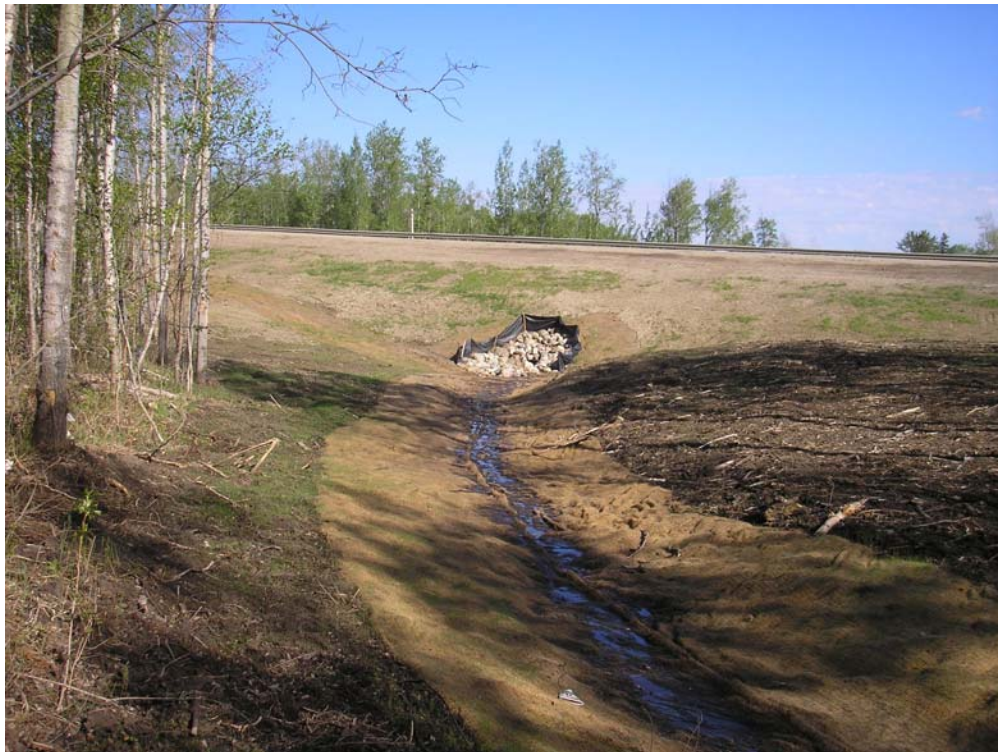
Photo 4 – New culvert inlet and drainage channel (south of highway),  
May 18, 2006.

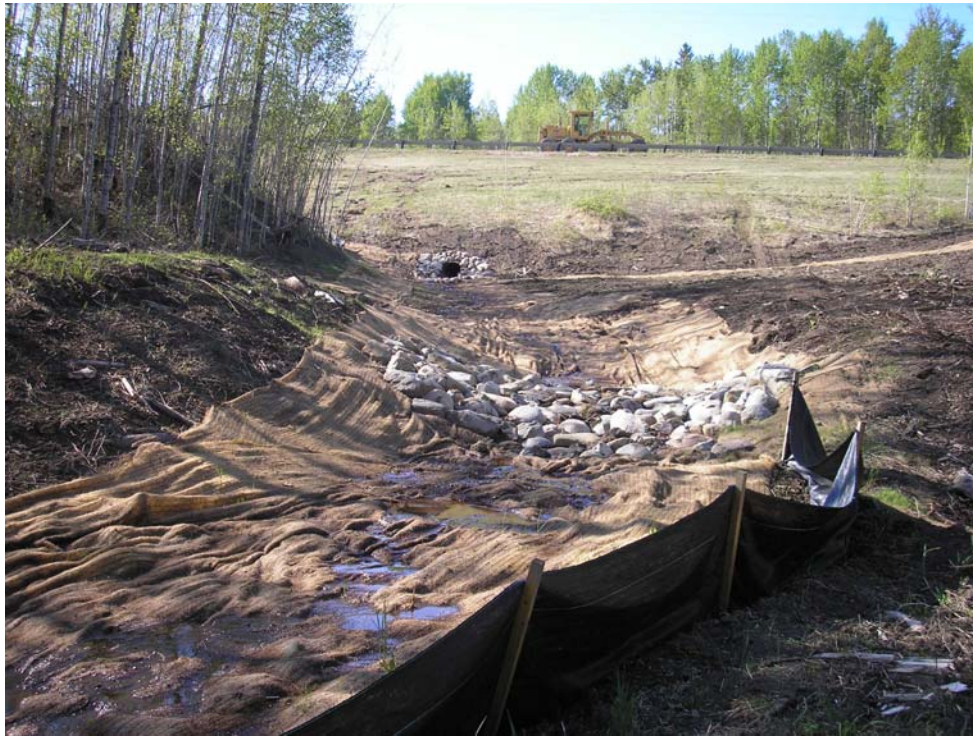
Photo 5 –New culvert outlet and drainage channel (north of highway), May 18, 2006

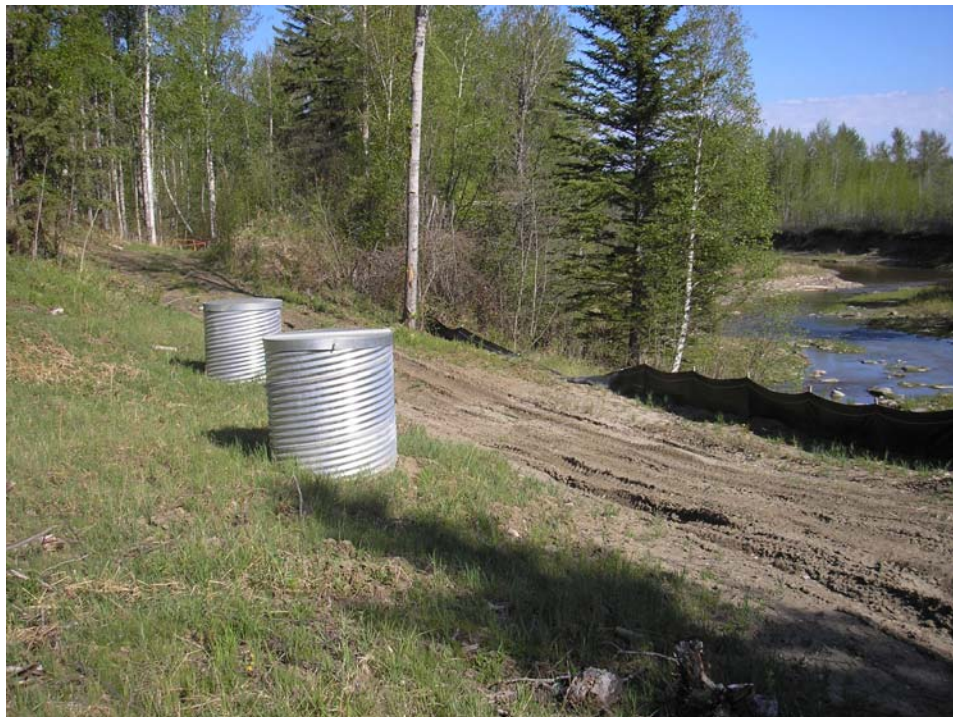
Photo 6 – Subhorizontal drain man access points, (note the knocked down section of the silt fence), May 18, 2006.

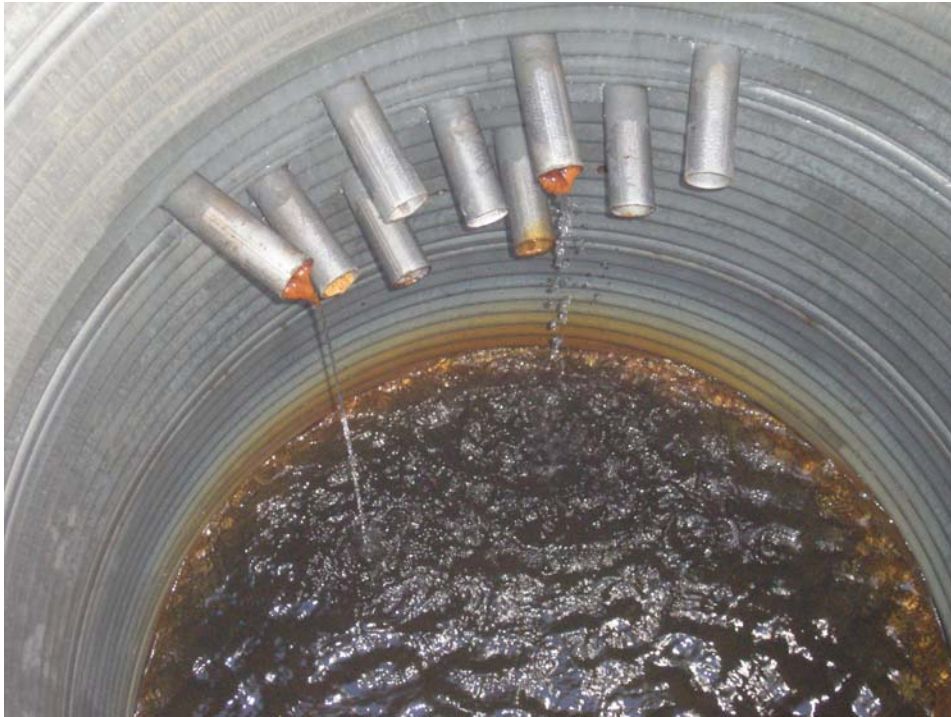
Photo 7 –West man access point producing water, May 18, 2006.

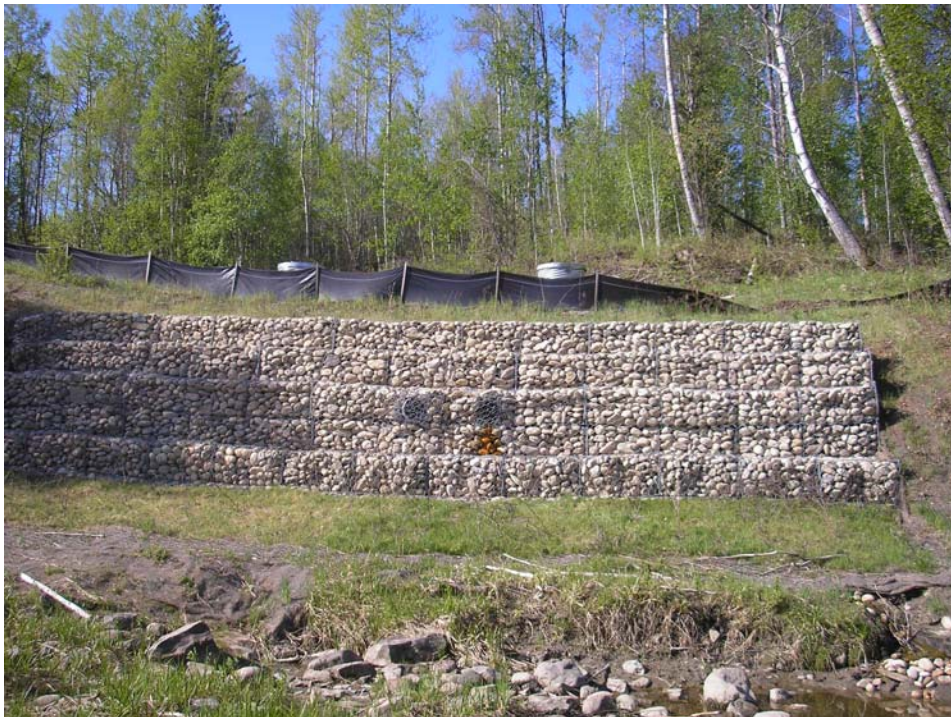
Photo 8 – Gabion outfall structure, May 18, 2006.
