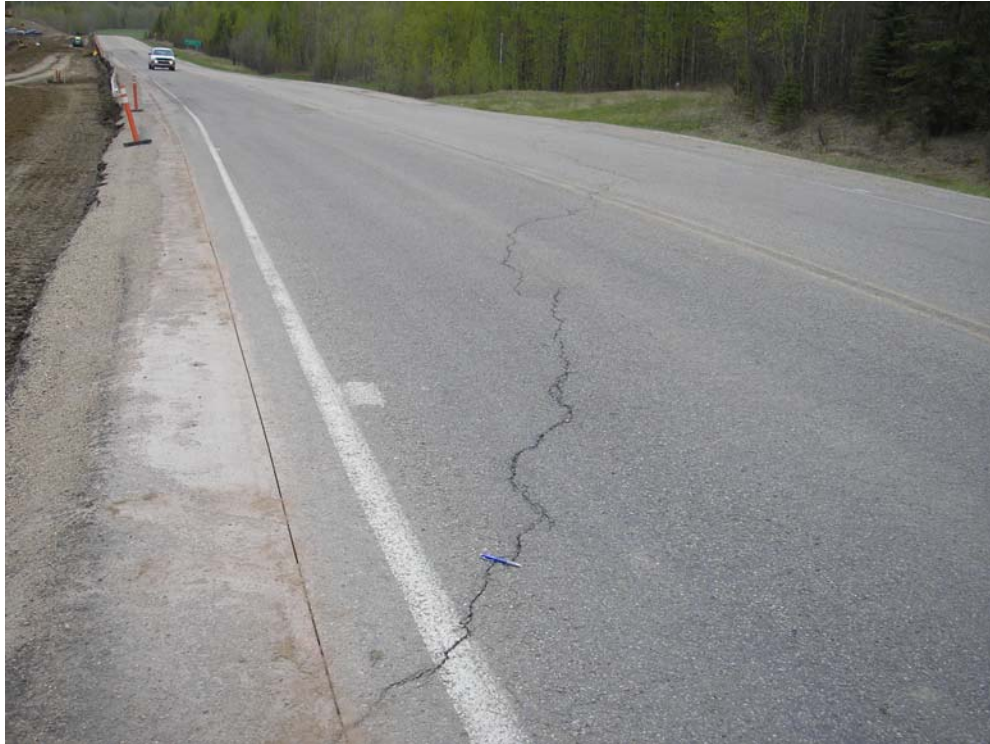
Photo 1 - Pavement distress area (looking east).

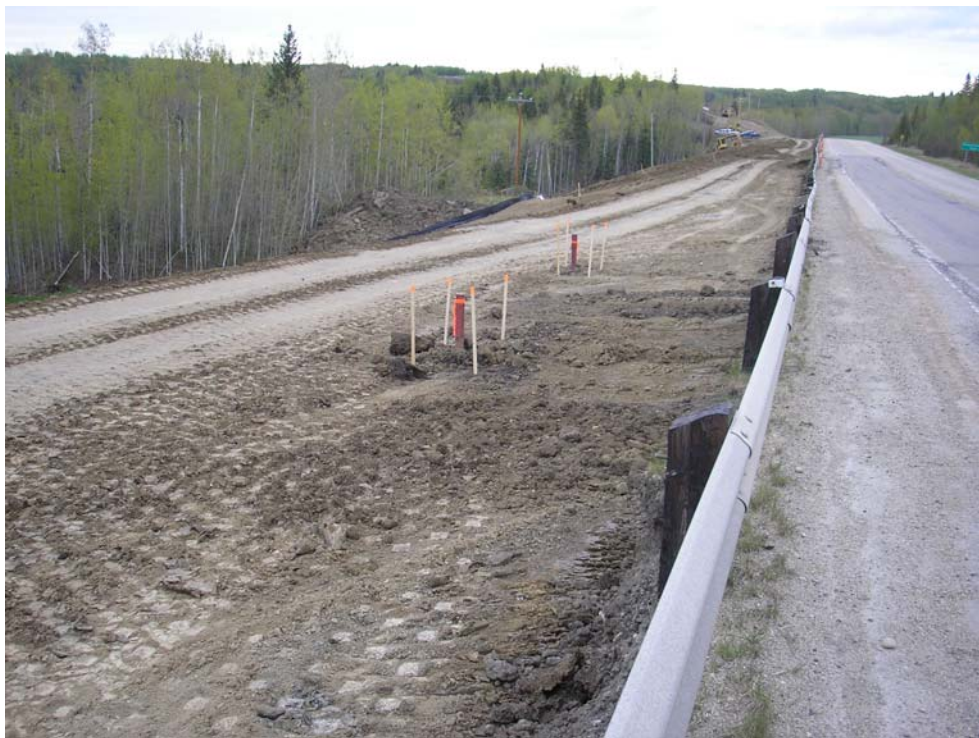
Photo 2 – Climbing lane fill (note the instrumentation being protected).

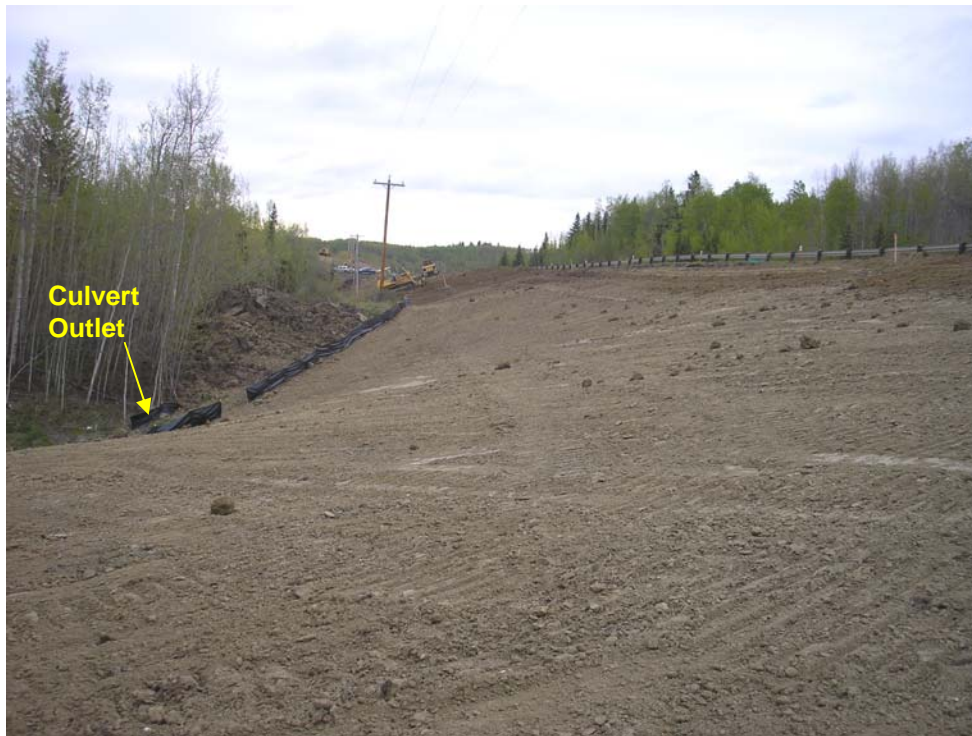
Photo 3 – Sideslope fill oversteepened at the culvert outlet location.

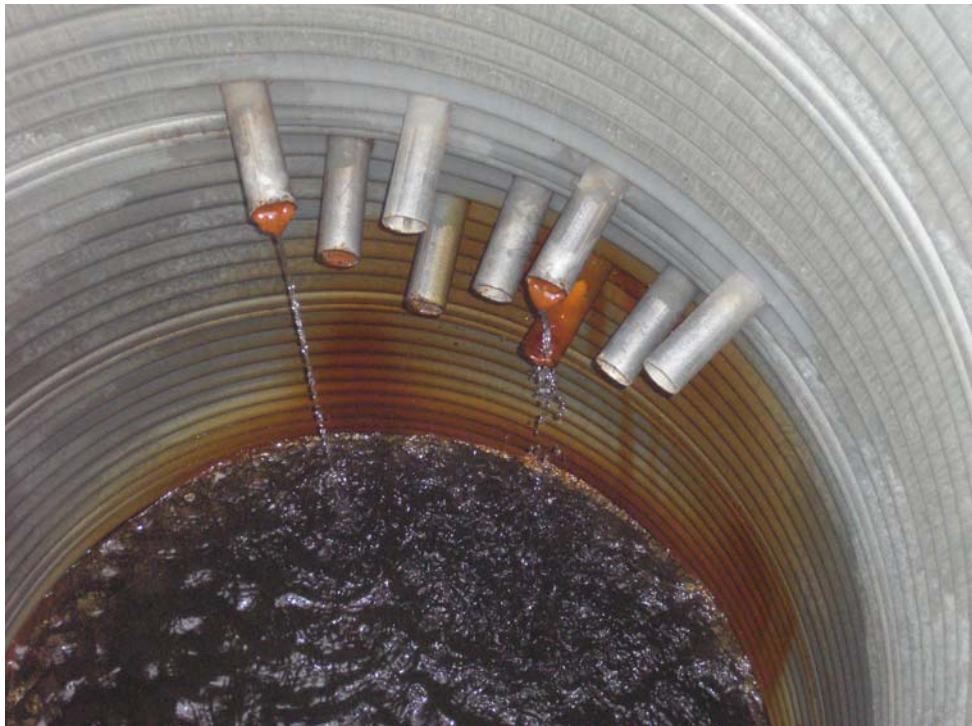
Photo 4 – West collection point subdrains.

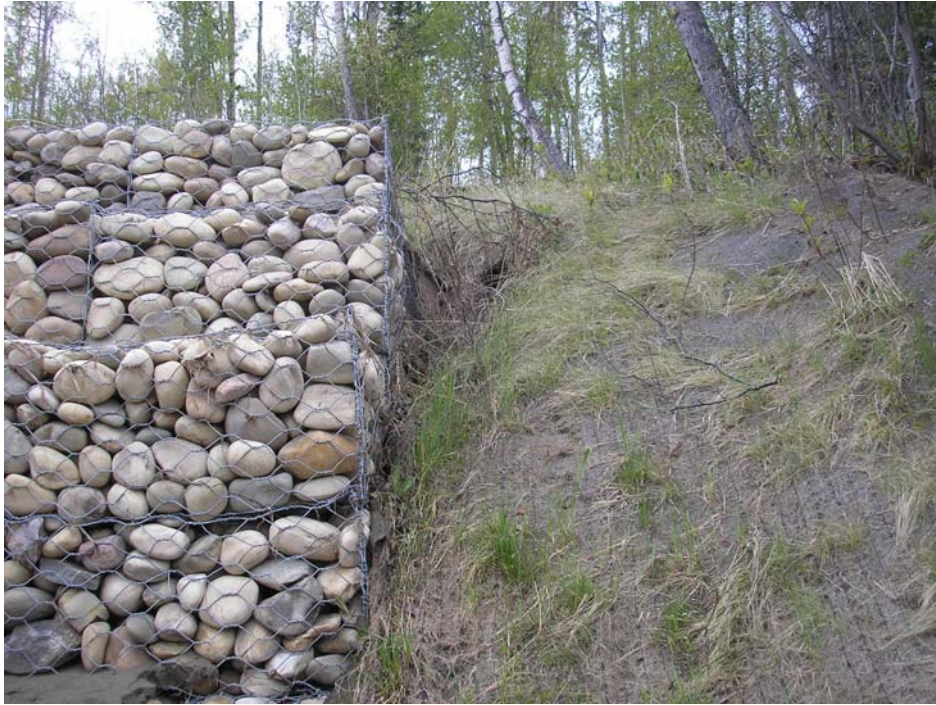
Photo 5 – Gabion wall interface erosion.

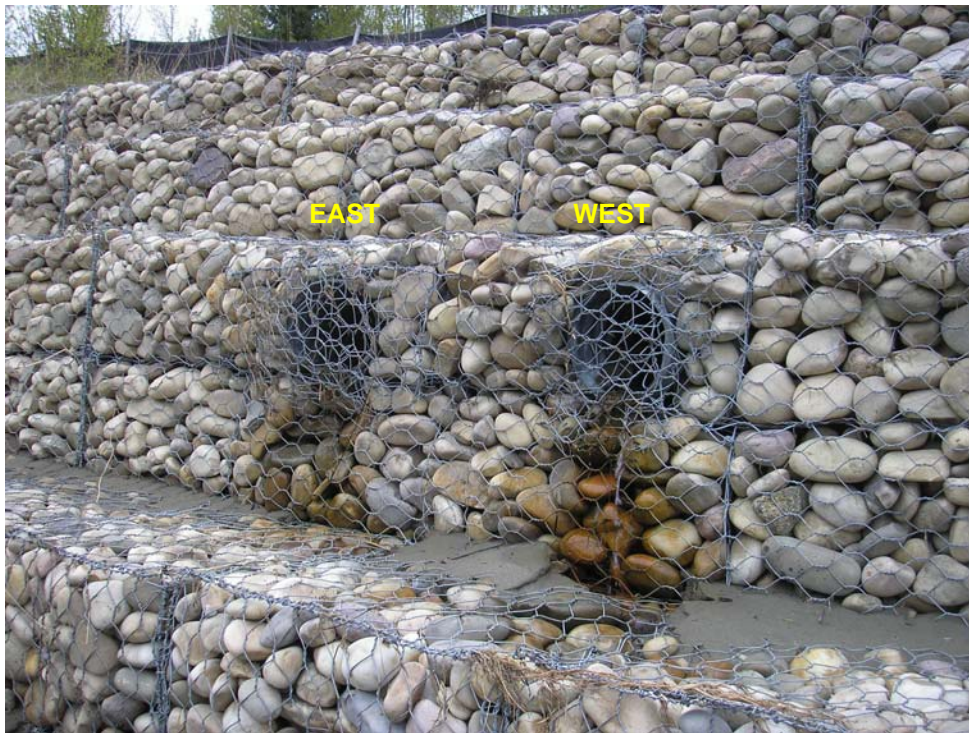
Photo 6 - Collection points east and west outlet (note that despite not currently producing water the east outlet shows signs of water stain below on the culvert).
