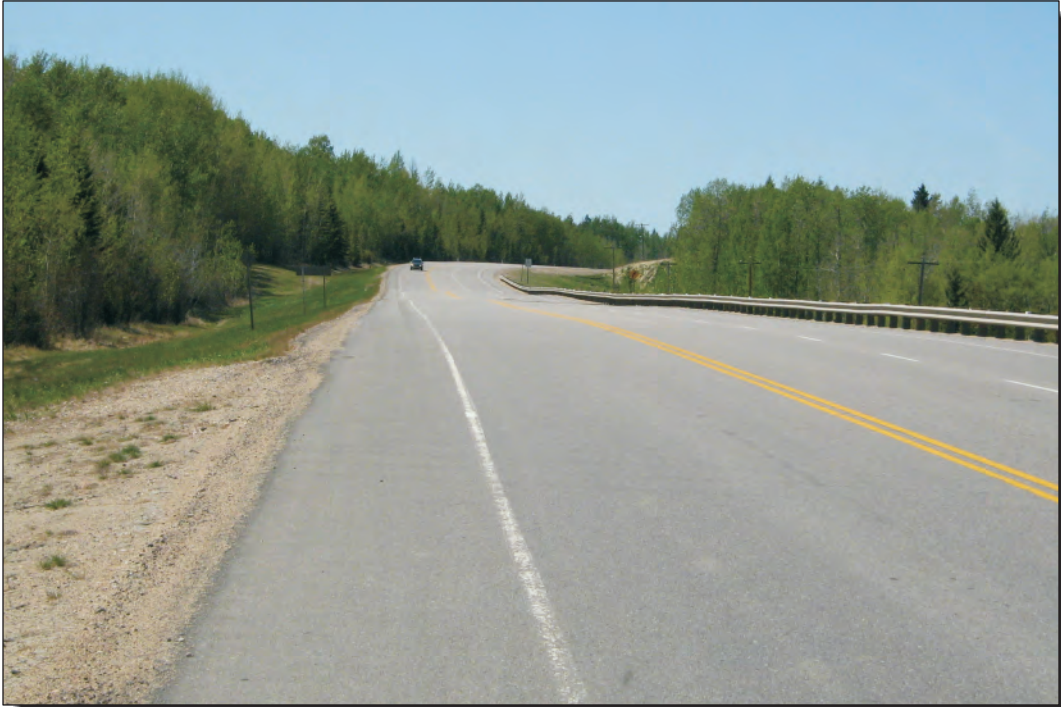
**Photo 1**

Looking west toward uneven pavement surface, indicating west flank of landslide

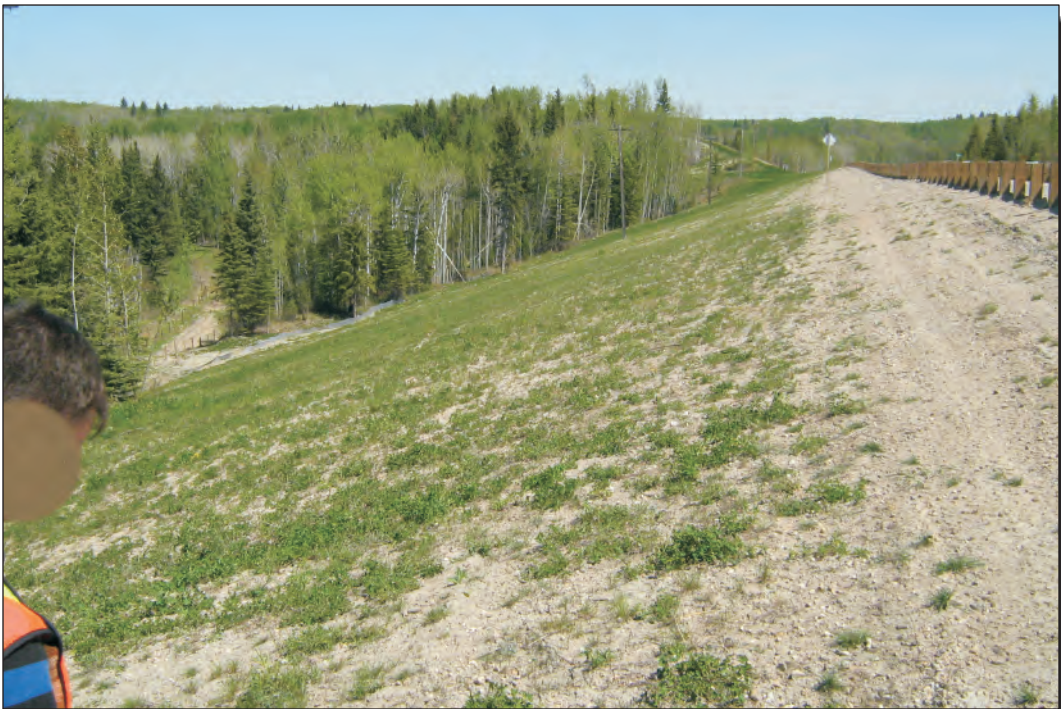
**Photo 2**

Vegetation beginning to grow on north embankment; no vegetation growing along top of embankment

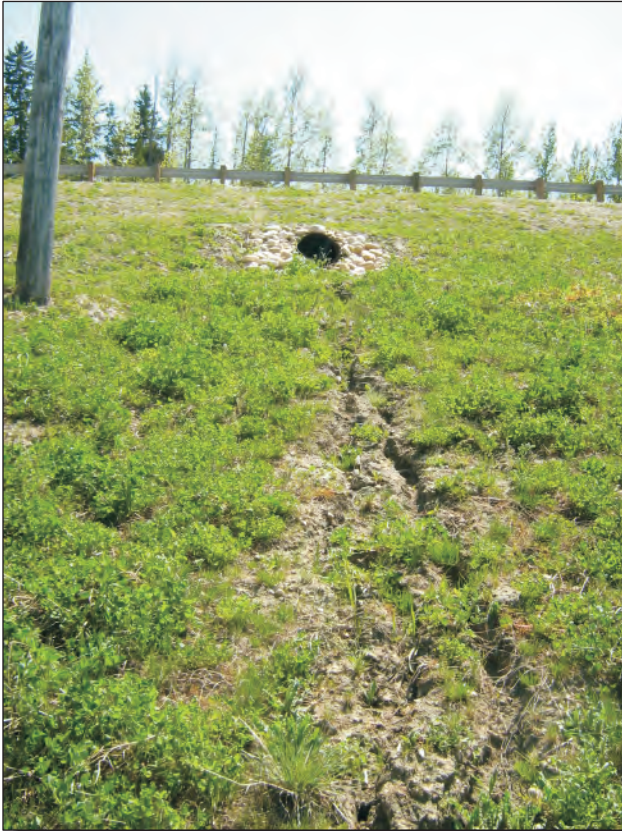
**Photo 3**  
Discharge end of culvert on north sideslope; note the erosion occurring below outlet

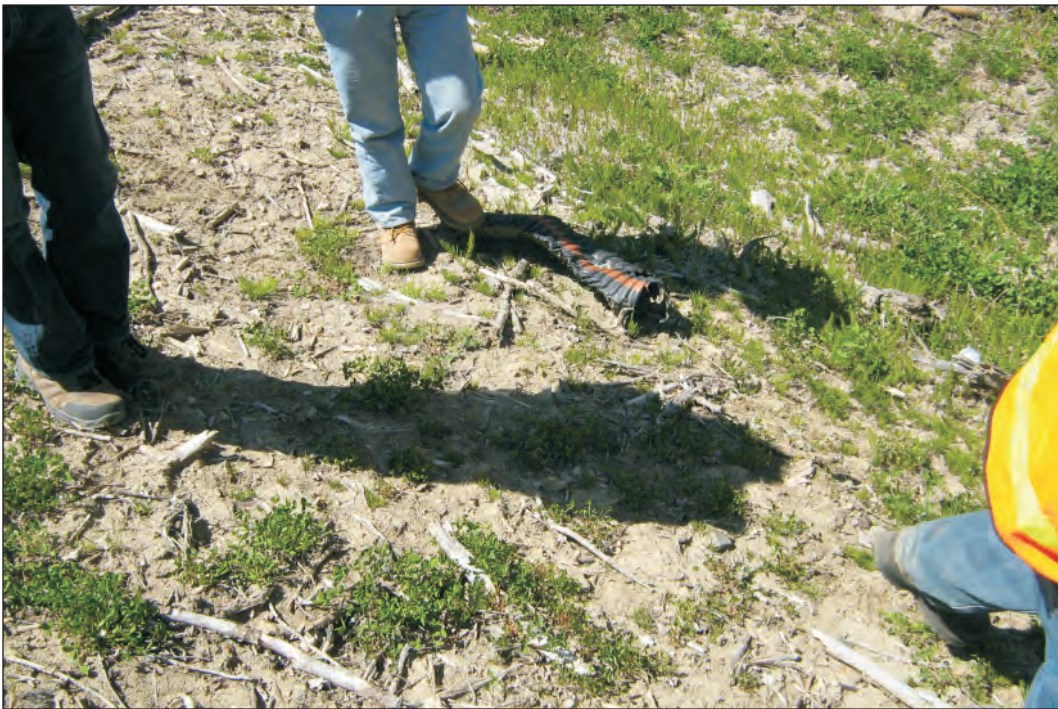
**Photo 4**  
Toe drain located near base of north embankment; was placed during construction of passing lane

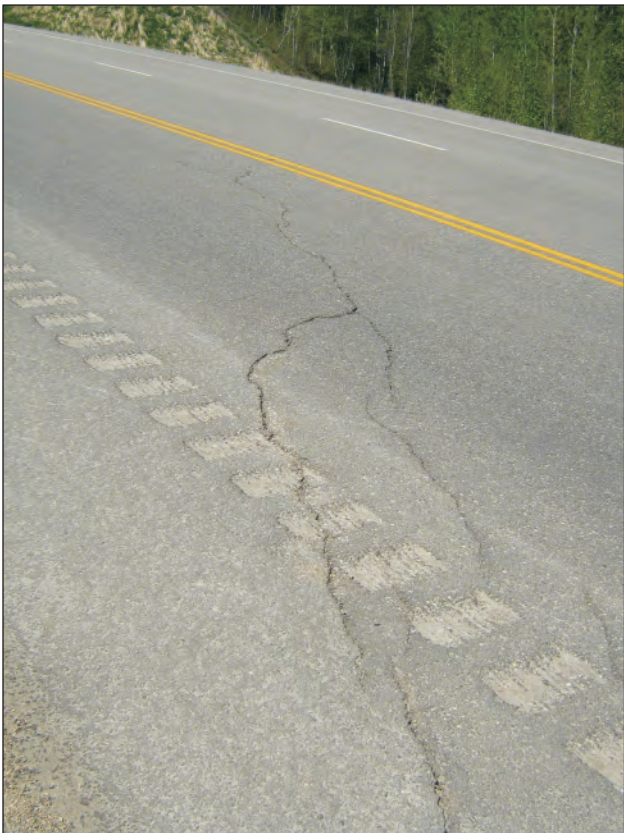
**Photo 6**  
Cracking of pavement near west flank of slide
