**SUMMARY OF MAINTENANCE RECOMMENDATIONS
2010 GEOHAZARD RISK ASSESSMENT
NORTH CENTRAL STONY PLAIN REGION**

NC-23 HWY 39:06 SLIDE NEAR GREENWOOD LAKE ROAD

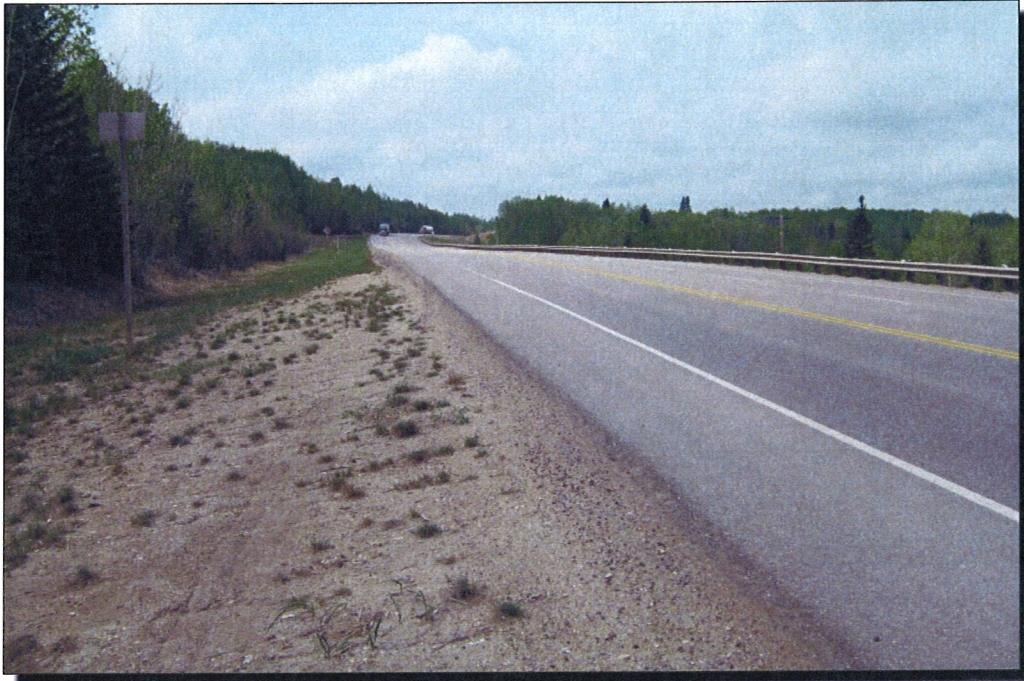
Photo 1

View of NC 23 slide site viewed from east flank; note dip in Hwy 39:06 at west flank

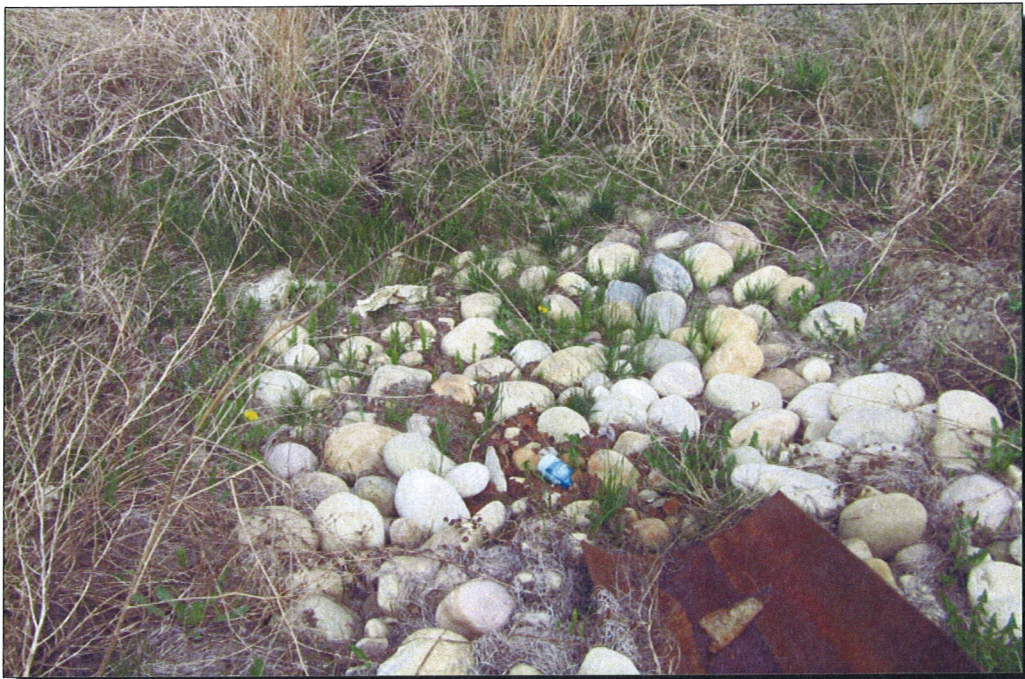
Photo 2

Rip-rap armouring does not extend to toe of slope at outlet of culvert on east portion of slide

4. The riprap splash pad on the outfall side of the culvert (eastern portion of slide area and passing lane fill) should be extended to the base of the embankment to reduce erosion occurring on the slope.
5. The inlet to the culvert on the east portion of the slide area should be graded to minimize potential for ponding and infillation

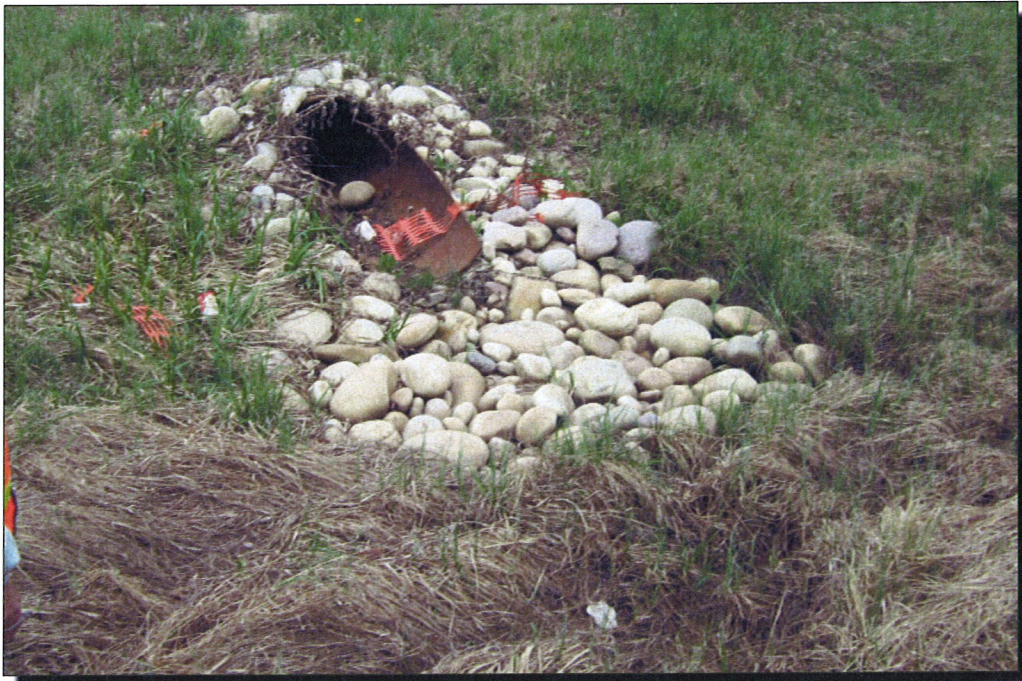
Photo 3
Inlet to culvert on east portion of slide above base of ditch

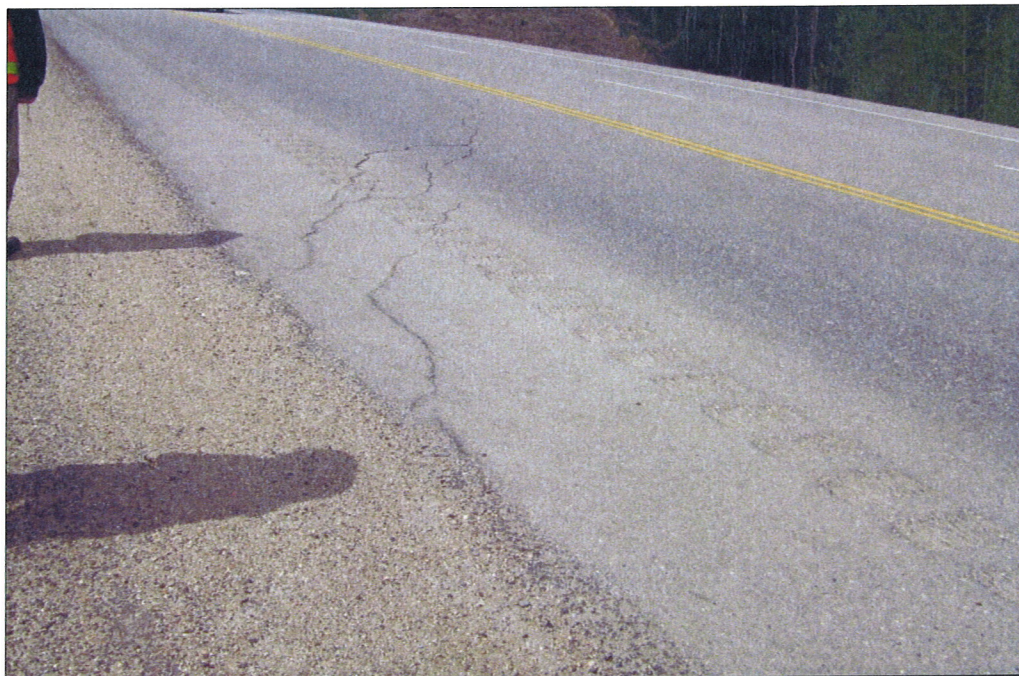
Photo 4
Pavement cracking at west flank of slide area

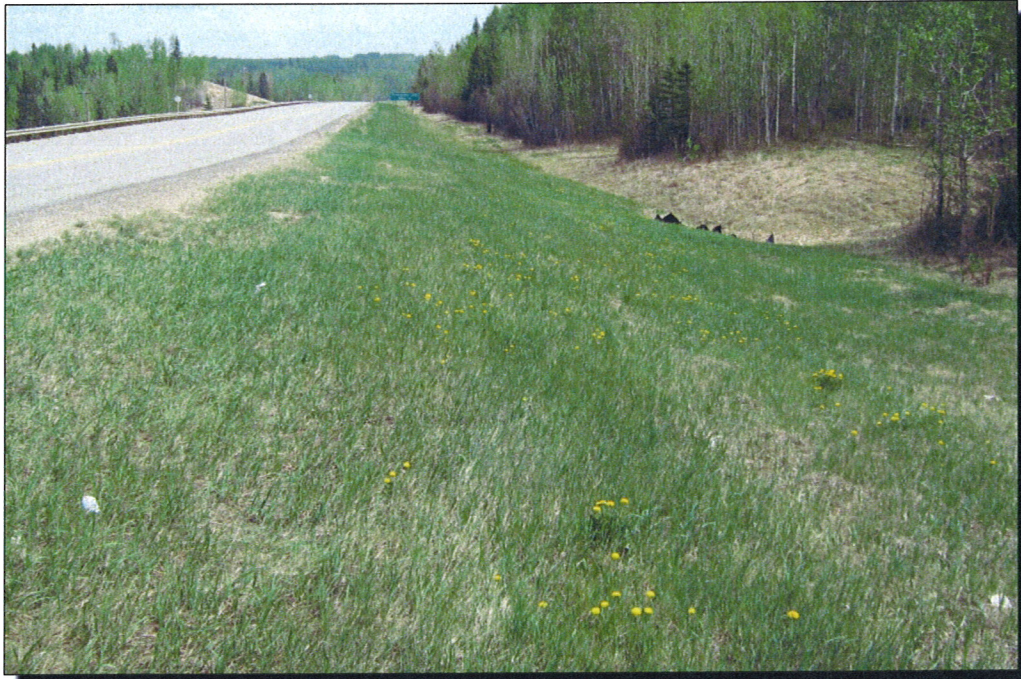
Photo 5
Hwy 39:06 looking east from west flank of slide area

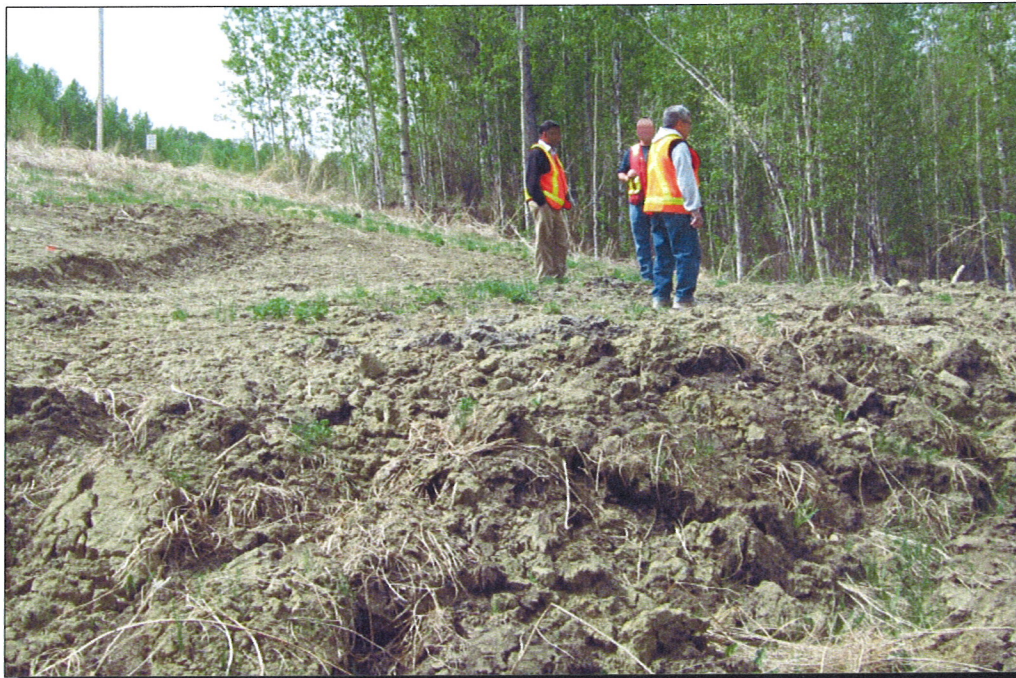
Photo 6
Drill pad from 2009 instrument installation needs to be regraded and seeded

3. Re-grade, topsoil and seed the drill pad created for instrument installation in 2009.

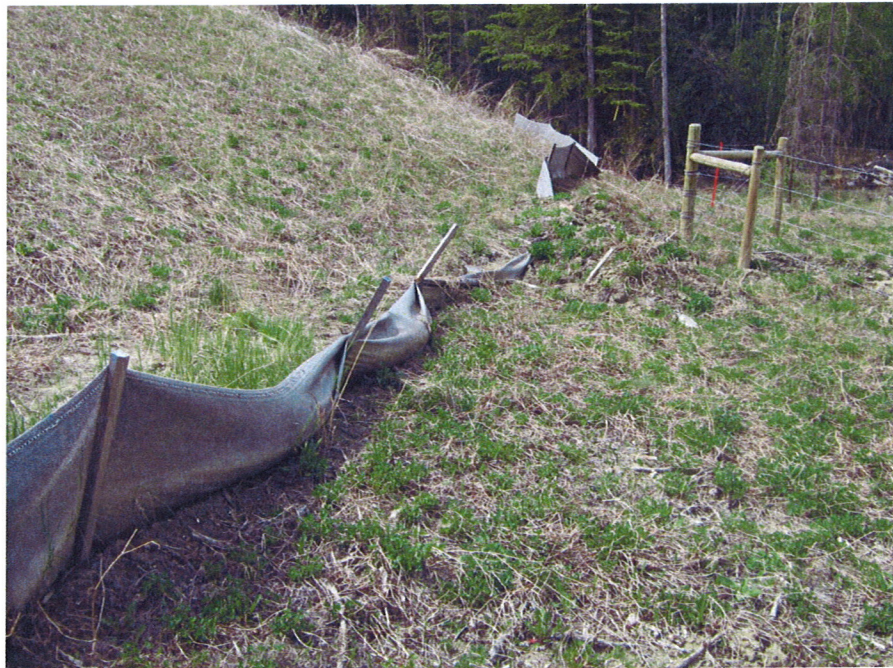
Silt fences in need of maintenance

1. All of the toe drains beneath the passing lane fill should be exposed, extended and backfilled with free draining gravel to assist drainage through the fill. A proposal has been issued for this work.
2. Clean out and re-install silt fences at toe of sideslope.

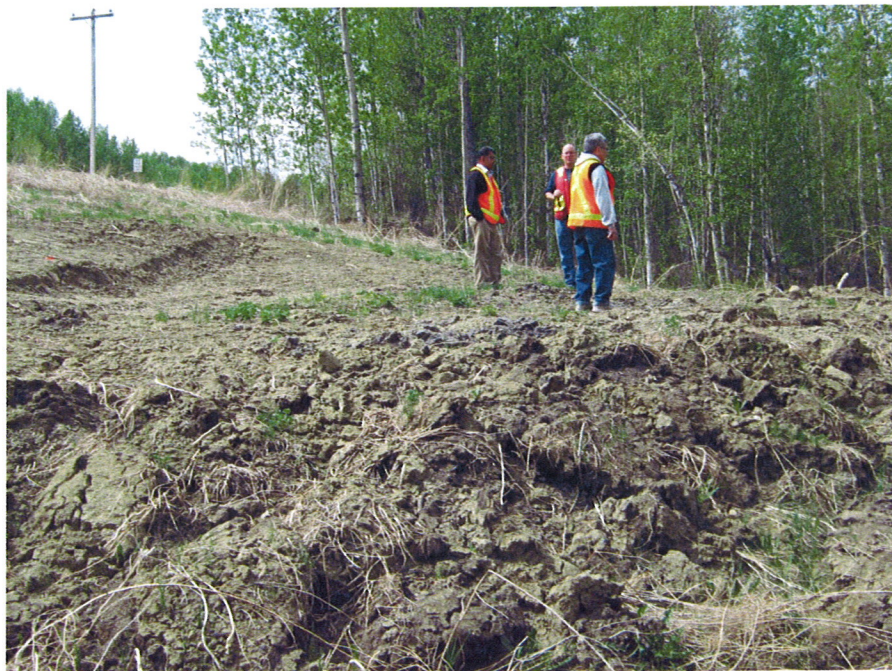
Drill pad created in 2009 to install additional instruments
