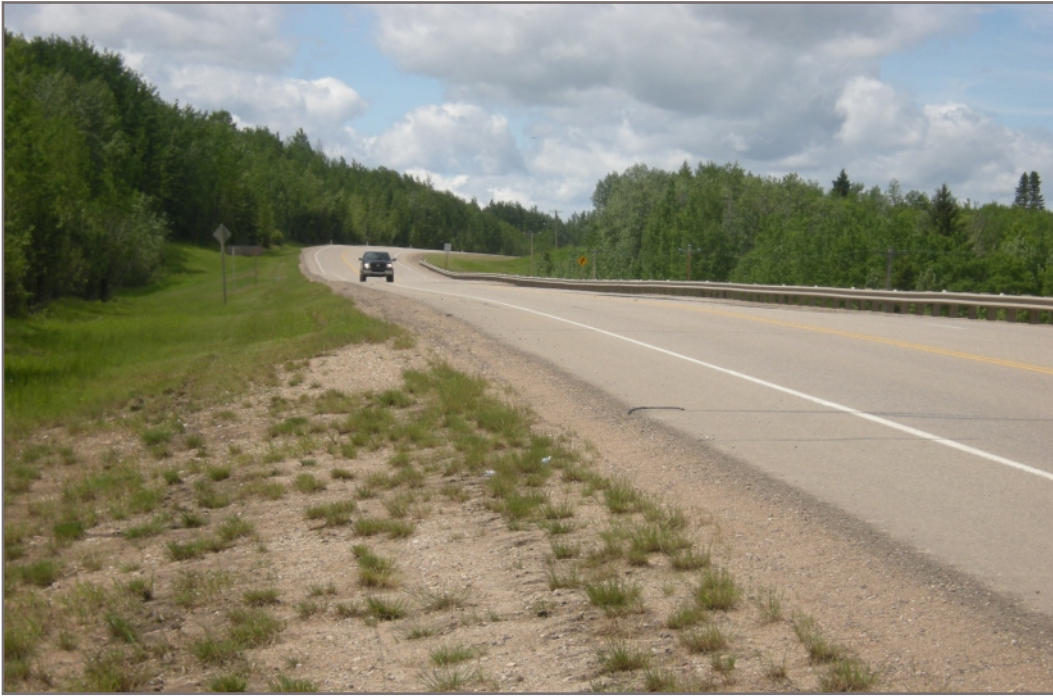
Photo 1: Lightly vegetated south sideslope at east flank of site; note pavement dip in Hwy 39:06 at west flank

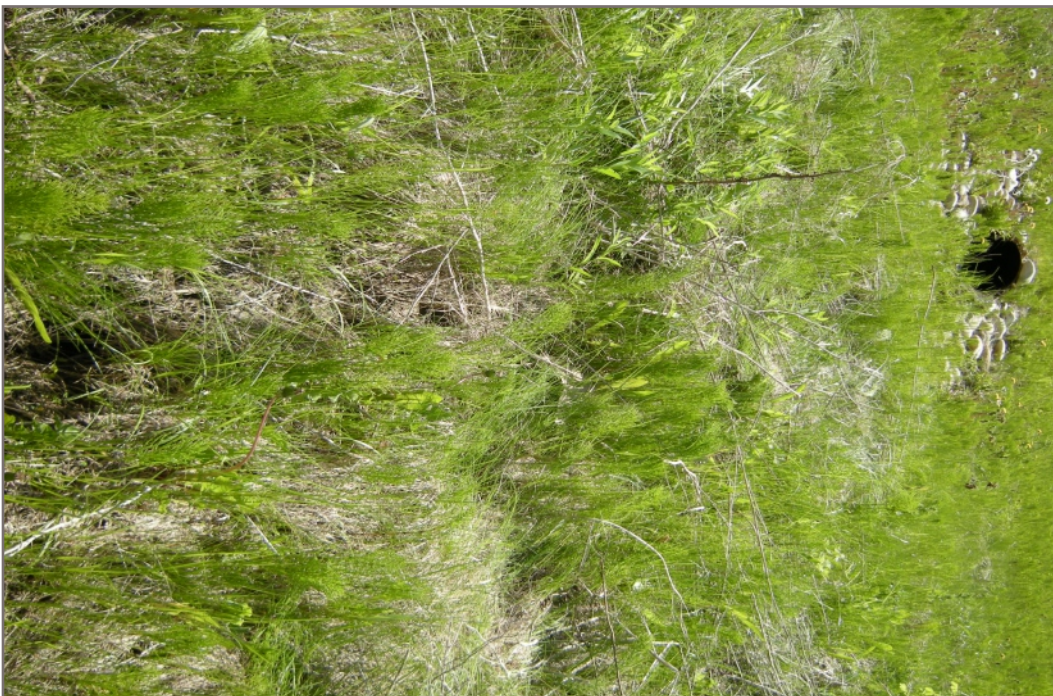
Photo 2: Rip-rap armoring does not extend to toe of slope at outlet of culvert at east portion of site

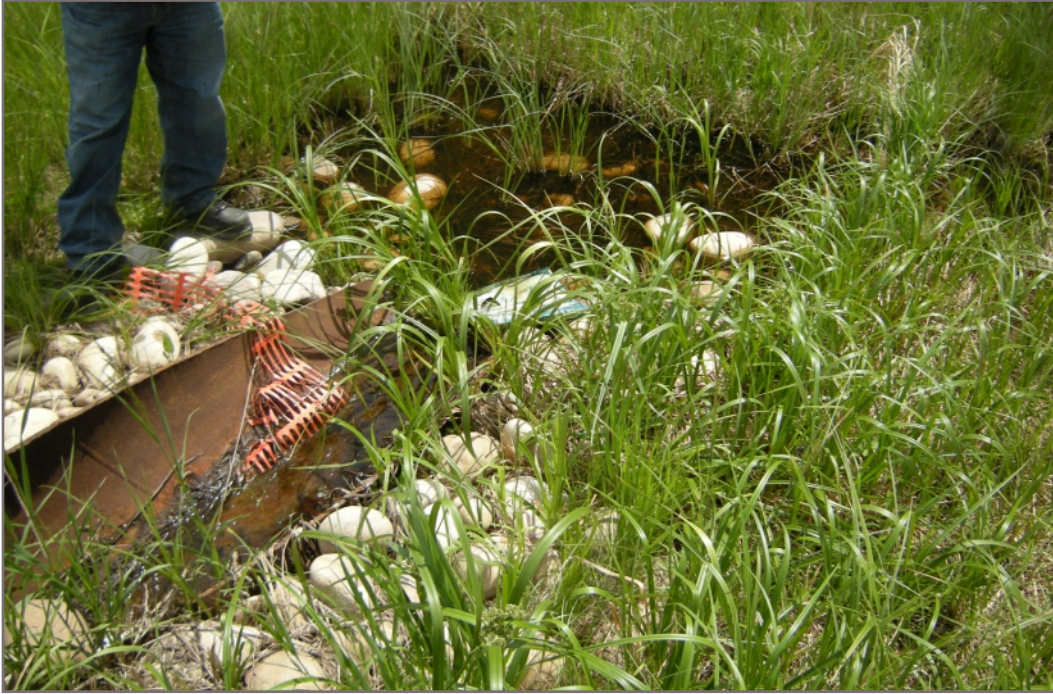
Photo 3: Inlet of culvert on east portion of slide above base of ditch

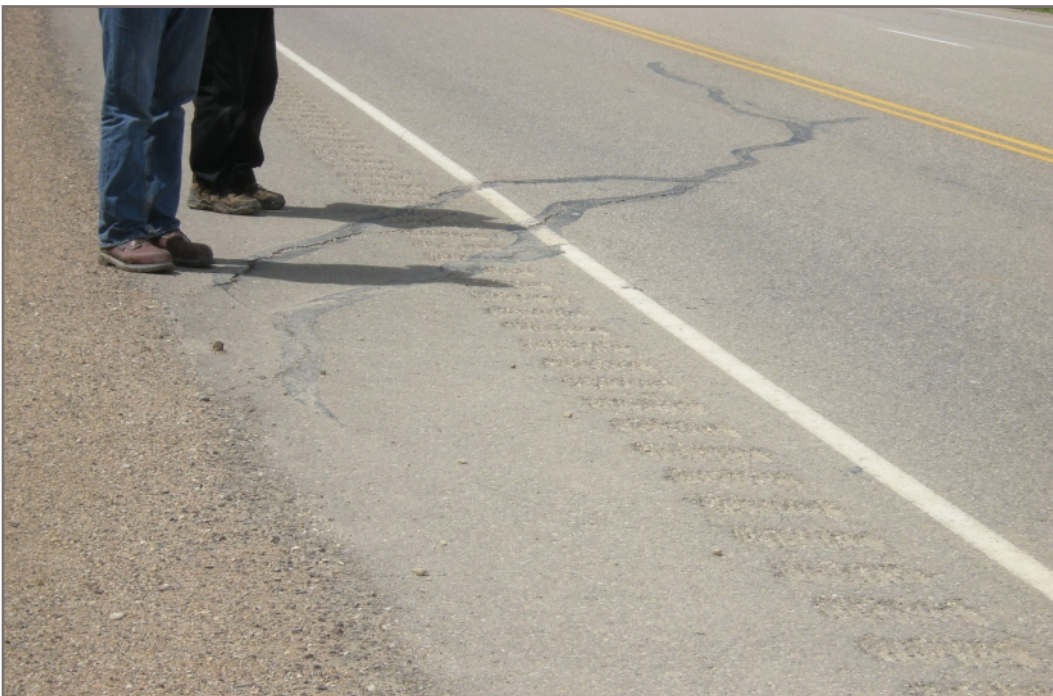
Photo 4: Pavement cracking at west flank of slide area sealed in 2010

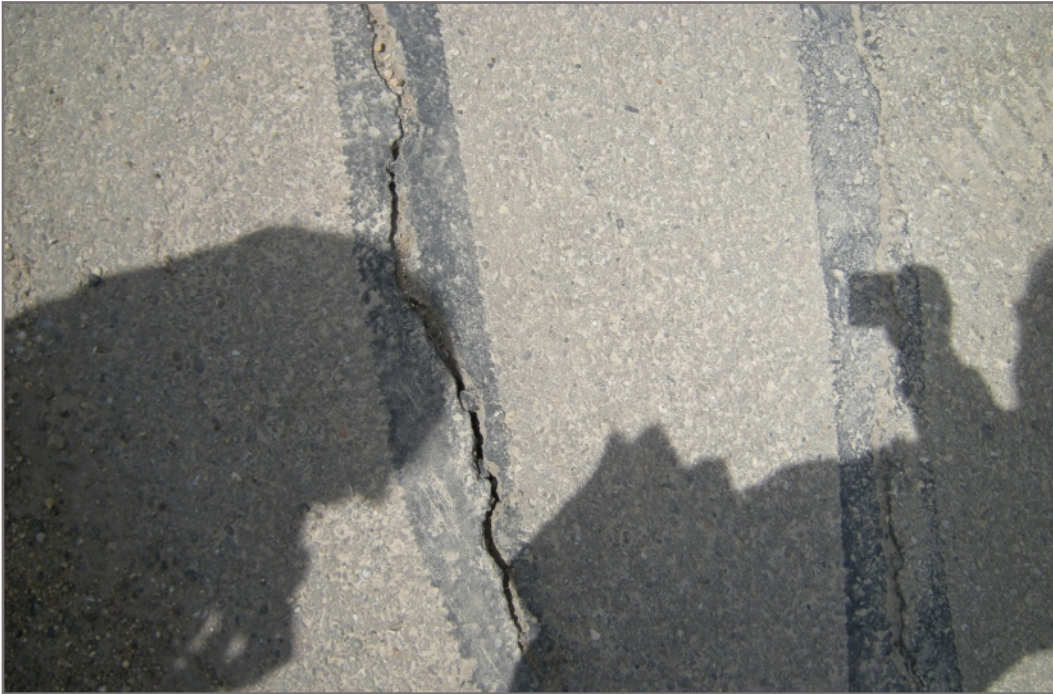
Photo 5: Pavement cracking through sealant

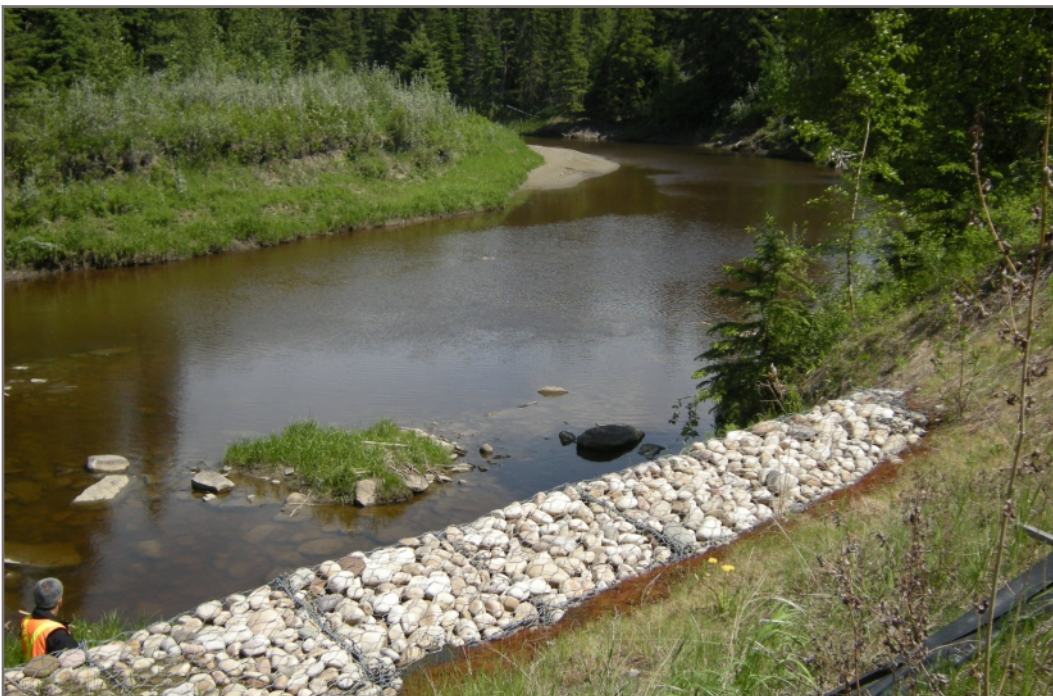
Photo 6: Gabion baskets erosion protection at Modeste Creek
