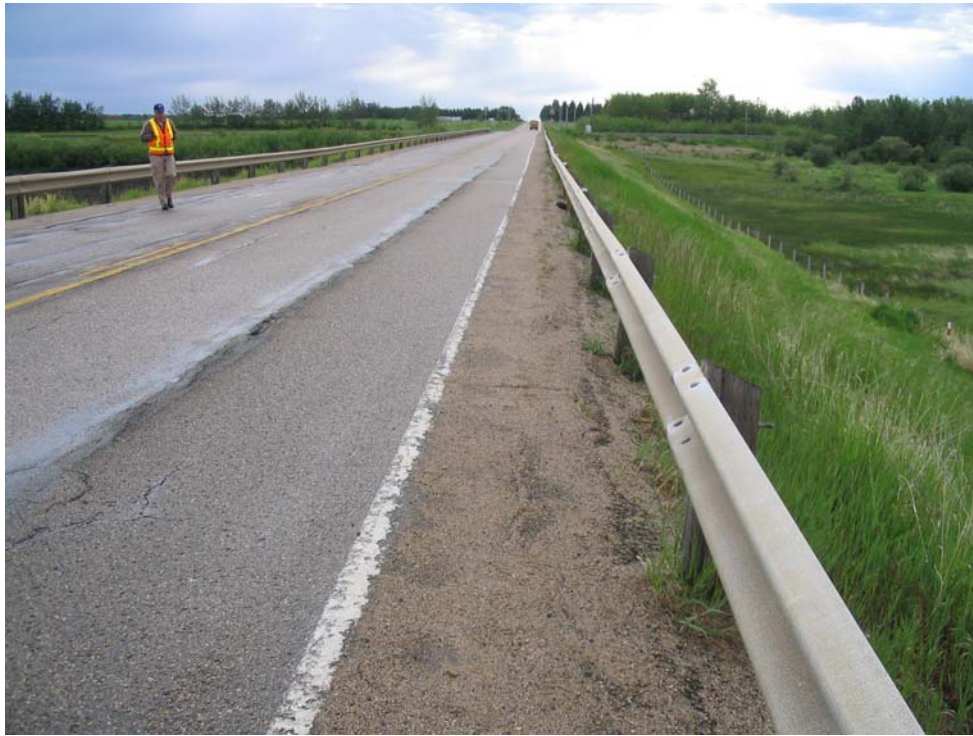
Photo 1 - Looking east at the re-aligned guard rails, June 7, 2006.

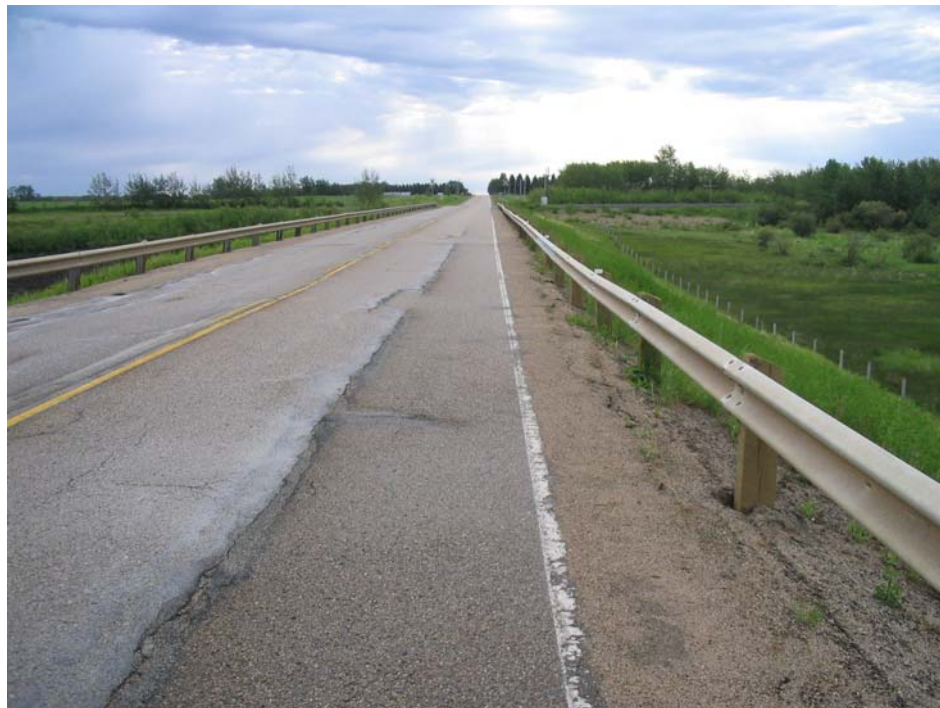
Photo 2 - Looking east possible slide crack, June 7, 2006.

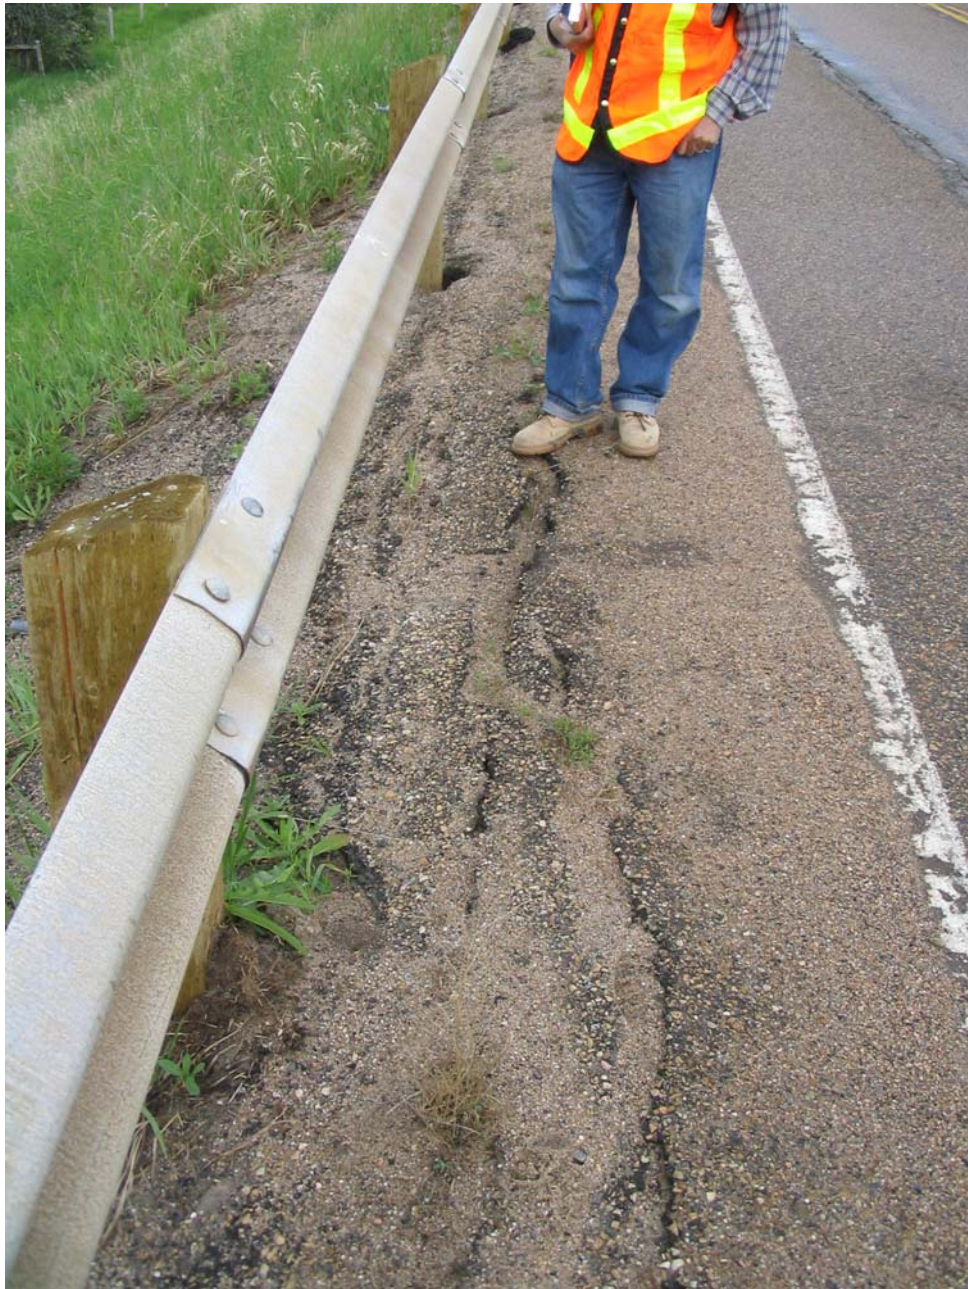
Photo 3 - Looking west at edge cracks over culvert, June 7, 2006.

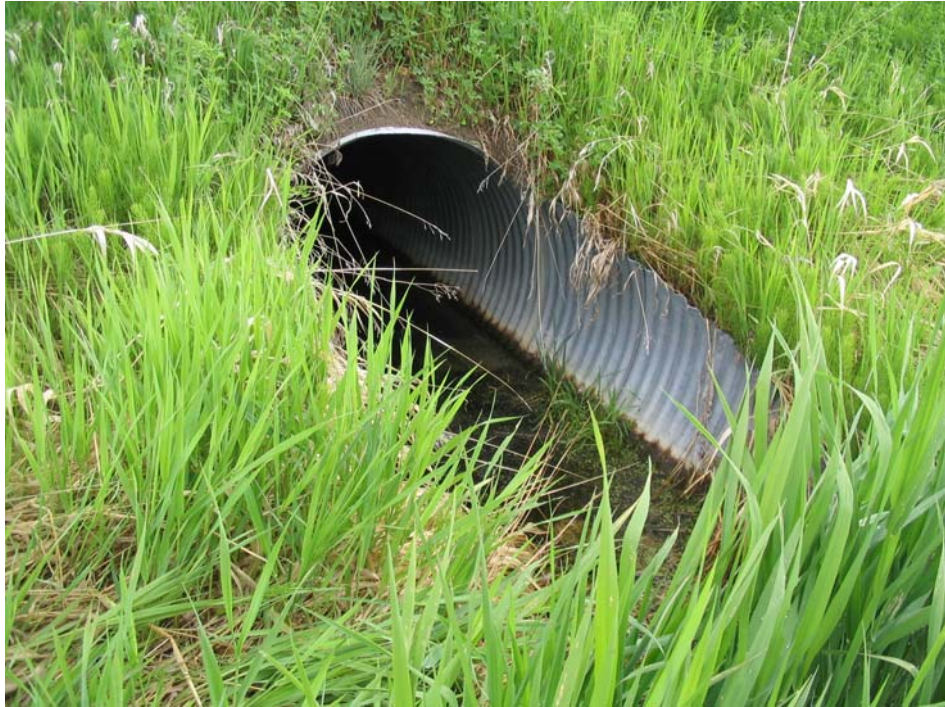
Photo 4 - Looking north at water ponded in culvert, June 7, 2006.

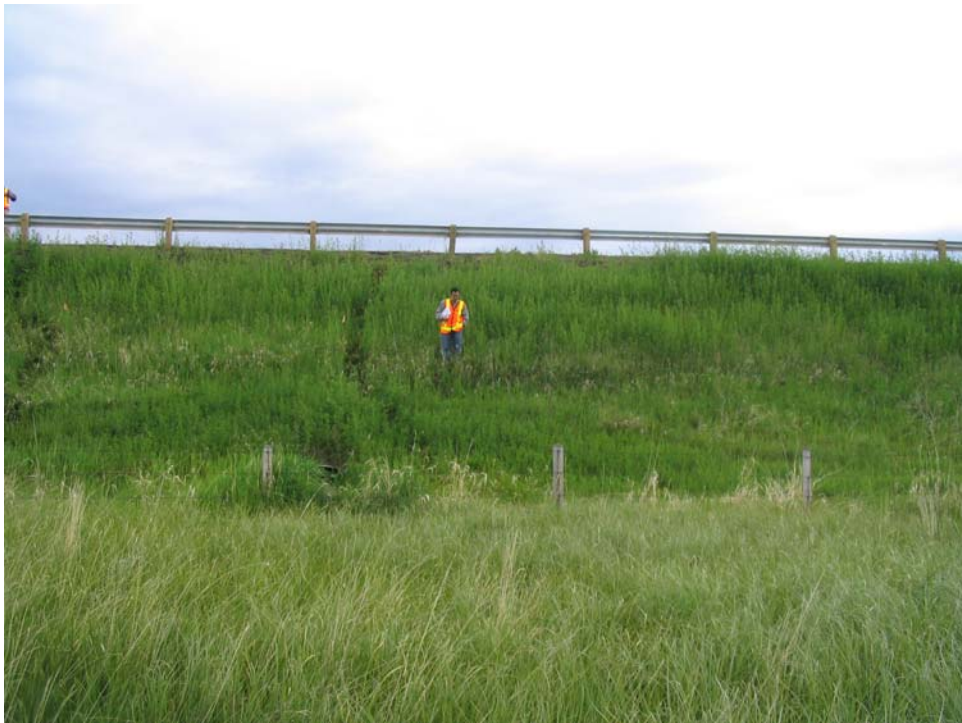
Photo 5 - Looking north at subdued shallow slump Area, June 7, 2006.

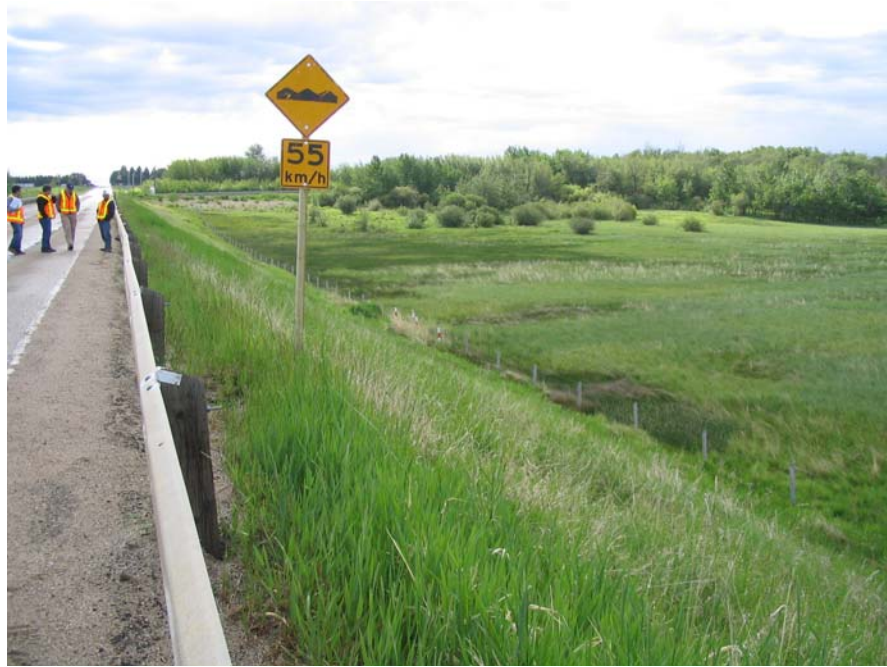
Photo 6 - Looking north at the top of north embankment slope, June 7, 2006.

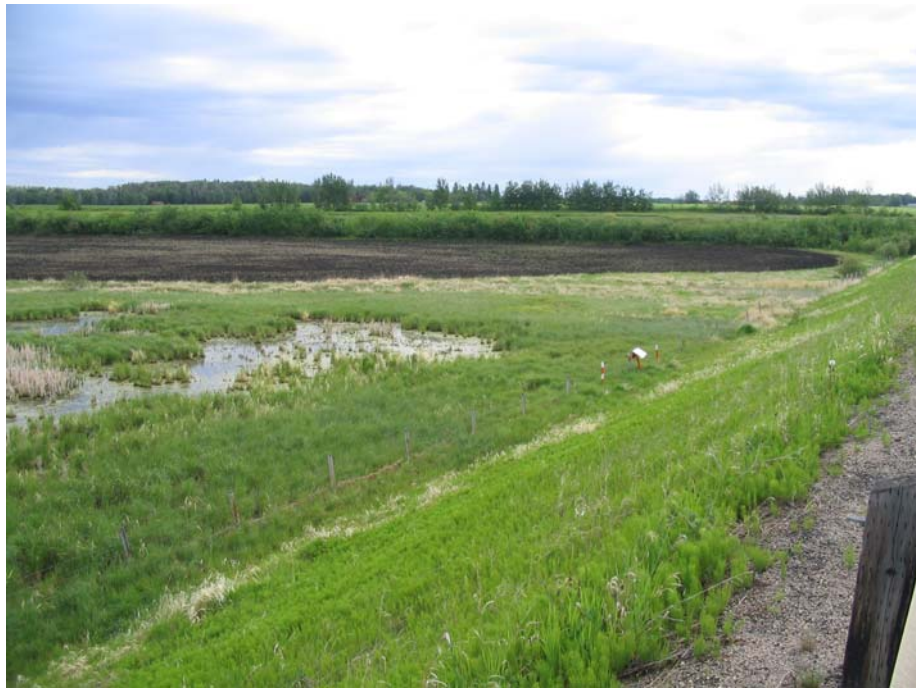
Photo 7 - Looking north - ponded water at toe of north embankment slope, June 7, 2006.
