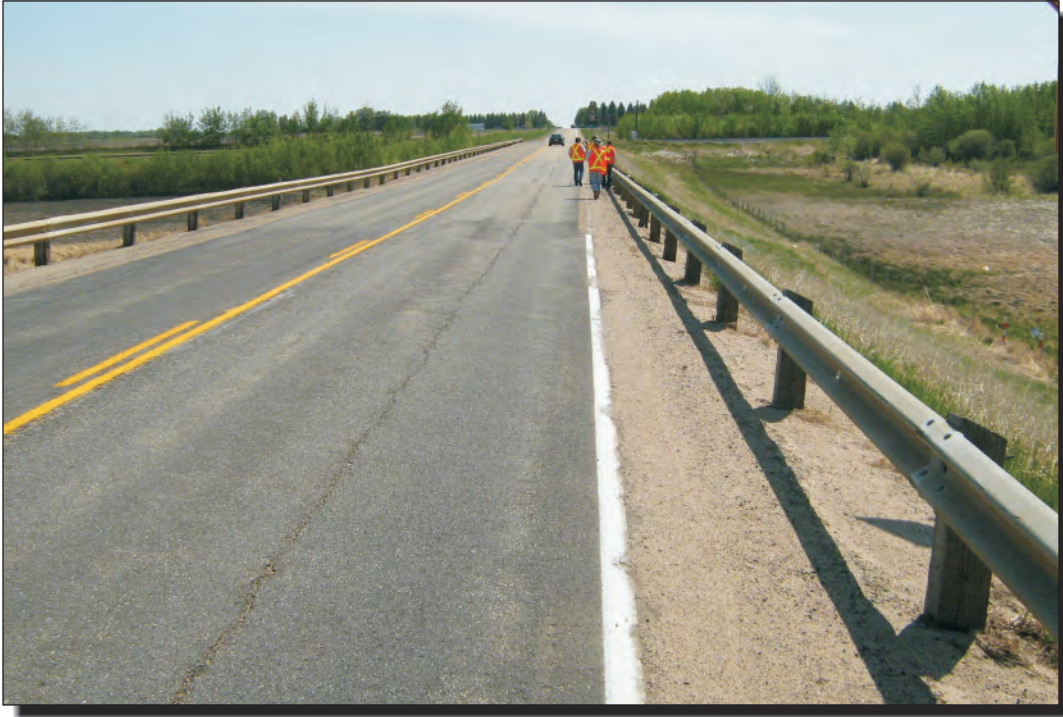
Photo 1

Looking east along roadway; note crack along pavement

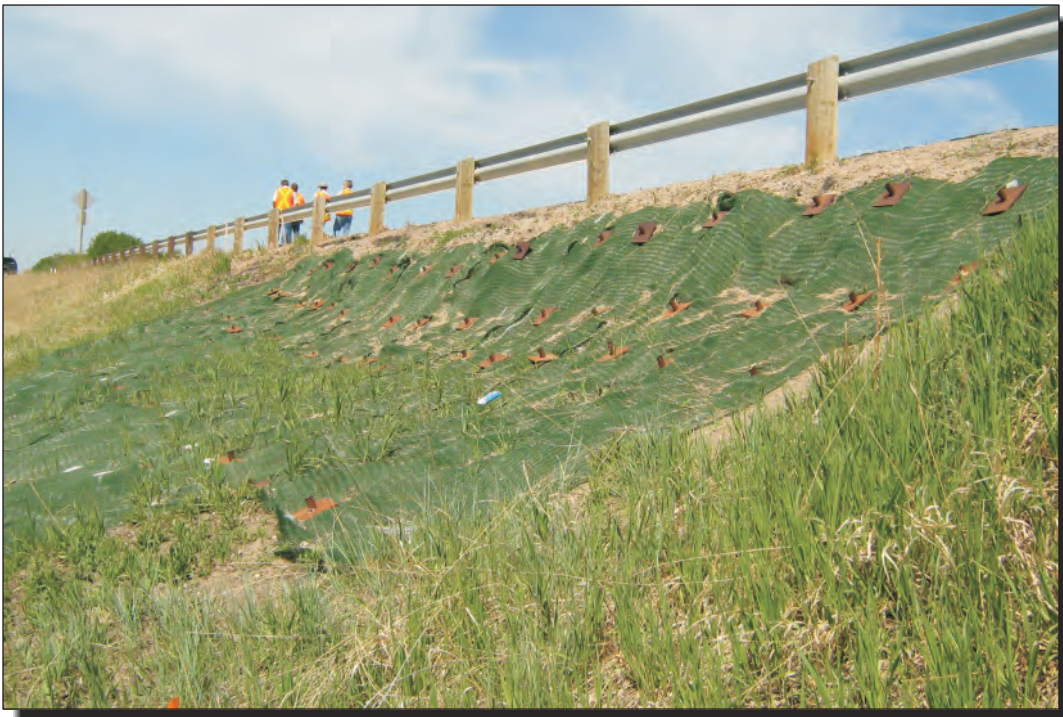
Photo 2

Repaired slope looking northwest

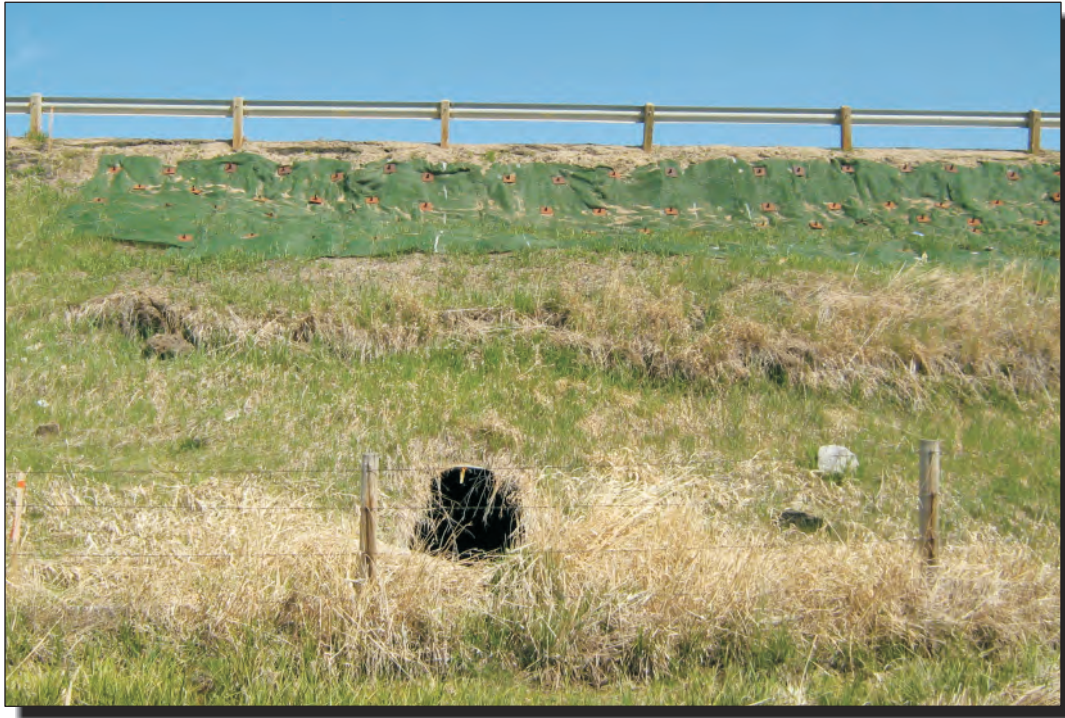
Photo 3
Profile of repaired slope
