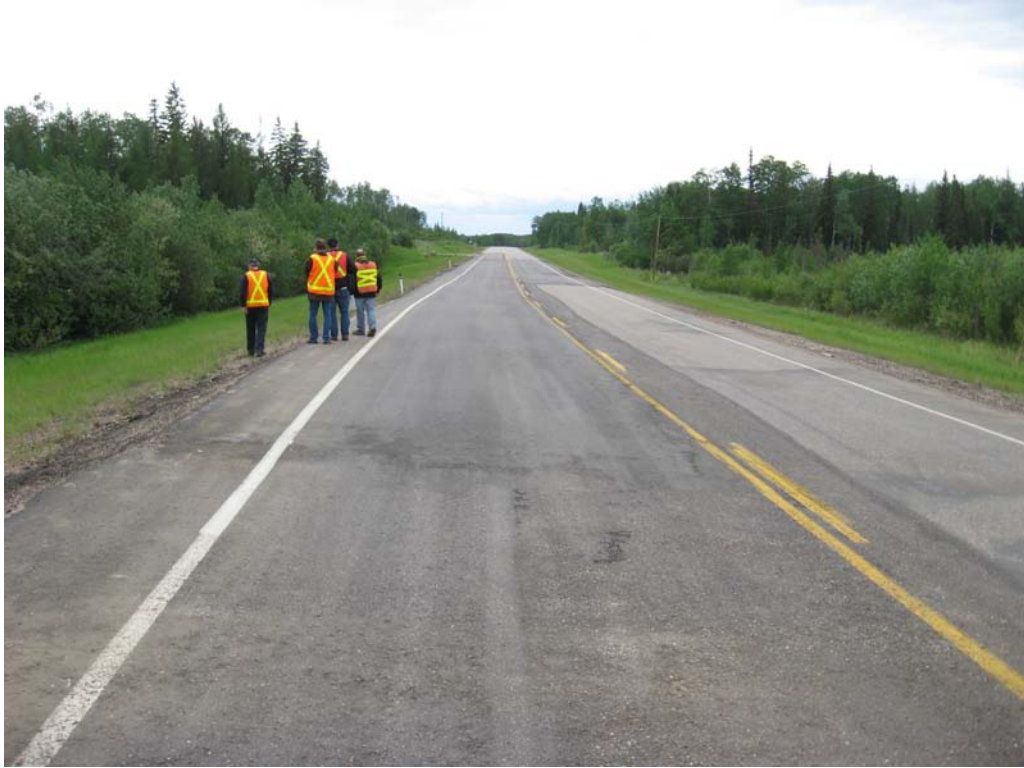
Photo #1 General view of highway surface at slide location, looking west

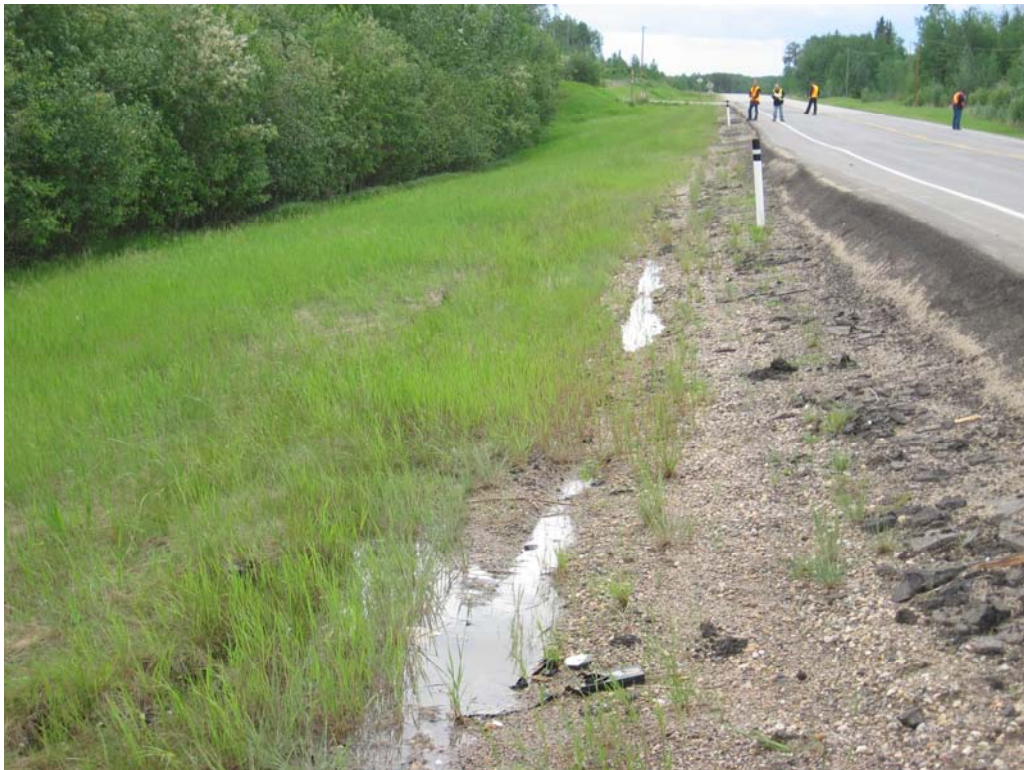
Photo #2 Looking west at the highway south side slope. Note the slight dip on the EBL, the water ponding on the side slope, and how thick the pavement overlays are (about 500 mm thick up to June 2009)

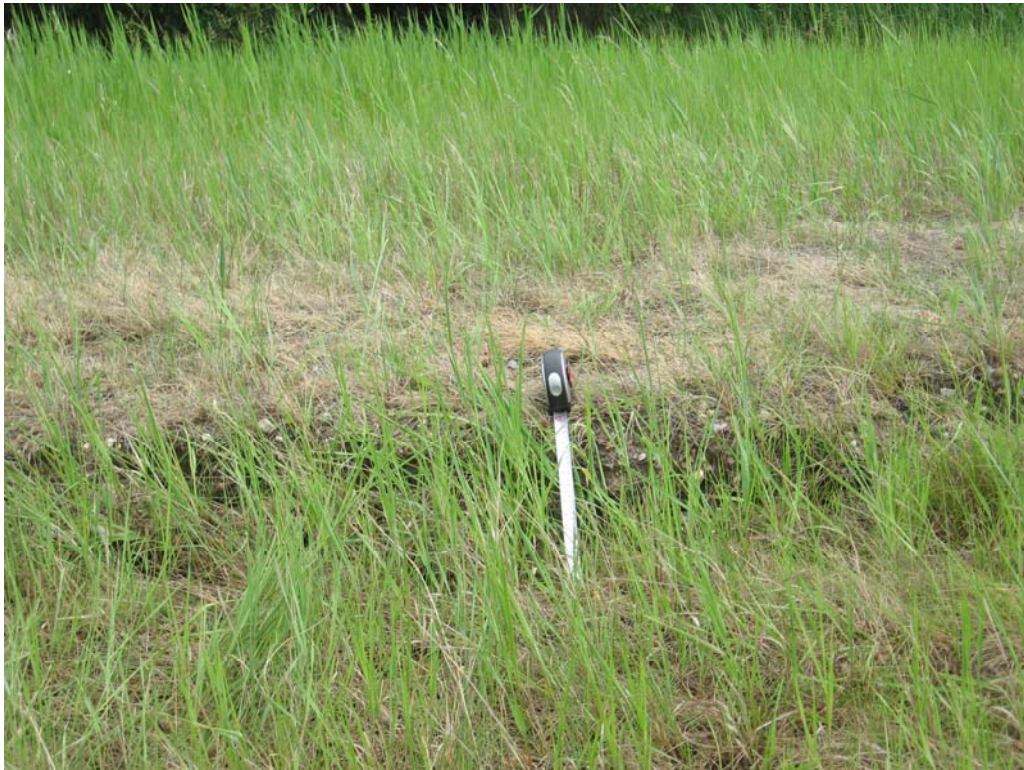
Photo #3 Looking at the graben counterscarp on the south side slope

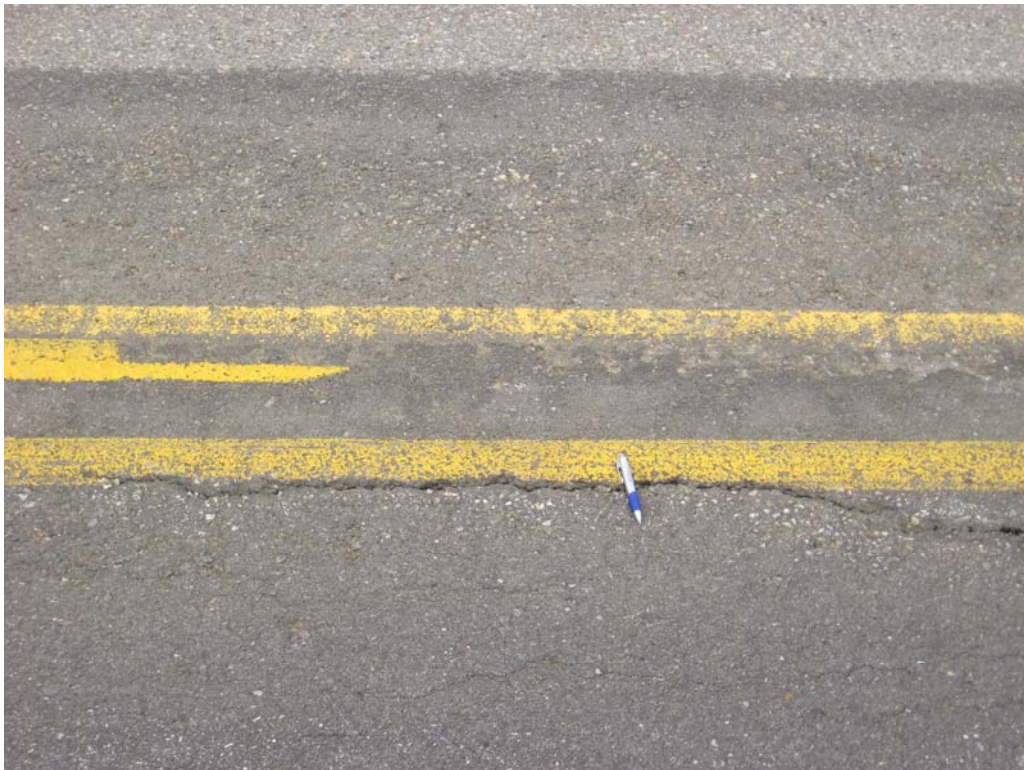
Photo #4 Looking north at a crack on the inner wheel path of the highway EBL

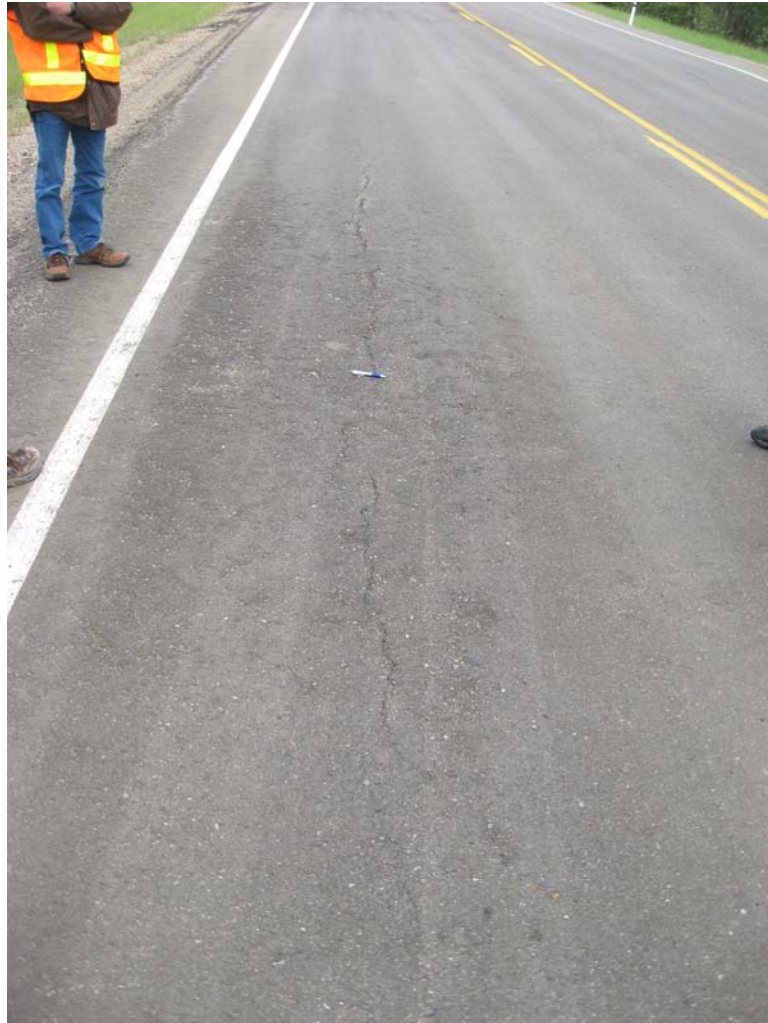
Photo #5 Looking at a longitudinal crack in the WBL

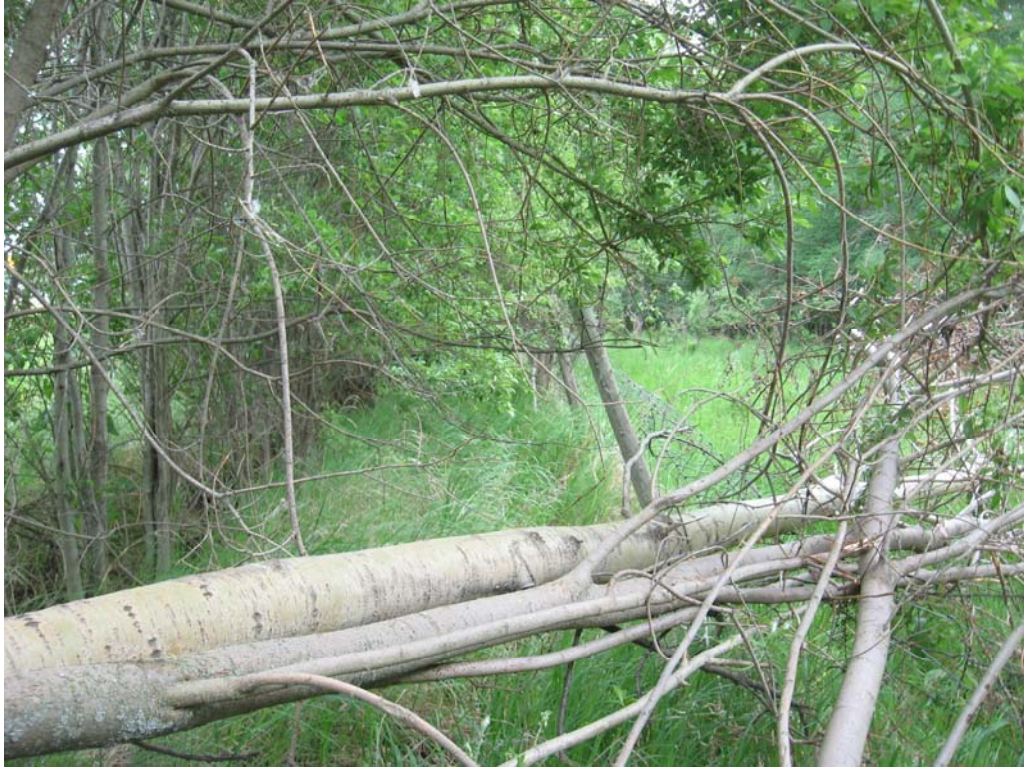
Photo #6 Looking at the distorted fence to the south of the south muskeg ditch

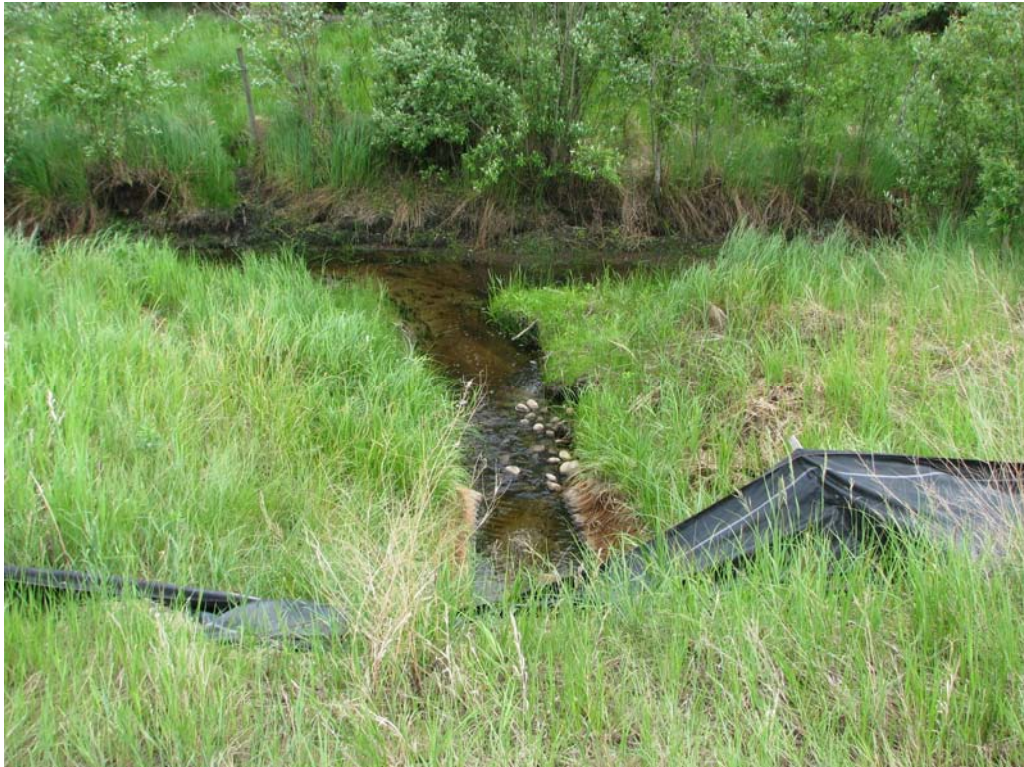
Photo #7 Looking at the inlet of a culvert on the south side of the highway at 200 m from the site. The inlet was previously blocked by a beaver dam in 2008. The beaver dam was cleared in 2009

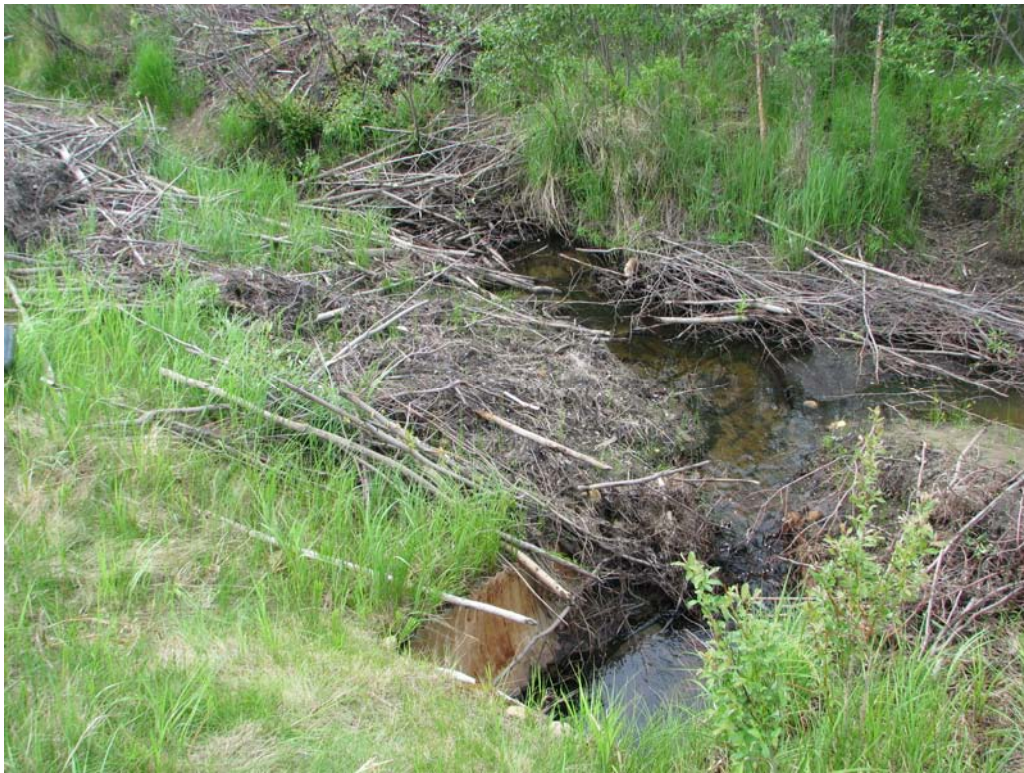
Photo #8 Looking at the outlet of a culvert on the north side of the highway at 300 m from the site. The inlet was previously blocked by a beaver dam in 2008. The beaver dam was cleared in 2009
