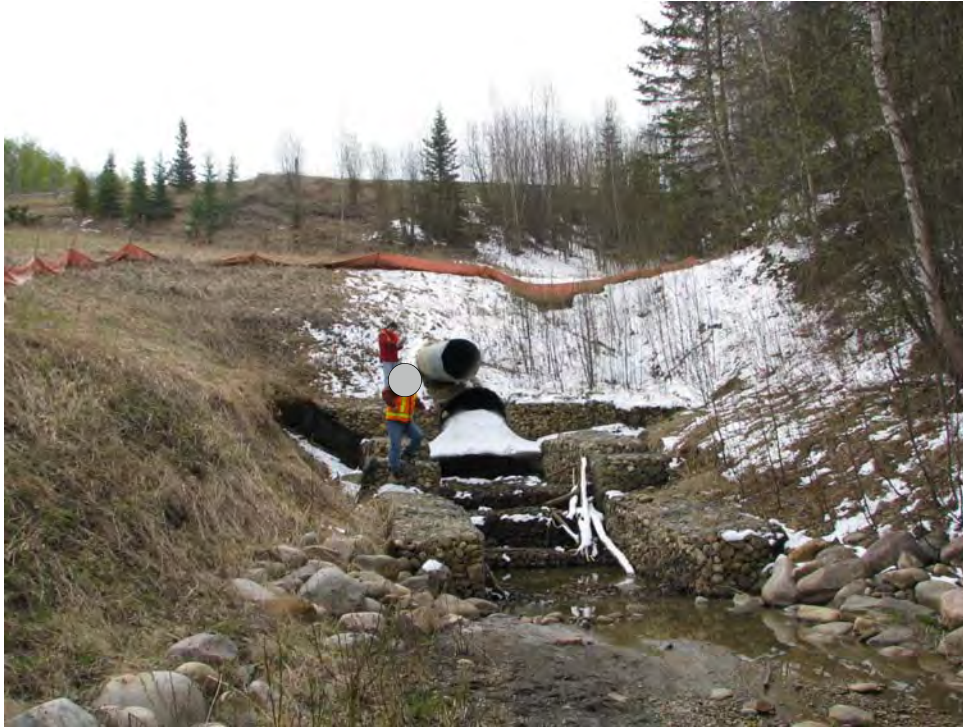
Photo 1 - Culvert outlet at Station 42+600, looking southeast.

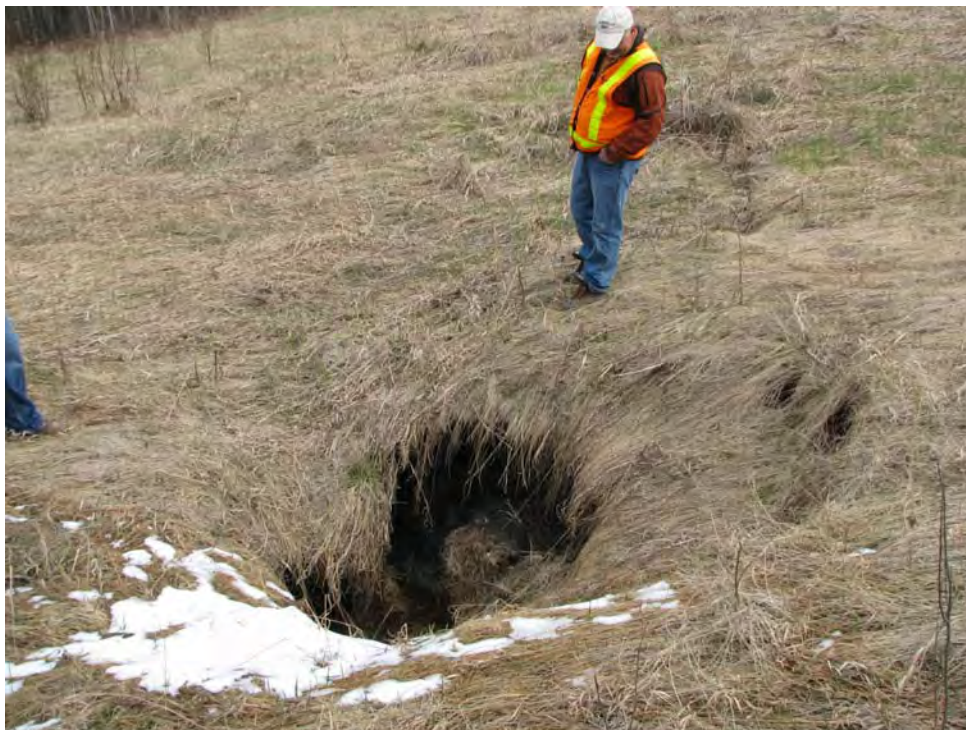
Photo 2 - Sinkhole on the west slope, near the culvert alignment.

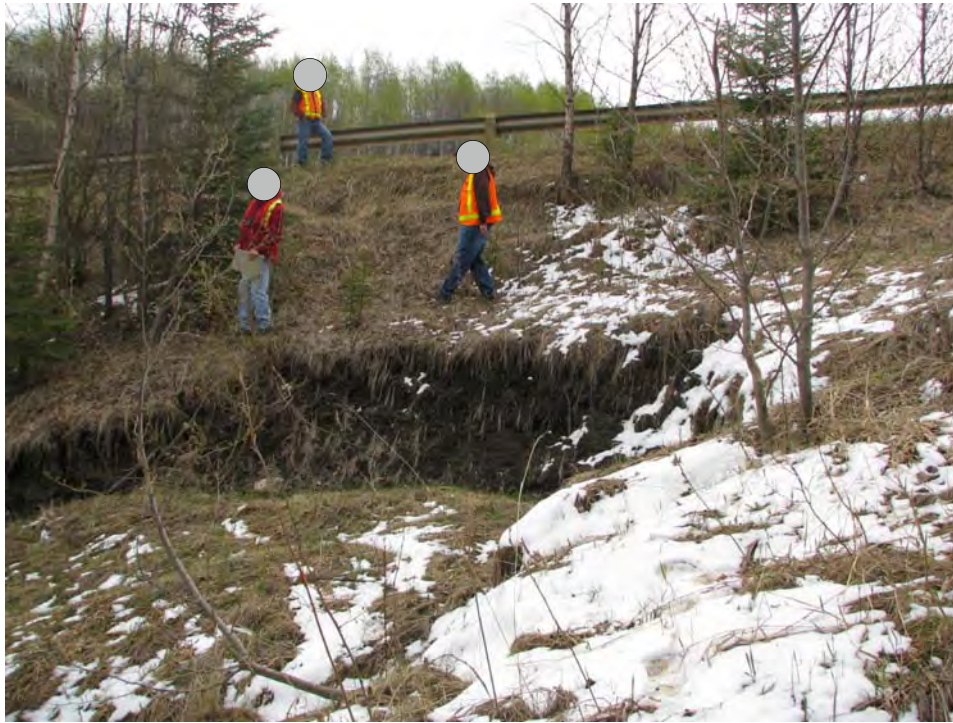
Photo 3 - New slump on the west sideslope, looking east.

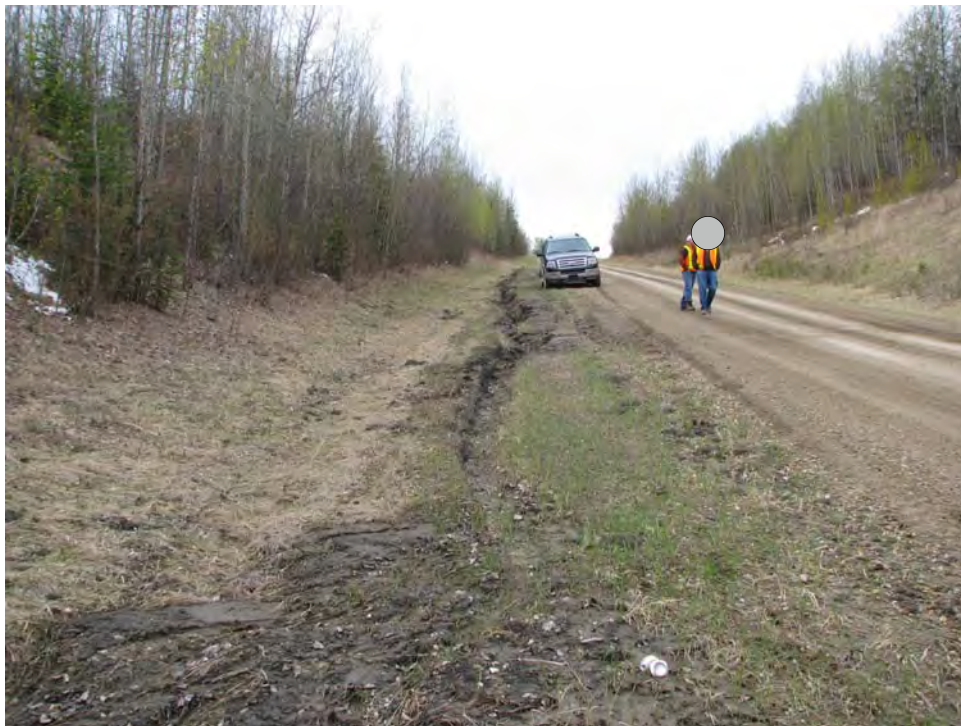
Photo 4 - Ditch erosion, looking south.

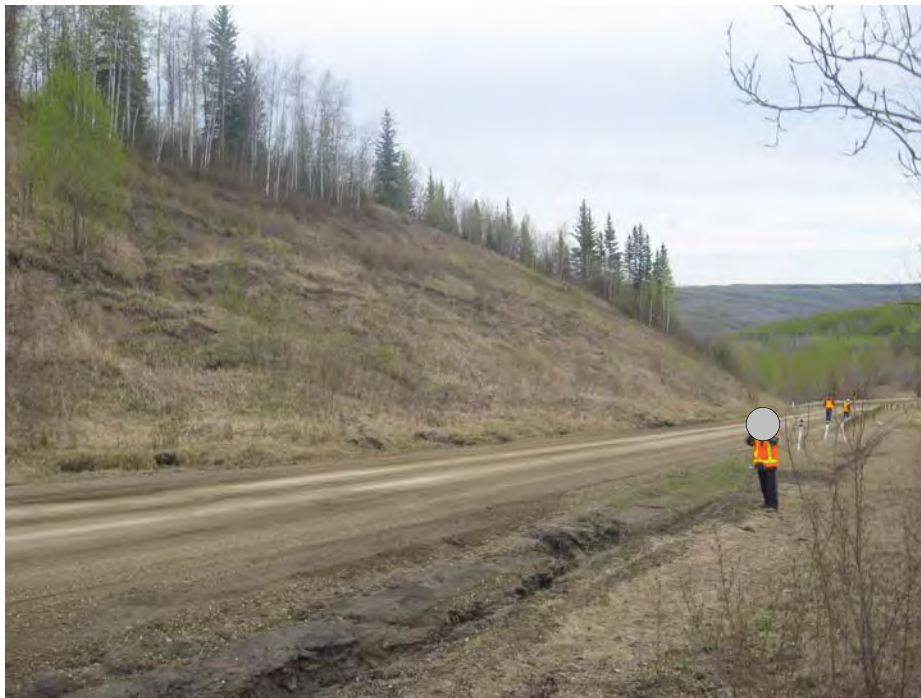
Photo 5 - View of shallow backslope failures at the south end of the site, looking northwest.

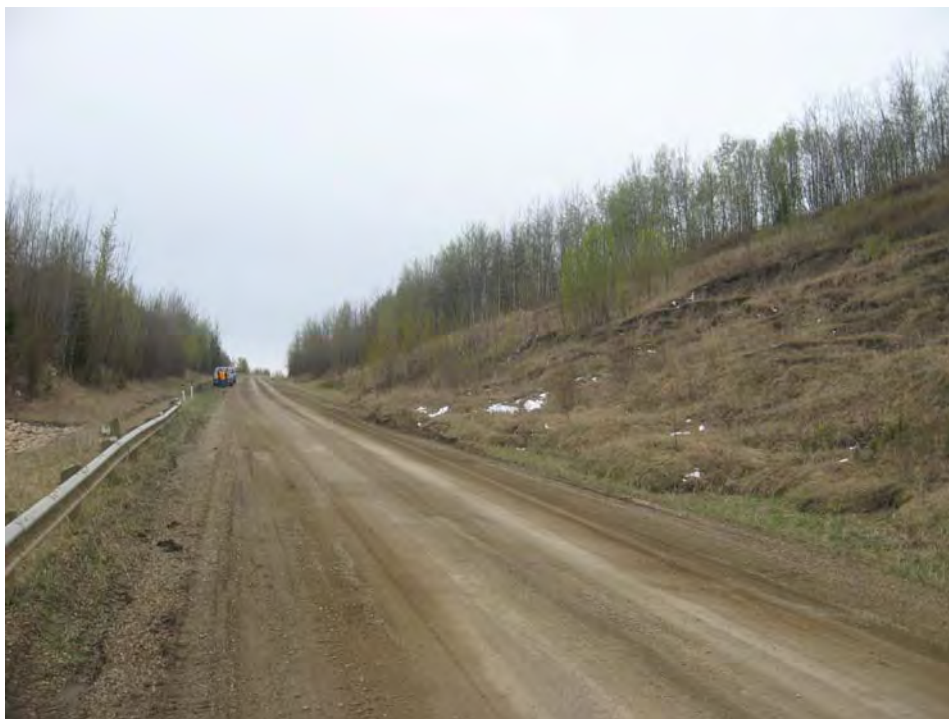
Photo 6 - Backslope failures on the west side of the highway, looking southwest.

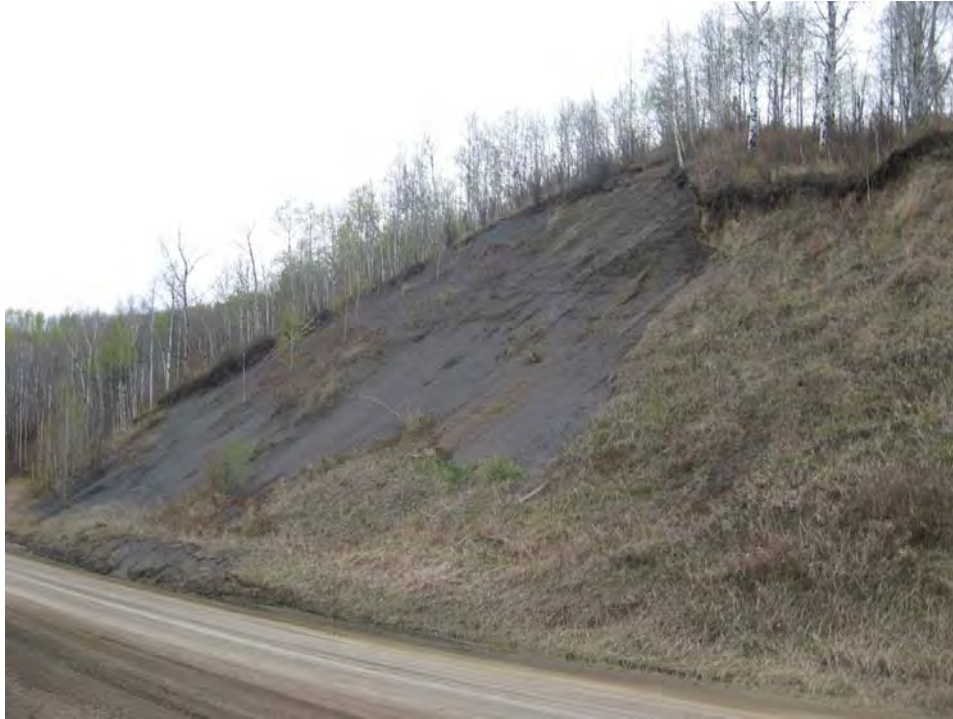
Photo 7 - Shale Slope at Station 43+200, looking northwest.
