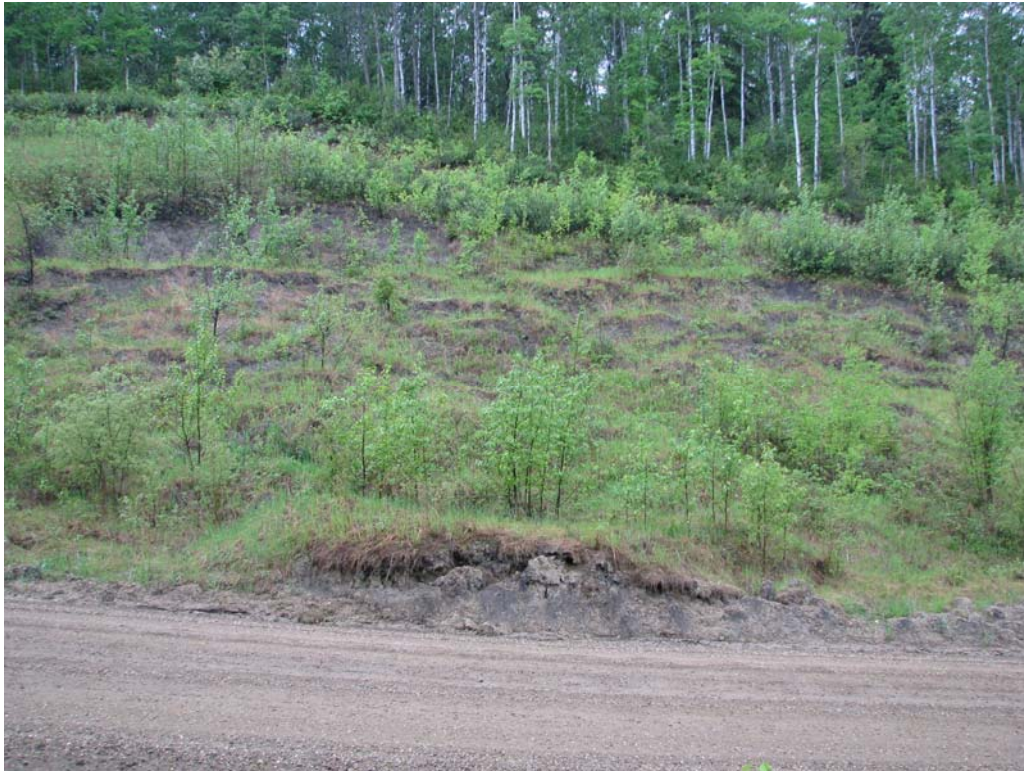
Photo 1 – Shallow slope failures on the south end of the site, looking west.

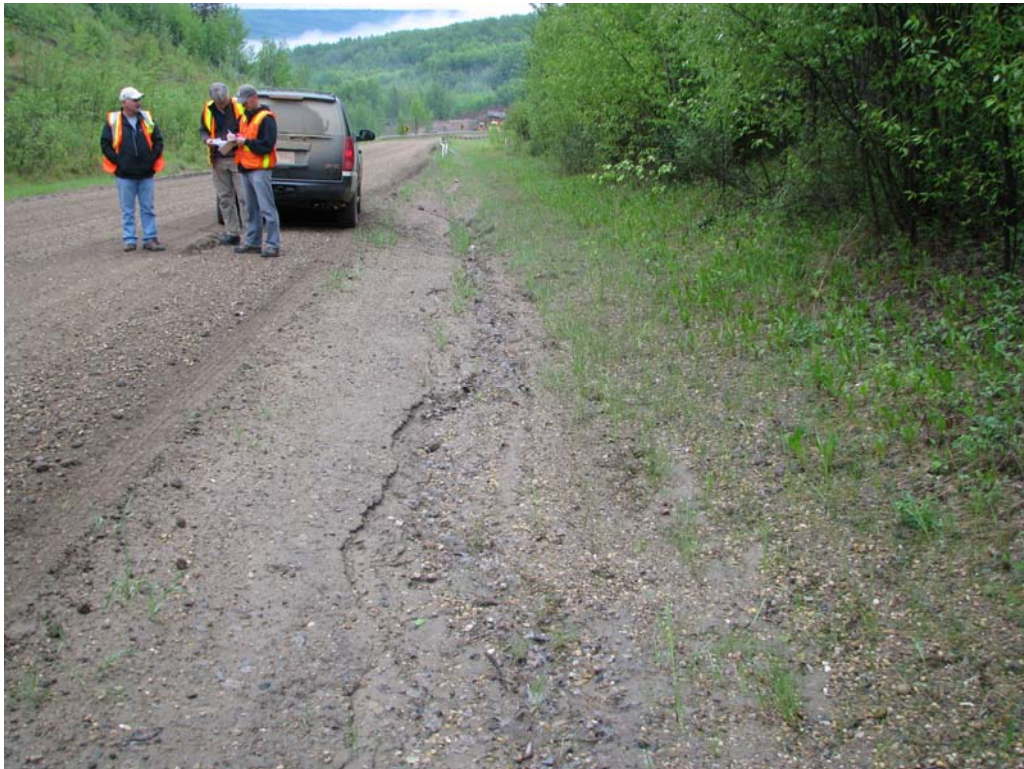
Photo 2 – Ditch erosion on the south end of the site, looking north.

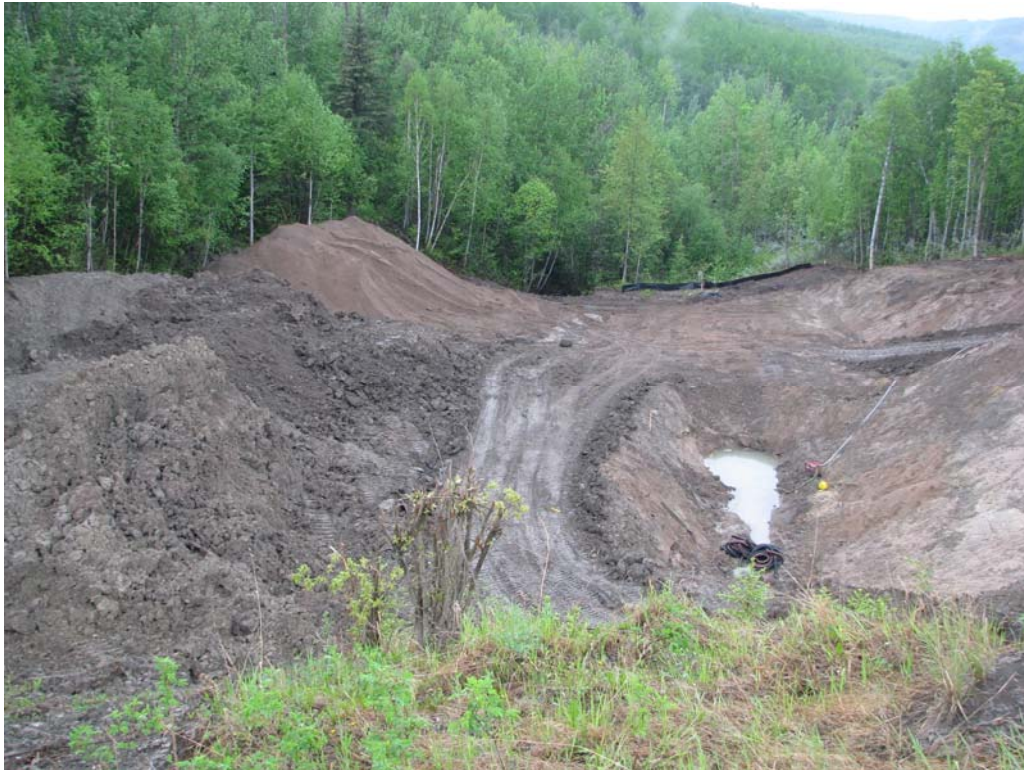
Photo 3 – Earthworks for new culvert installation, looking towards the outlet.

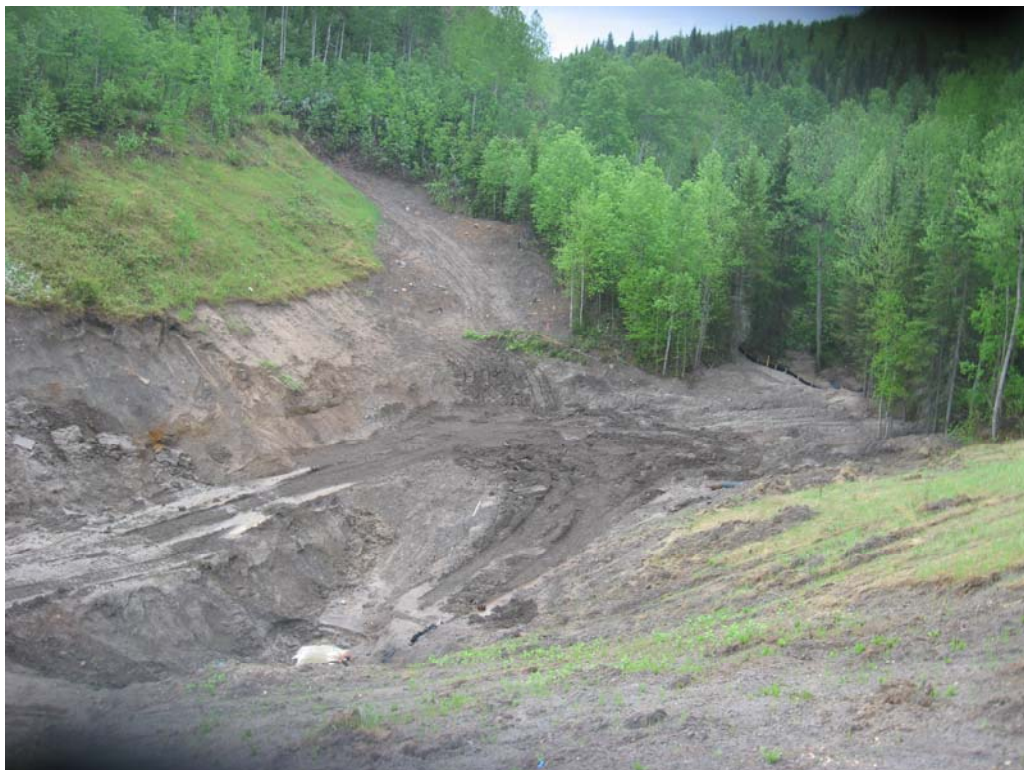
Photo 4 – Earthworks for new culvert installation, looking towards the inlet.

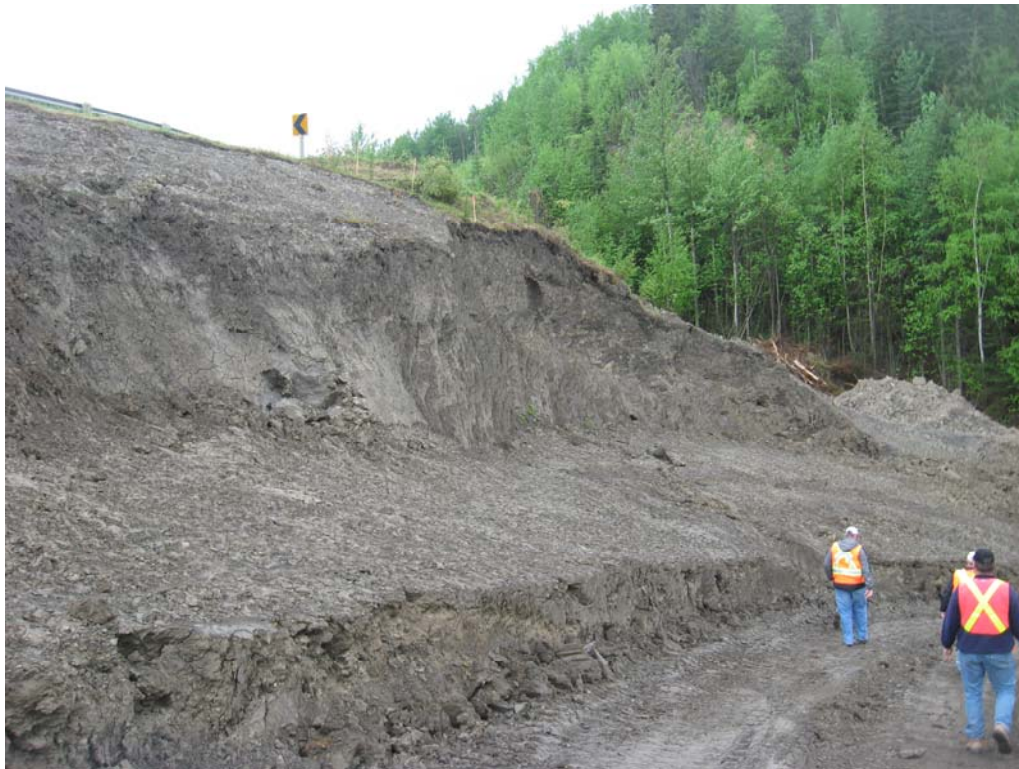
Photo 5 – Steep cut west of the highway near the culvert outlet, looking southeast.

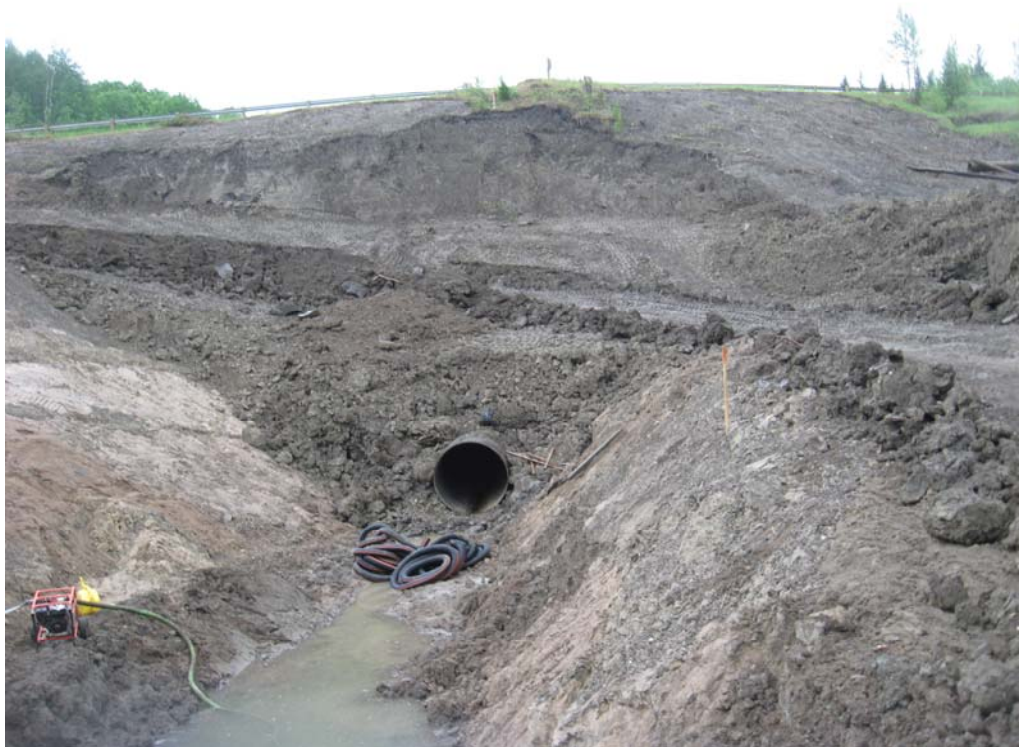
Photo 6 – View of open cut excavation at the culvert outlet, looking southeast.

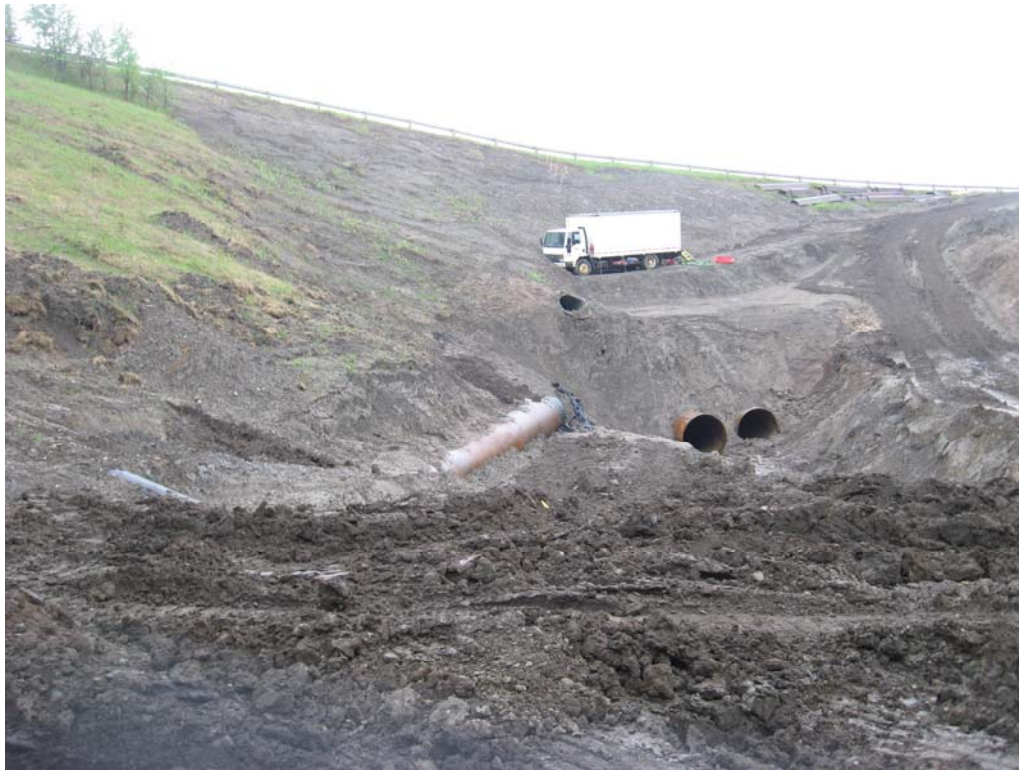
Photo 7 - View of open cut excavation at the culvert inlet, looking northwest.

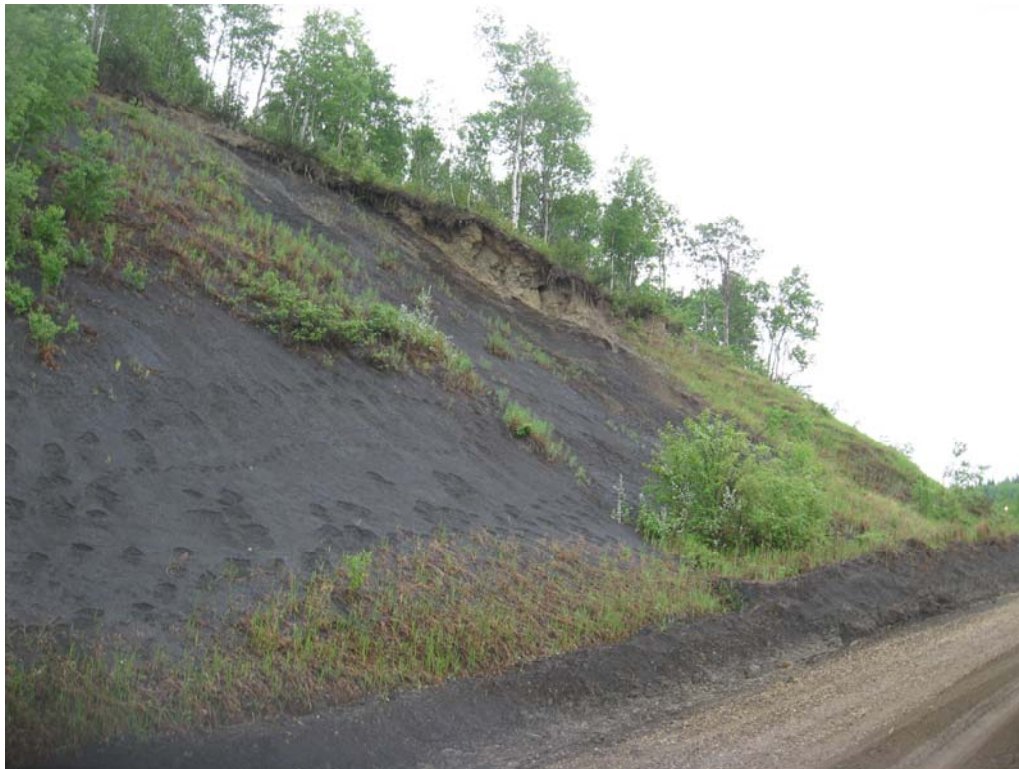
Photo 8 - Shale Slope at Station 43+200, looking southeast.
