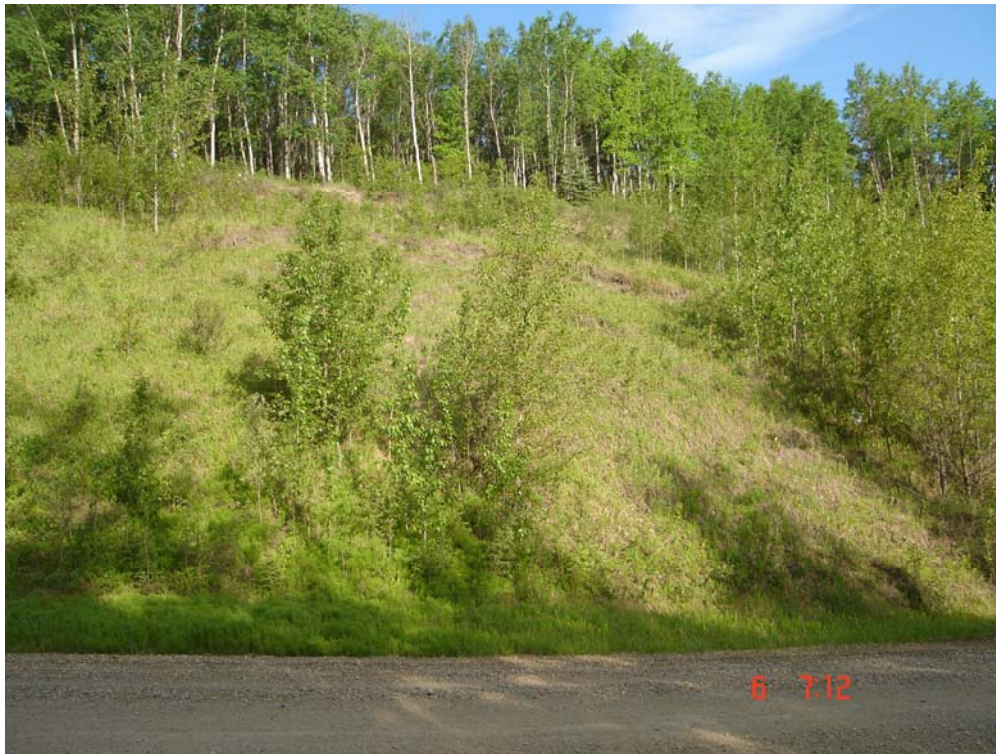
Photo 1 – Shallow slope failures on the south end of the site, looking west.

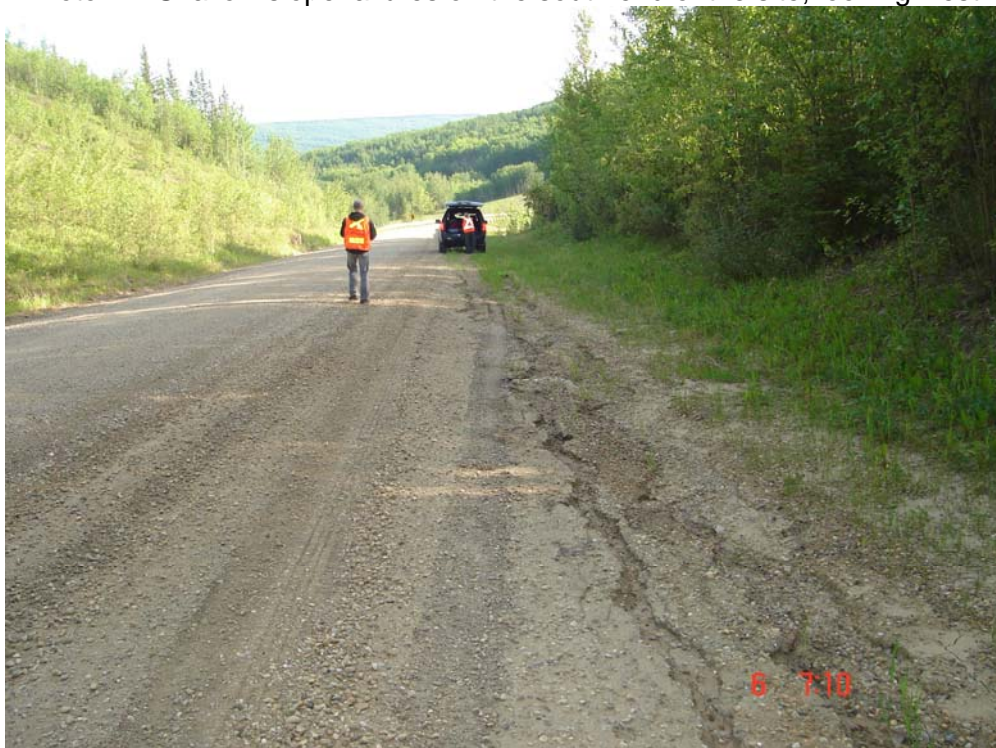
Photo 2 – Ditch erosion on the south end of the site, looking north.

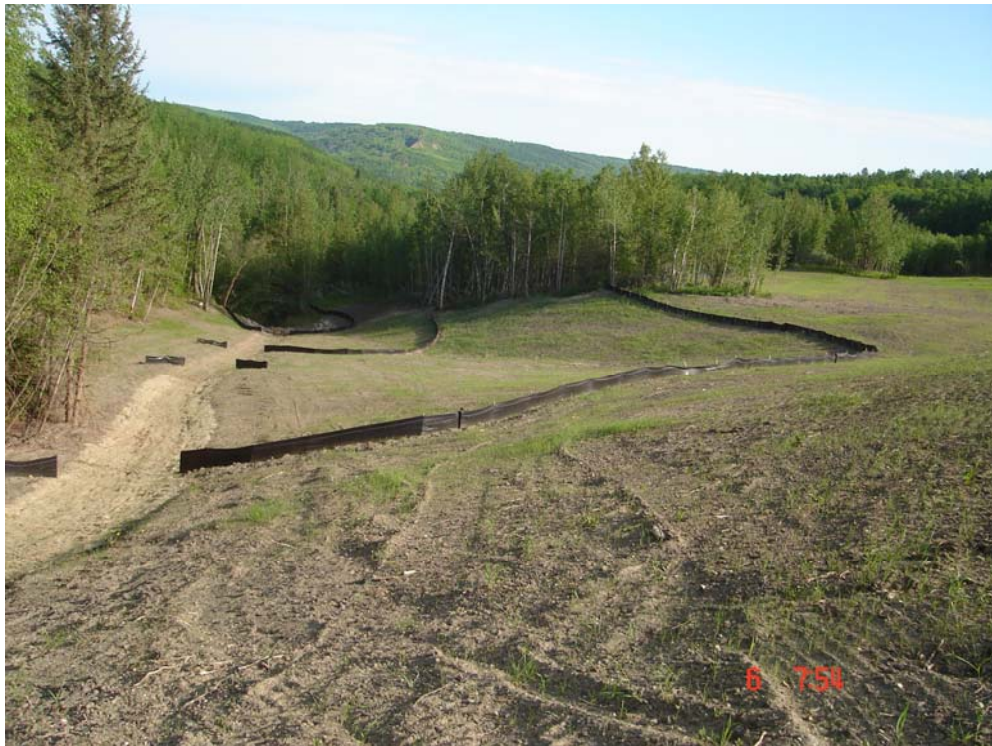
Photo 3 – Earthworks for new culvert installation, looking towards the outlet.

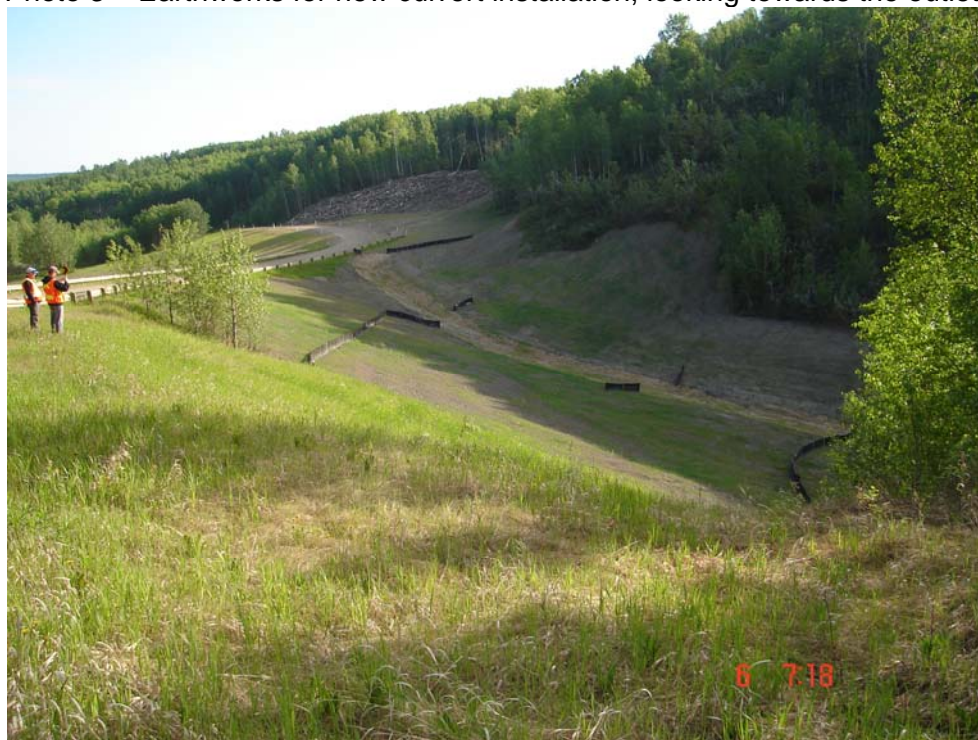
Photo 4 – Earthworks for new culvert installation, looking towards the inlet.

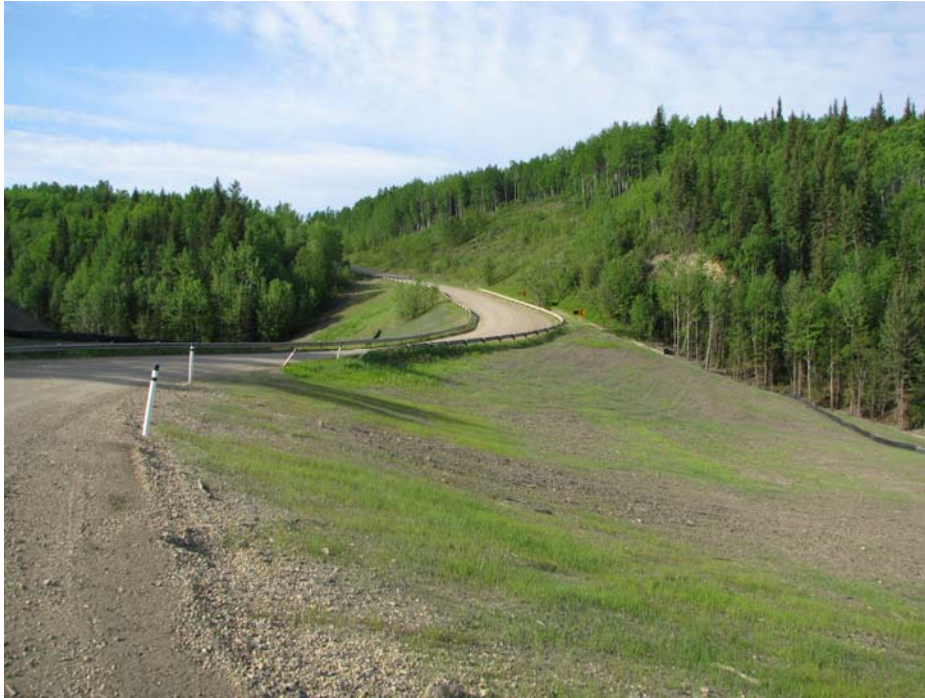
Photo 5 – Highway embankment, looking southeast.

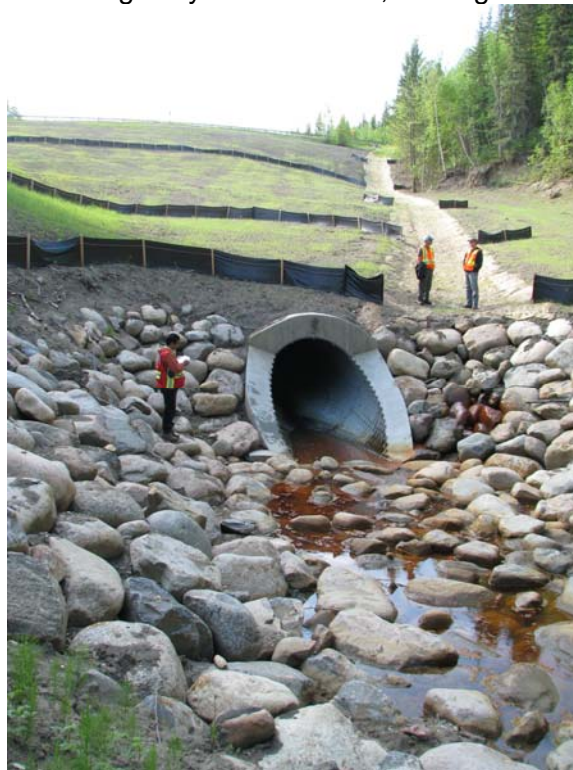
Photo 6 – View of culvert outlet, looking southeast.

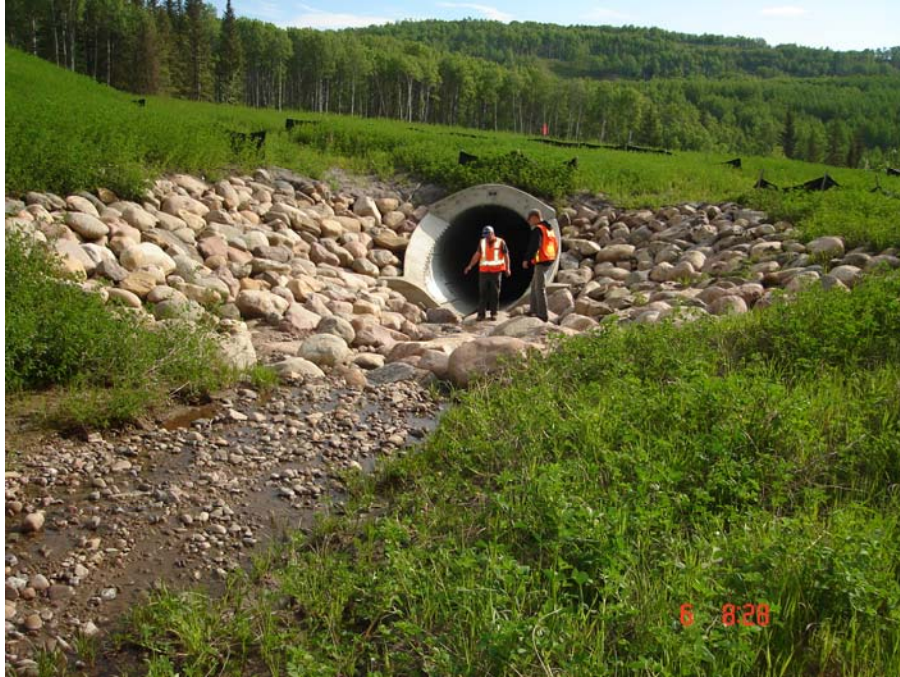
Photo 7 - View of culvert inlet, looking northwest

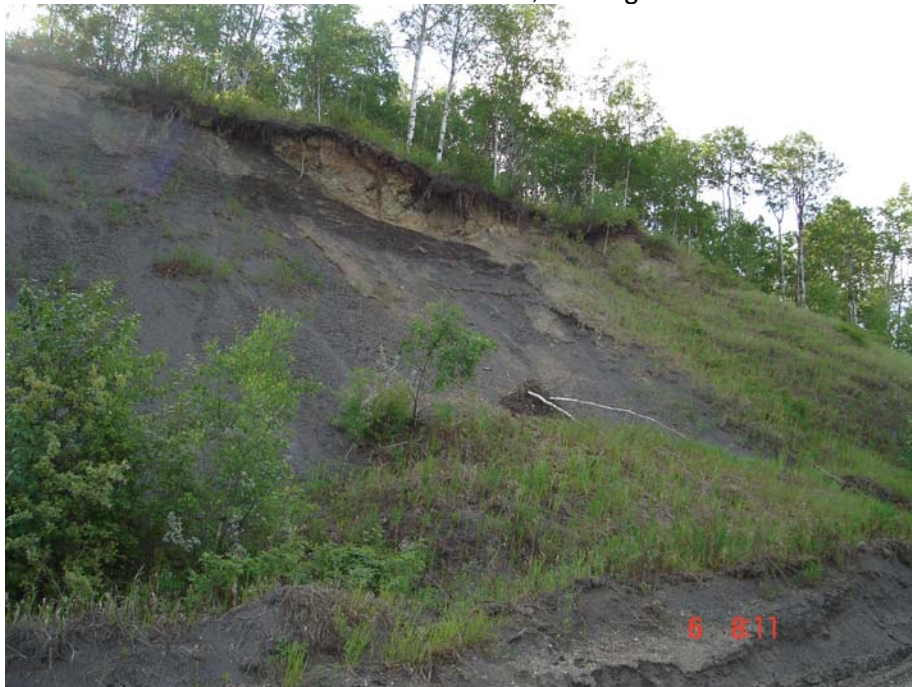
Photo 8 - Shale Slope at Station 43+200, looking southeast.
