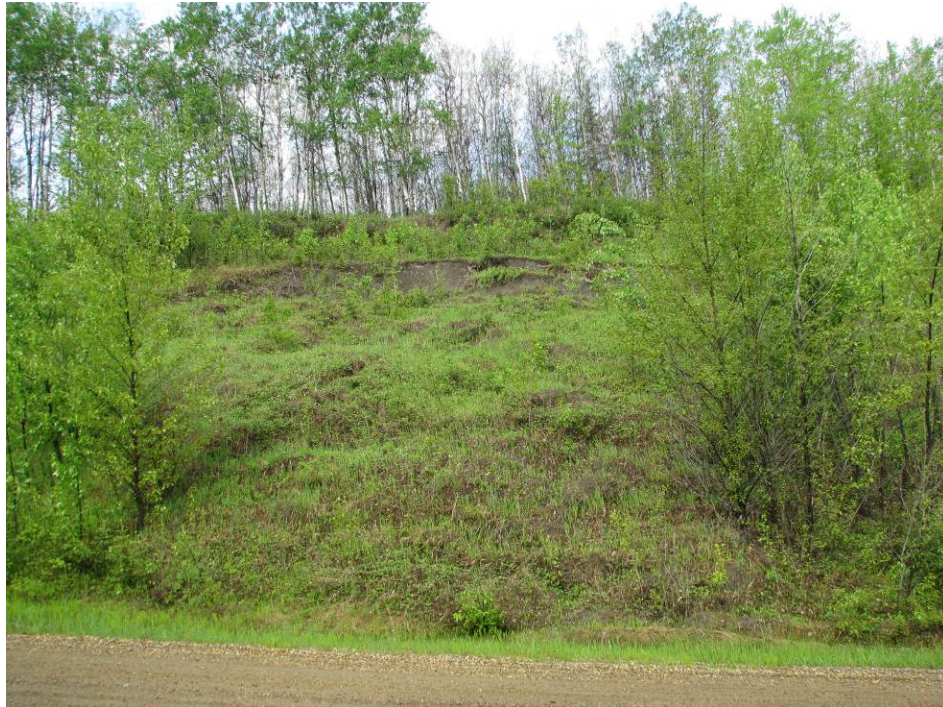
Photo 1 – Shallow back slope failures on the south end of the site, looking west.

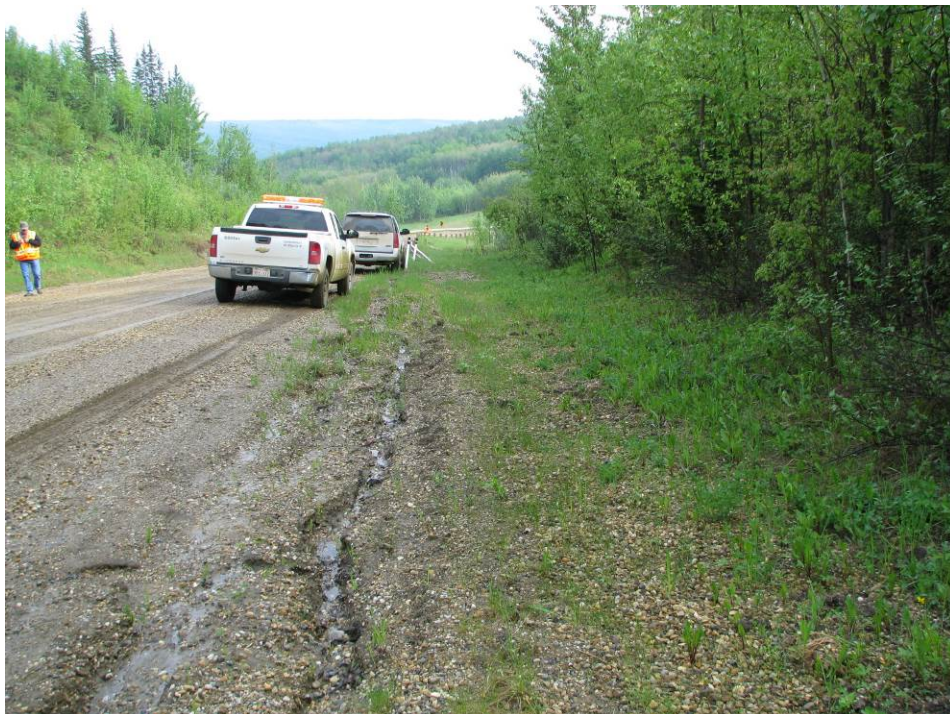
Photo 2 – Ditch erosion on the south end of the site, looking north.

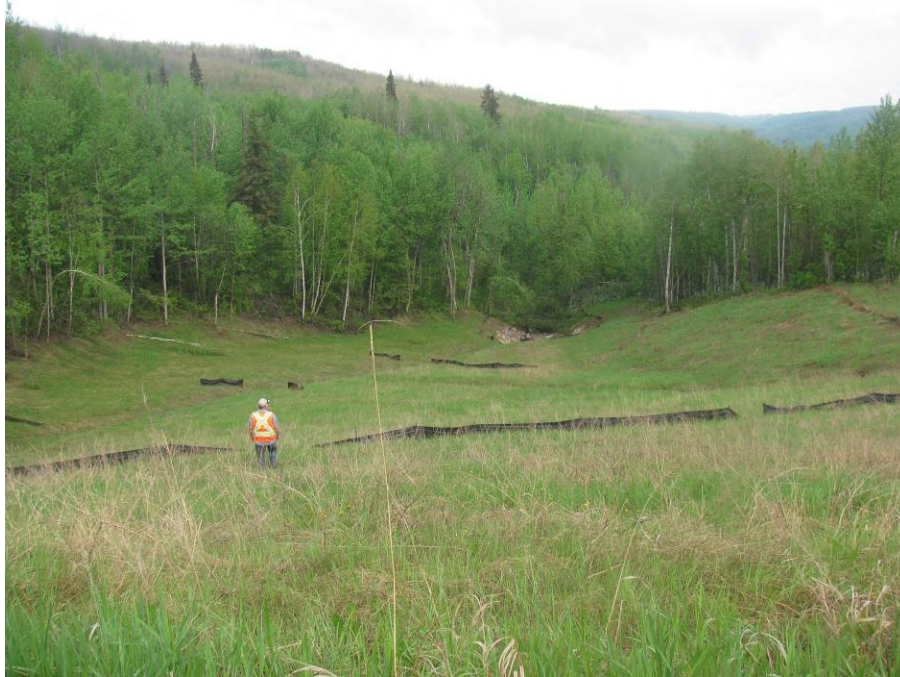
Photo 3 – Side slope, looking towards the outlet.

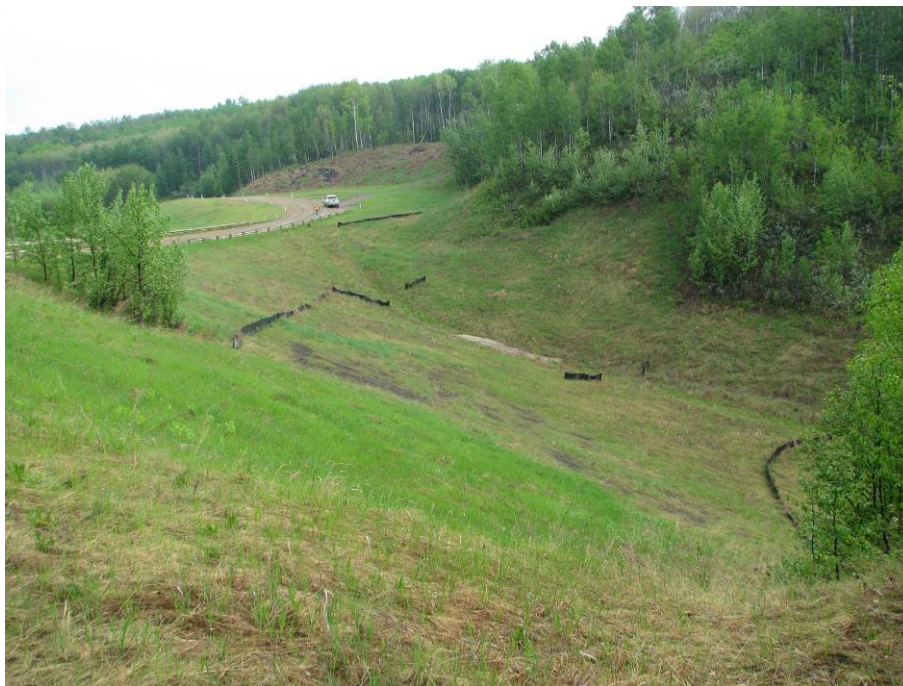
Photo 4 – Side slope, looking towards the inlet.

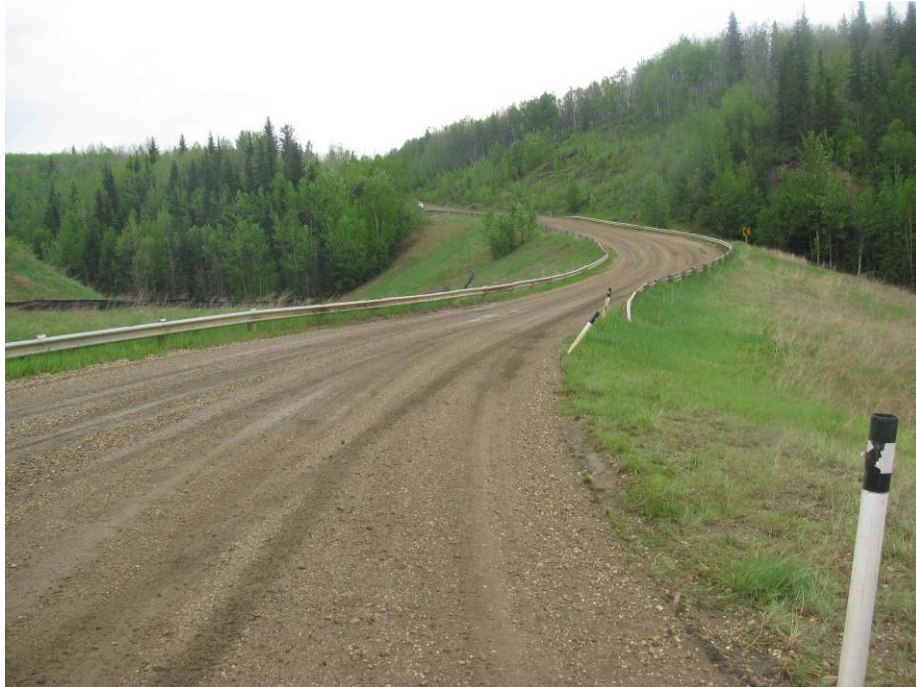
Photo 5 – Highway embankment, looking southwest.

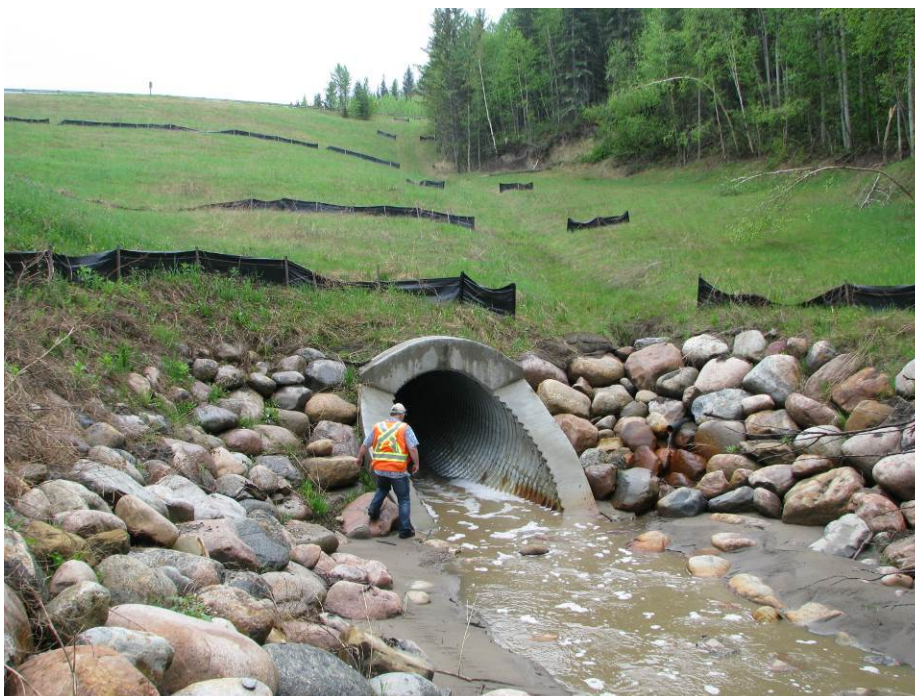
Photo 6 – View of culvert outlet, looking southeast.

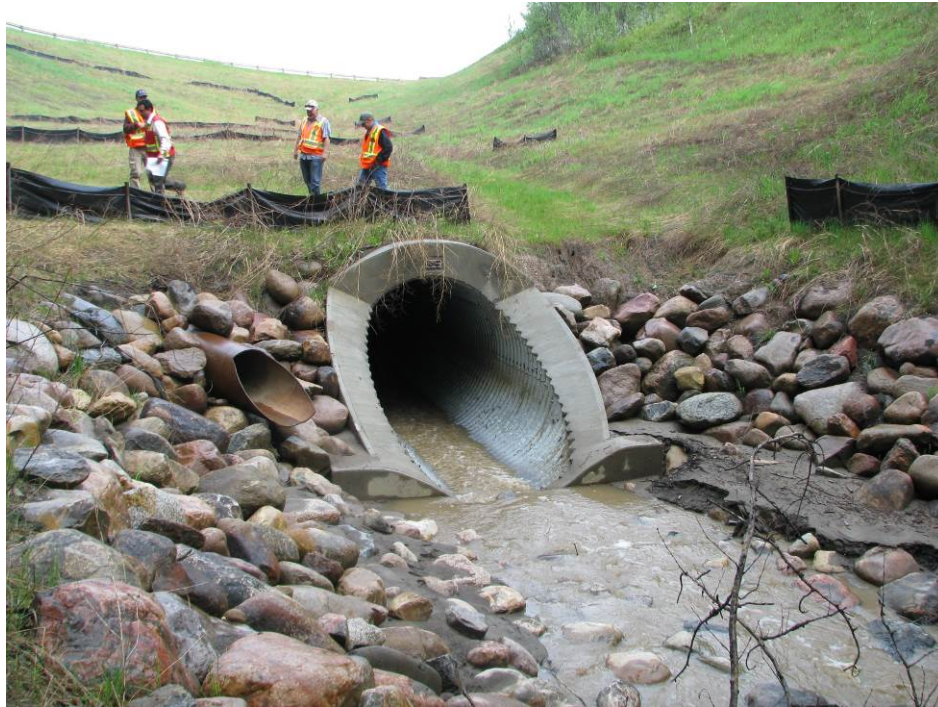
Photo 7 - View of culvert inlet, looking northwest.

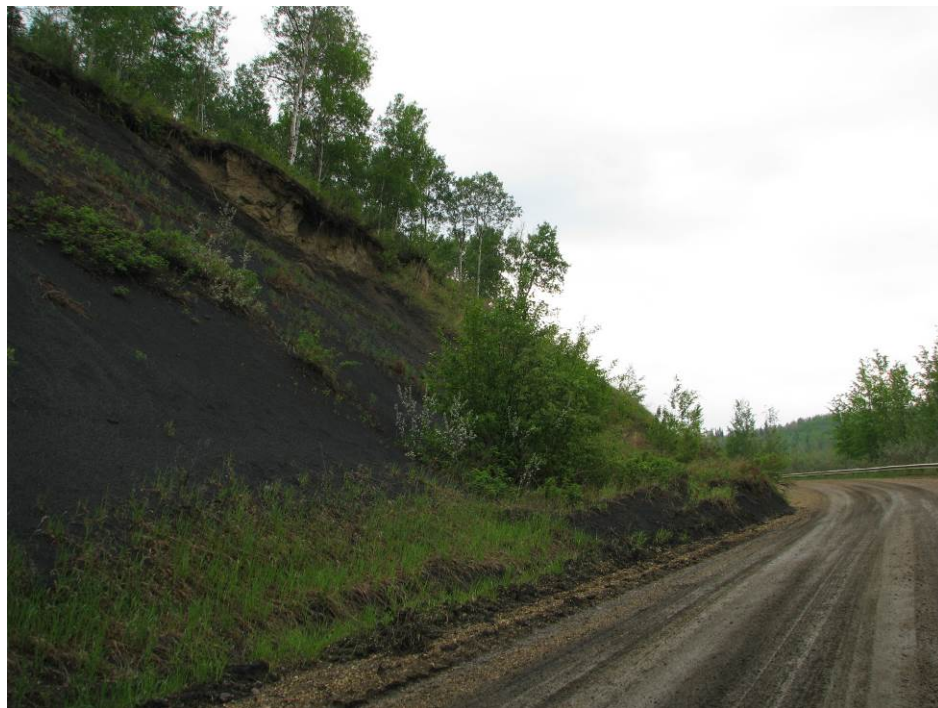
Photo 8 - Shale Slope at Station 43+200, looking southeast.
