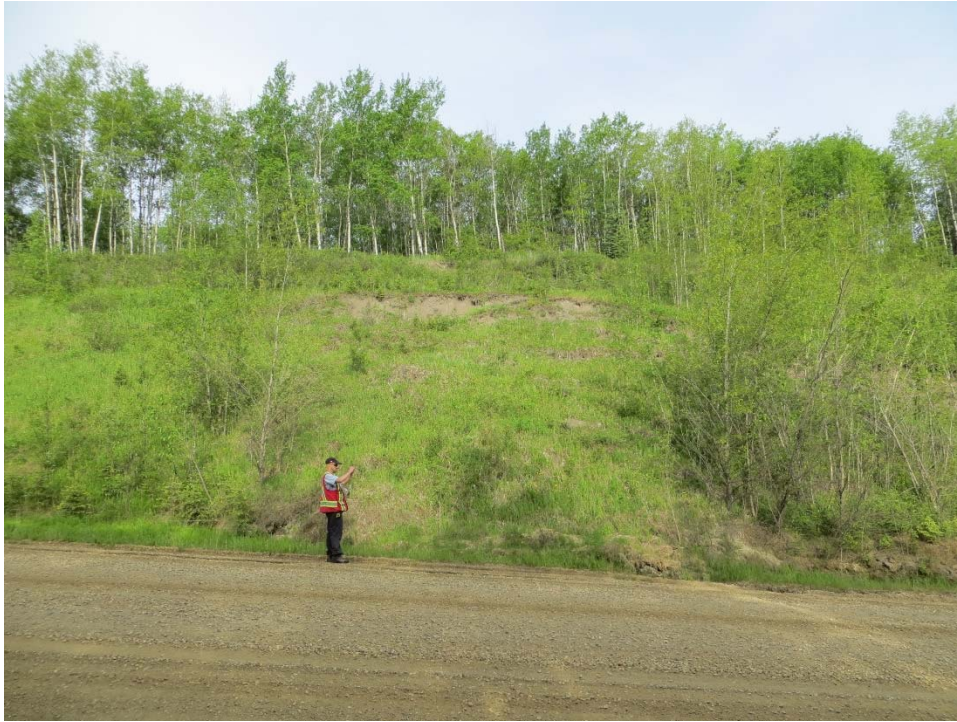
Photo 1 – Looking west at shallow west backslope failures on the south end of the site.

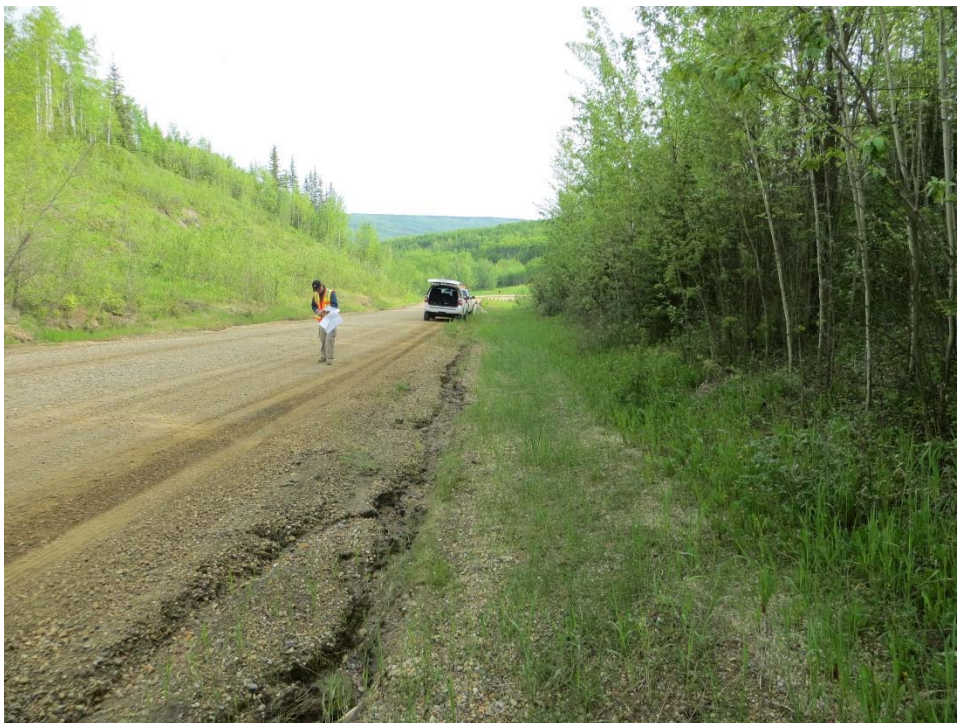
Photo 2 – Looking north at east ditch erosion at the south end of the site.

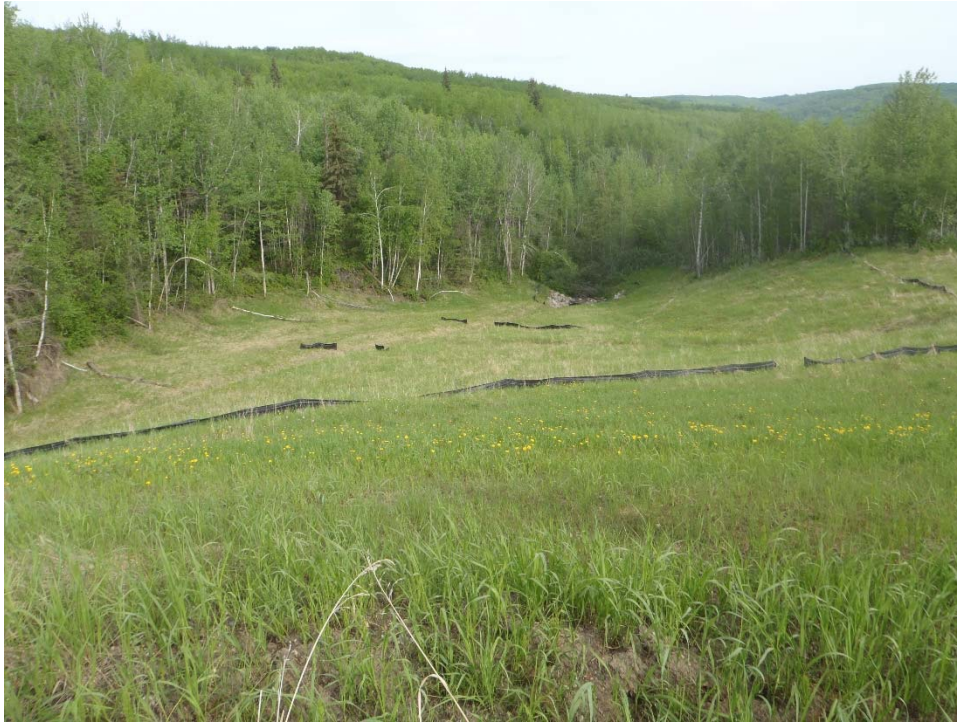
Photo 3 – Looking west toward culvert outlet along west sideslope.

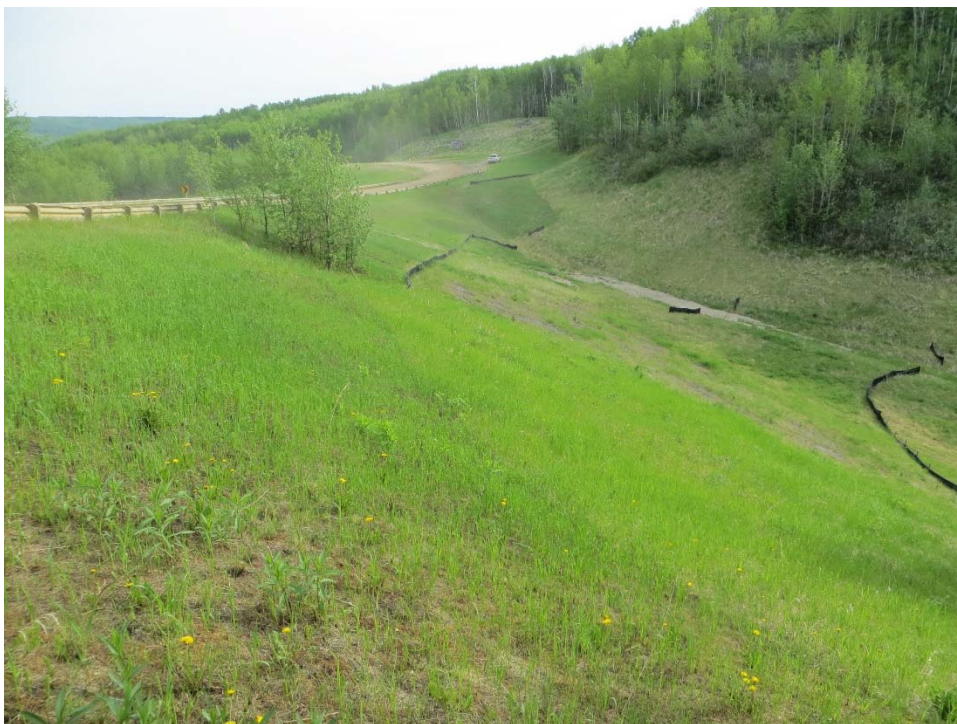
Photo 4 – Looking north at east sideslope above culvert inlet.

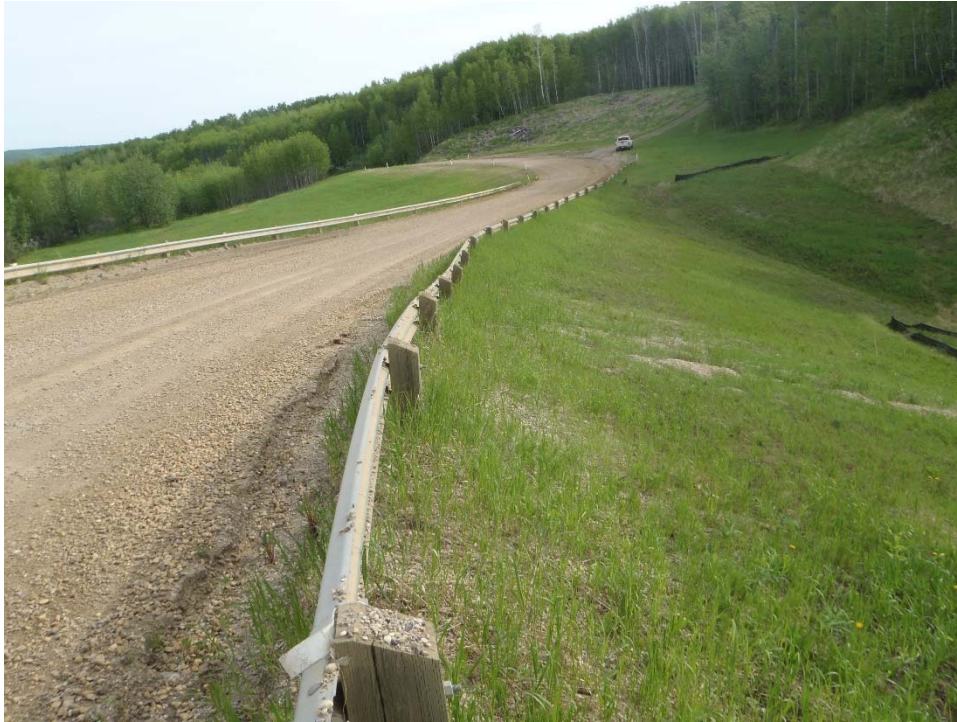
Photo 5 – Looking north along east guardrail. Note deflection in guardrail at gully.

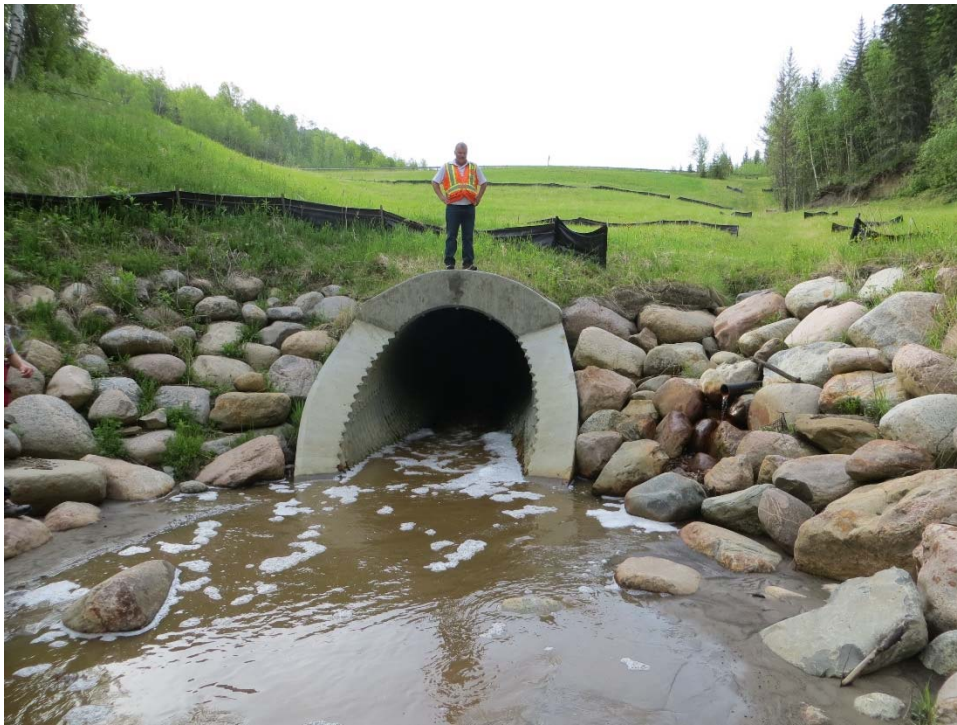
Photo 6 – Looking southeast at culvert outlet. Note erosion in riprap on right side of the culvert.

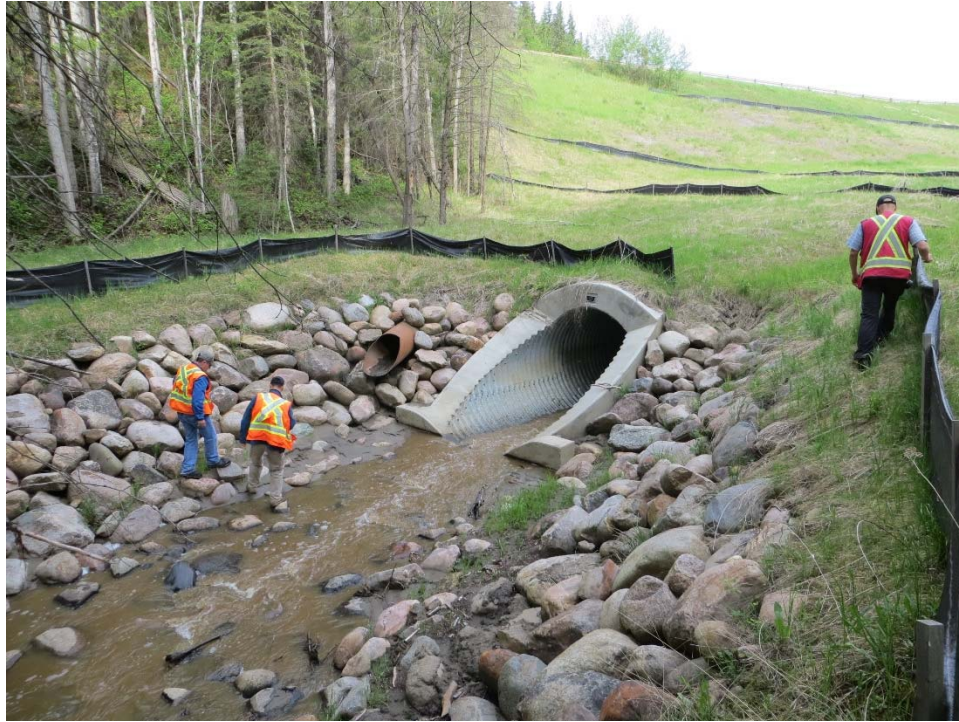
Photo 7 – Looking northwest at culvert inlet. Note erosion to right of culvert above the riprap.

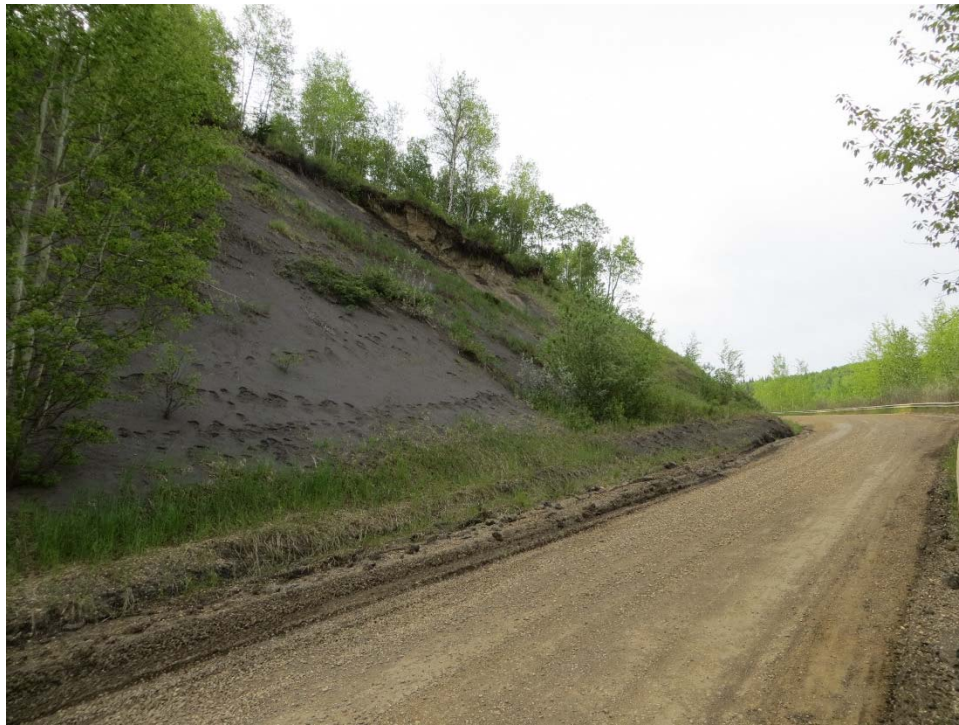
Photo 8 – Looking southeast at shale slope at km 43.2.
