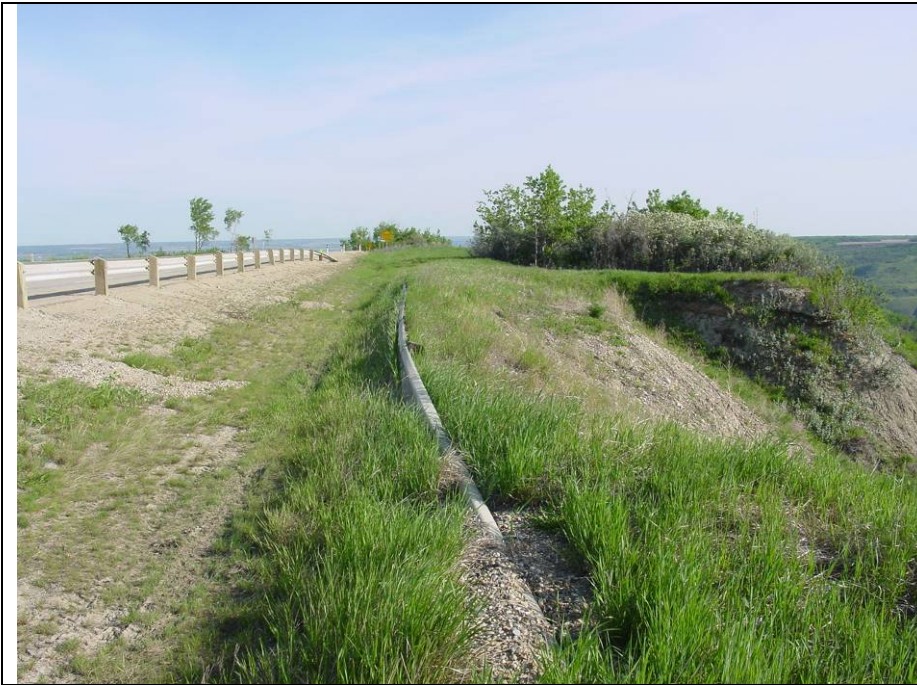
**Photo 1.**  
Slide 1 – there is a damp area at the north end of the slide, but otherwise no changes from 2006.

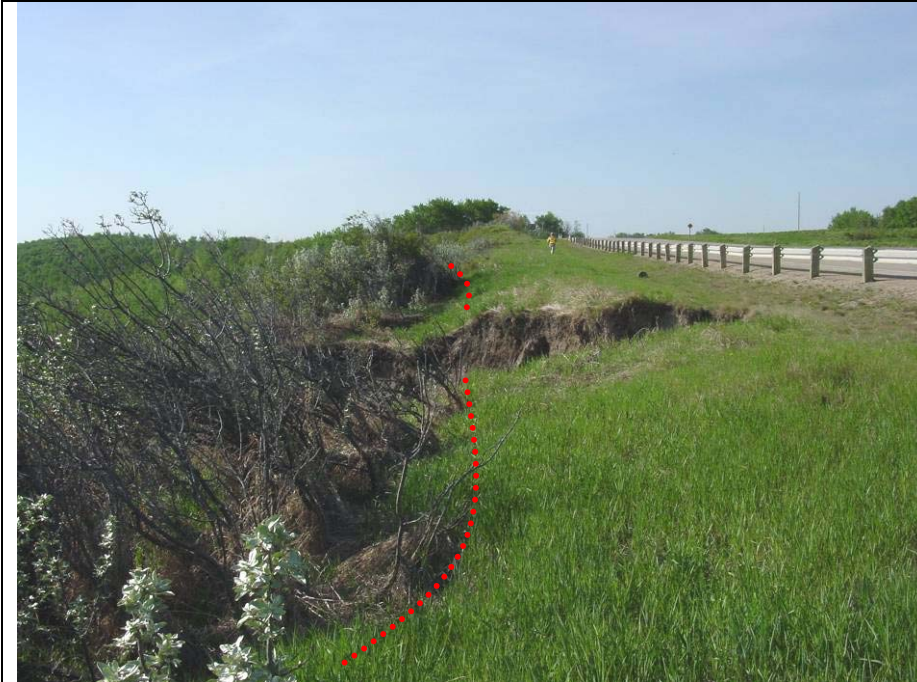
**Photo 2.**  
Slide 2 looking south. Note the dip in the slope on either side of the slide – these areas show fresh cracking, suggesting that the slide may expand laterally. Note how close the backscarp is to the pavement, though this distance has not changed since 2006.

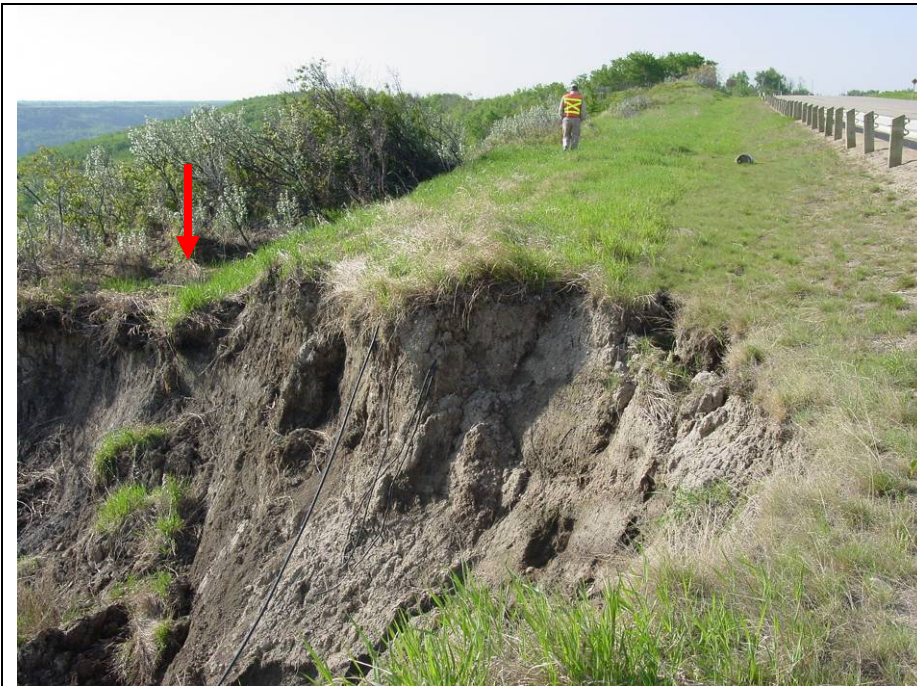
**Photo 3.**  
Fresh movement in the backscarp of Slide 2. There is movement and cracking along the break in slope (arrow) suggesting that this block has slumped. This block is expected to move further, and will ultimately widen the slide. A similar feature occurs on the north side.

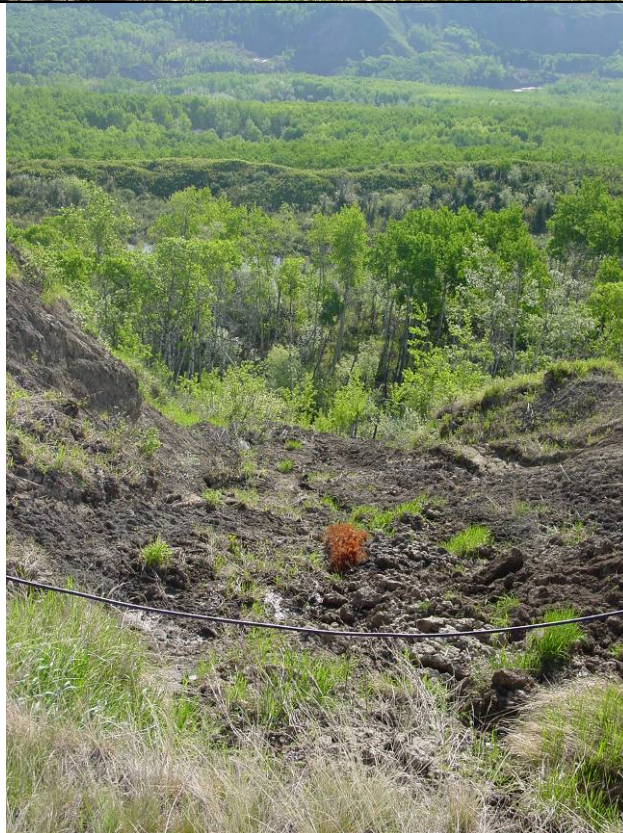
**Photo 4.**  
Slide 2 – looking downslope along the slide. Note the fresh material.

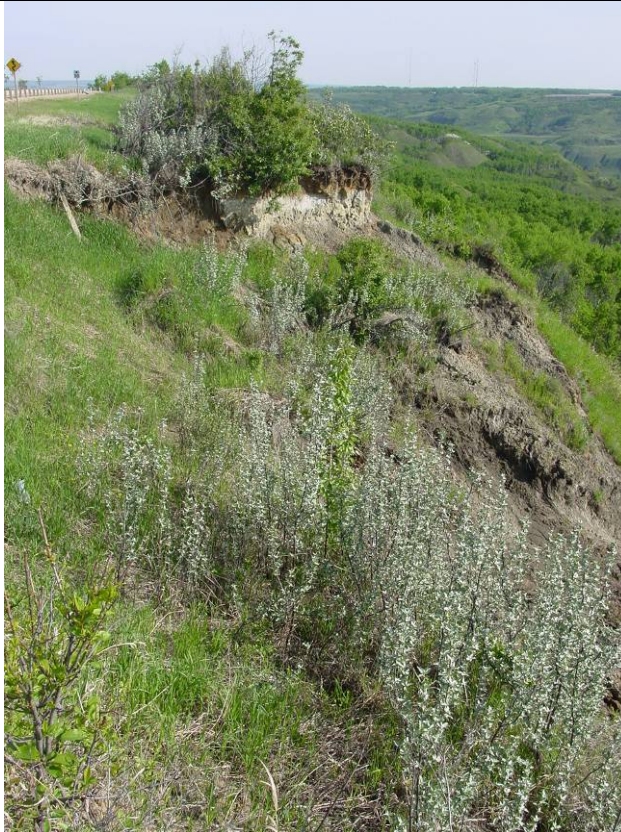
**Photo 5.**  
Slide 3 – looking towards the north at the edge of the slide. The steep face appears fresh, but there does not appear to be any significant new movement in the backscarp area.

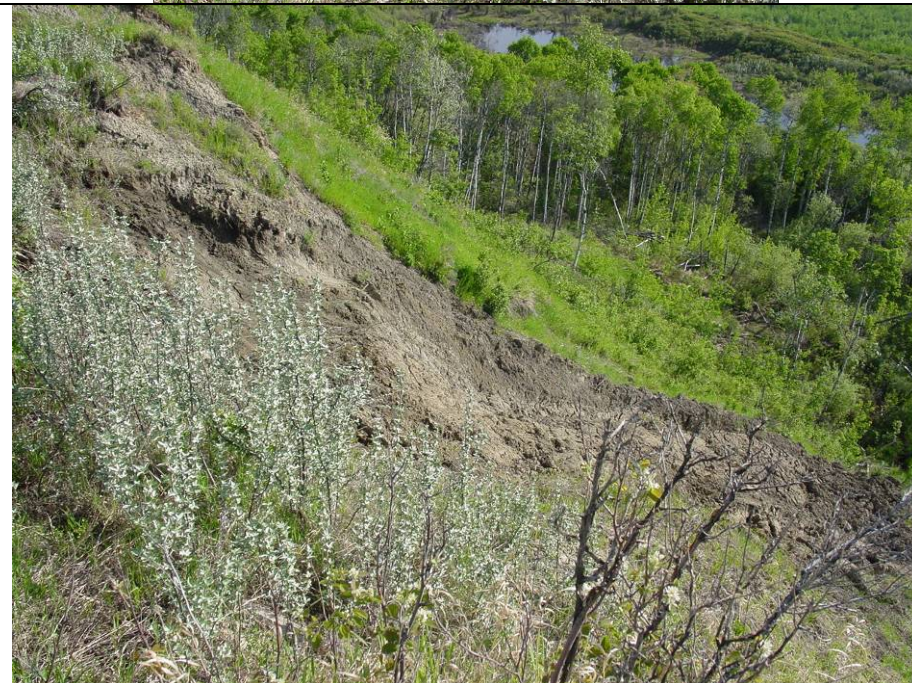
**Photo 6.**  
Slide 3 – some fresh soil flows below the backscarp area. Also note the water in the sag pond area below.

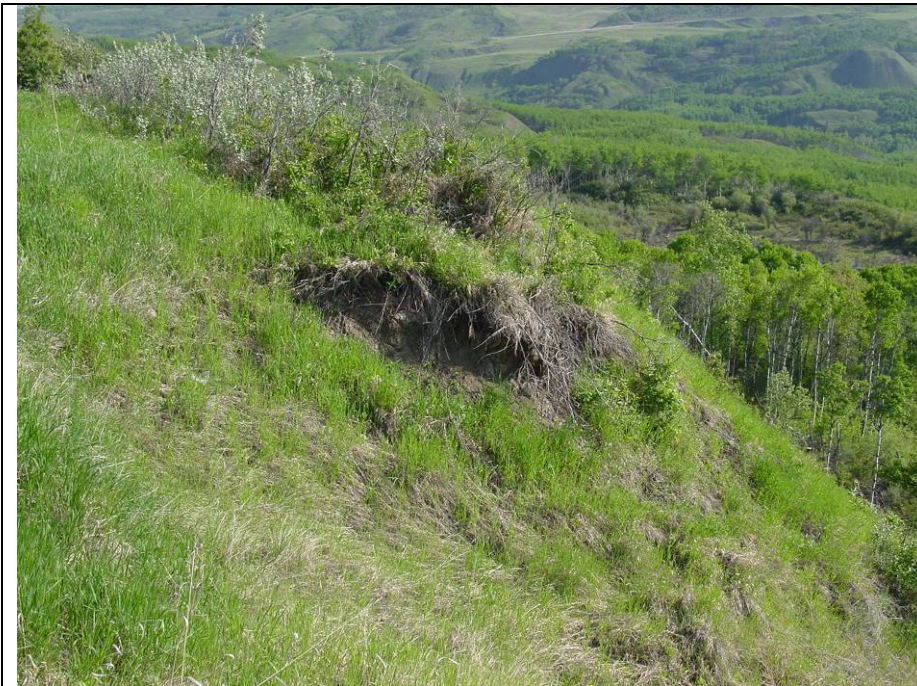
**Photo 7.**  
Slide 4 – steep slope at the north side of the backscarp. There is some possible cracking on either side of the slide area, but no fresh movement in the main slide.

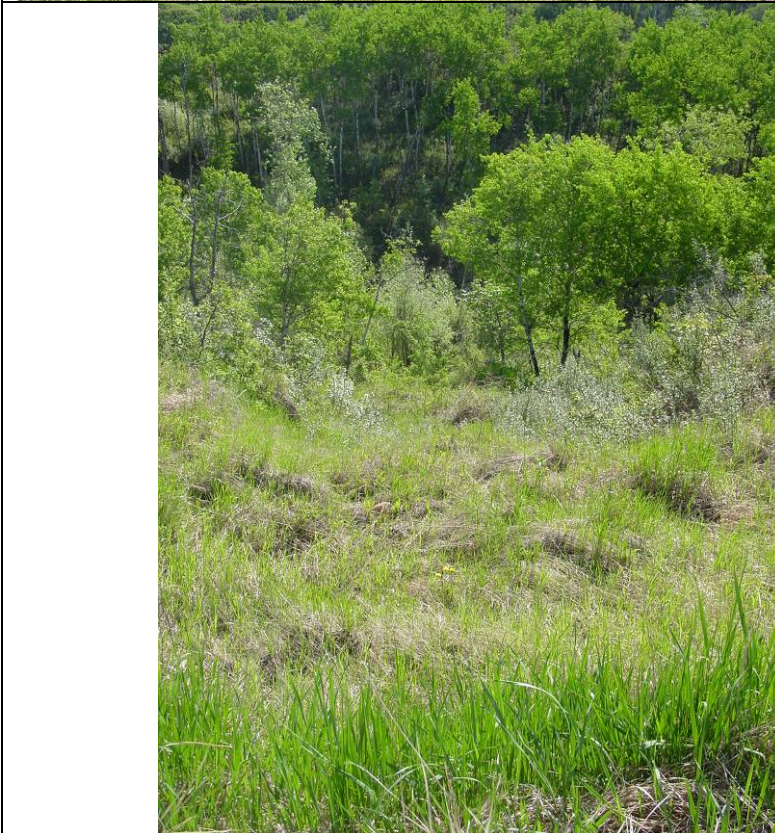
**Photo 8.**  
Slide 4 – looking downslope from the backscarp area. No fresh movement since 2006 – the slide runout appears “stable” at present.
