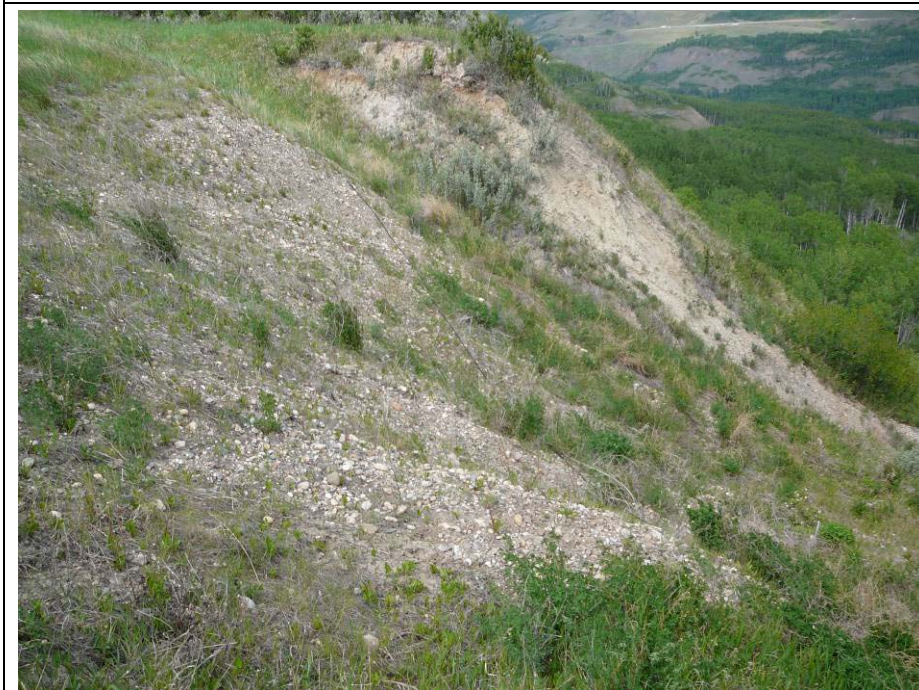
Photo 2.
No change in the
backscarp of Slide 1
– the repair is
working well.

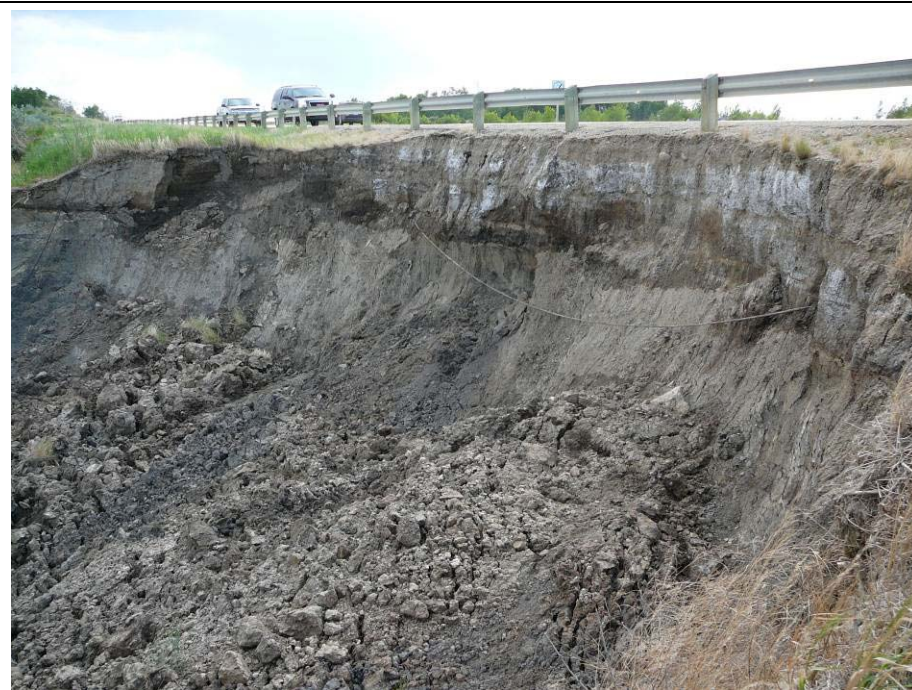
Photo 3.
Significant additional movement in the backscarp of Slide 2. The backscarp is now within 0.5 m to 0.75 m of the guardrail – it has retrogressed almost 2 m since 2009.

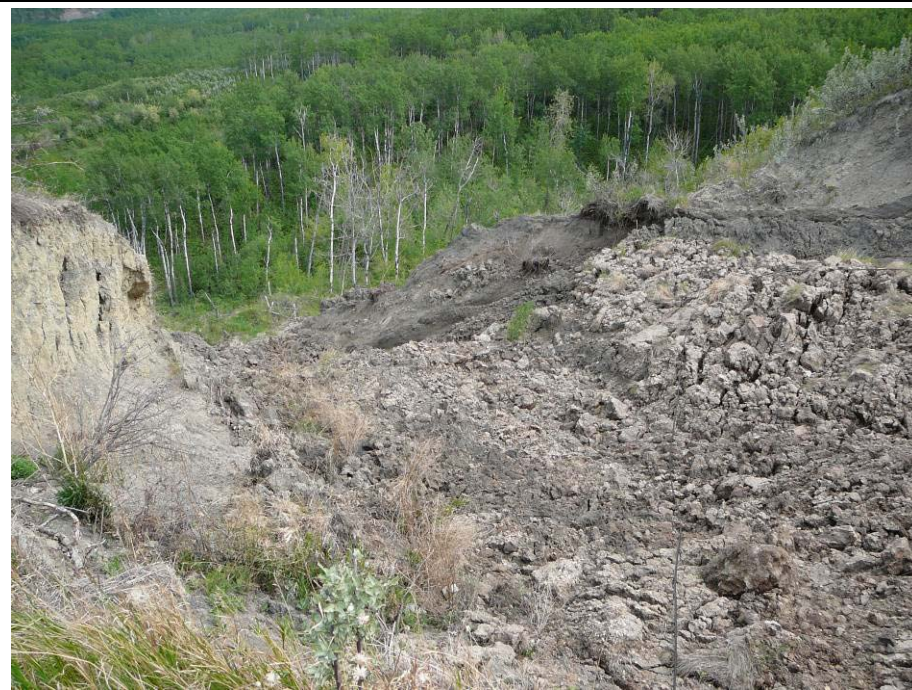
Photo 4.
Slide bowl of Slide 2 – significant additional debris has been added.

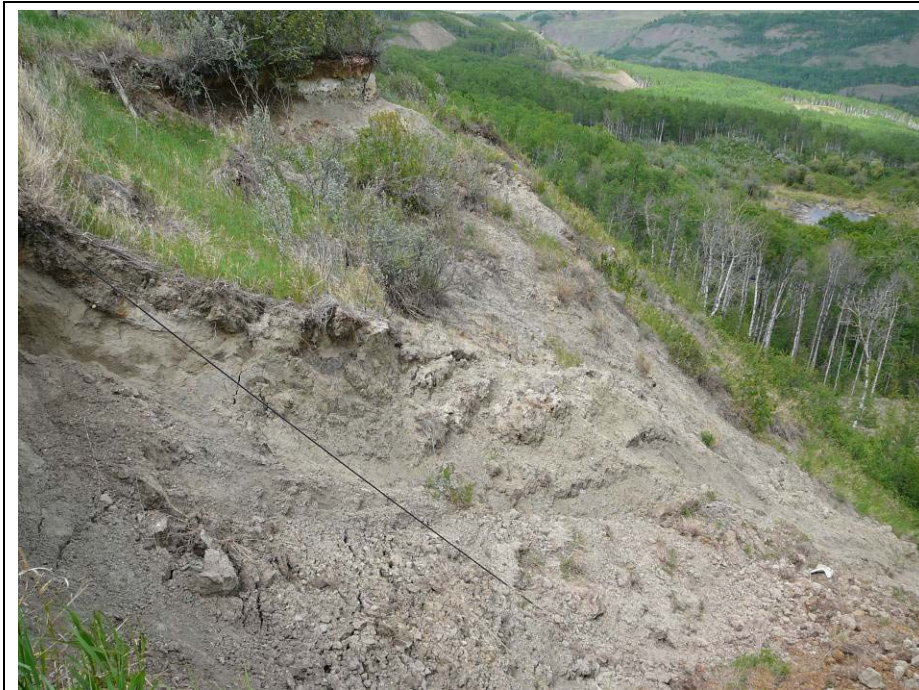
Photo 5.
North side of Slide 3.
There is not much movement on the north flank of the slide bowl, though significant movement in the remainder of the backscarp, as can be seen in the foreground.

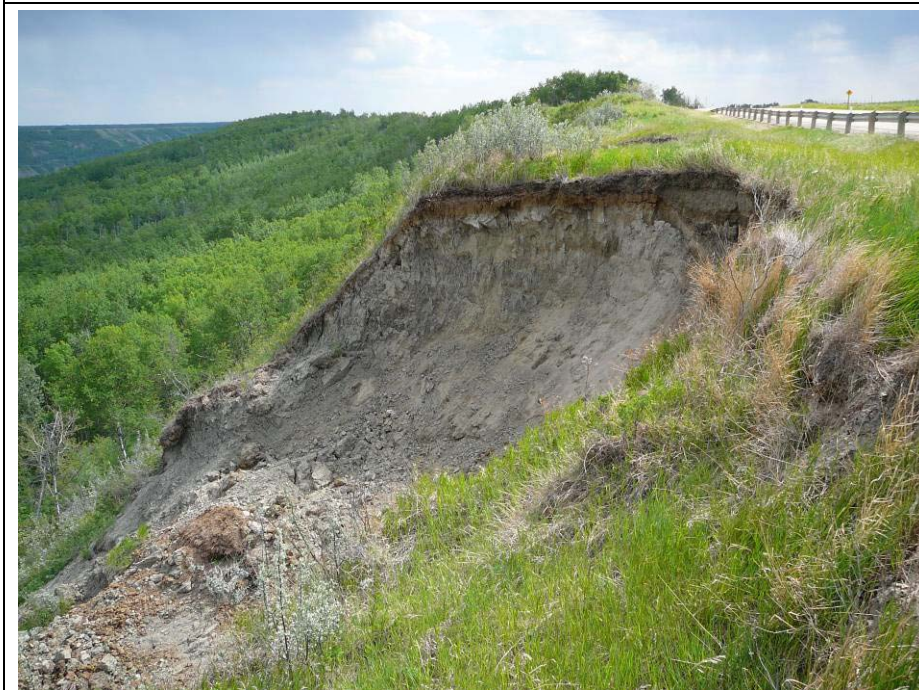
Photo 6.
Significant movement on the south flank of the backscarp of Slide 3.

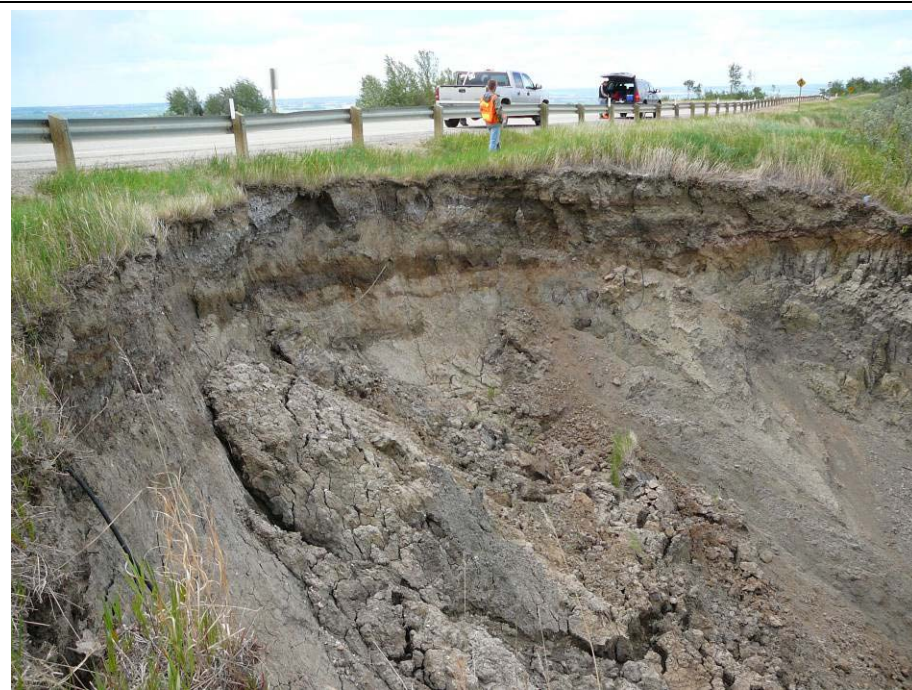
Photo 7.
Looking northwards across the backscarp of Slide 4. There has been significant retrogression (1.9 m since 2009) and movement in the slide bowl. The backscarp is roughly 5 m – 8 m high.

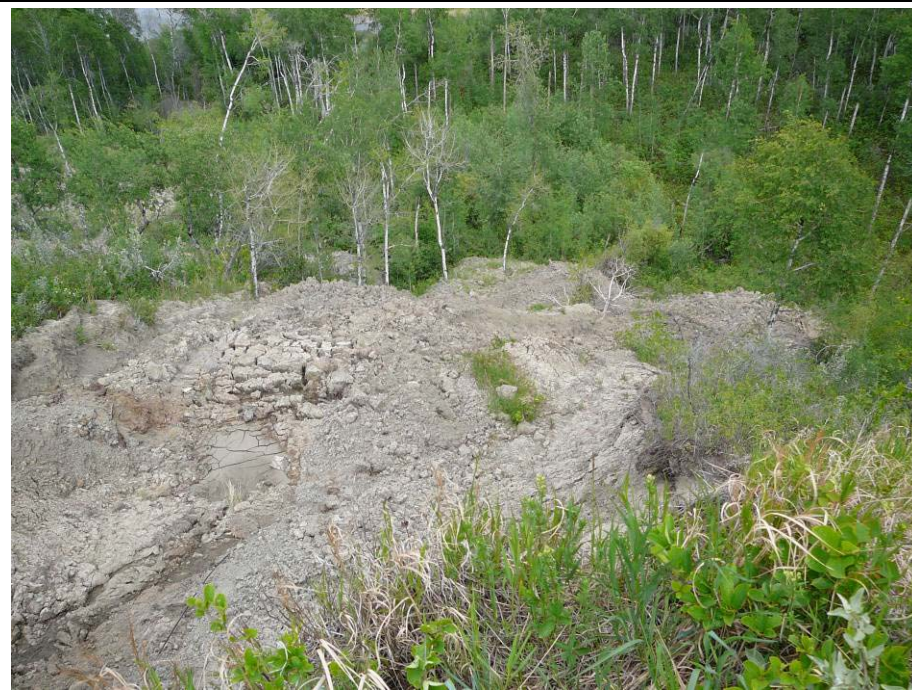
Photo 8.
Looking downslope at the debris runout from Slide 4.
