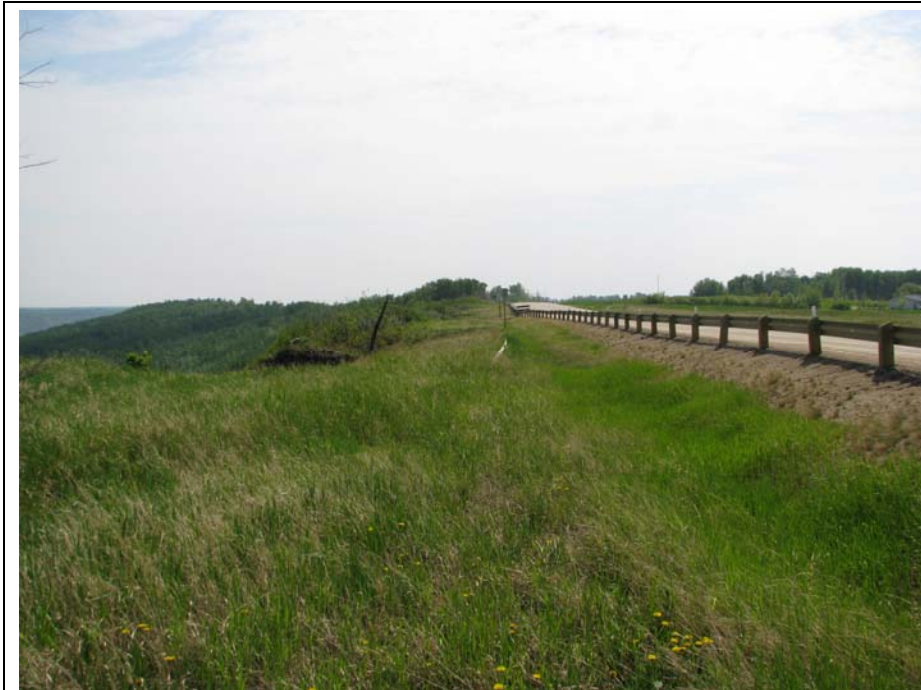
Photo 1.
Looking south along Hwy744 from the south end of Slide 1.

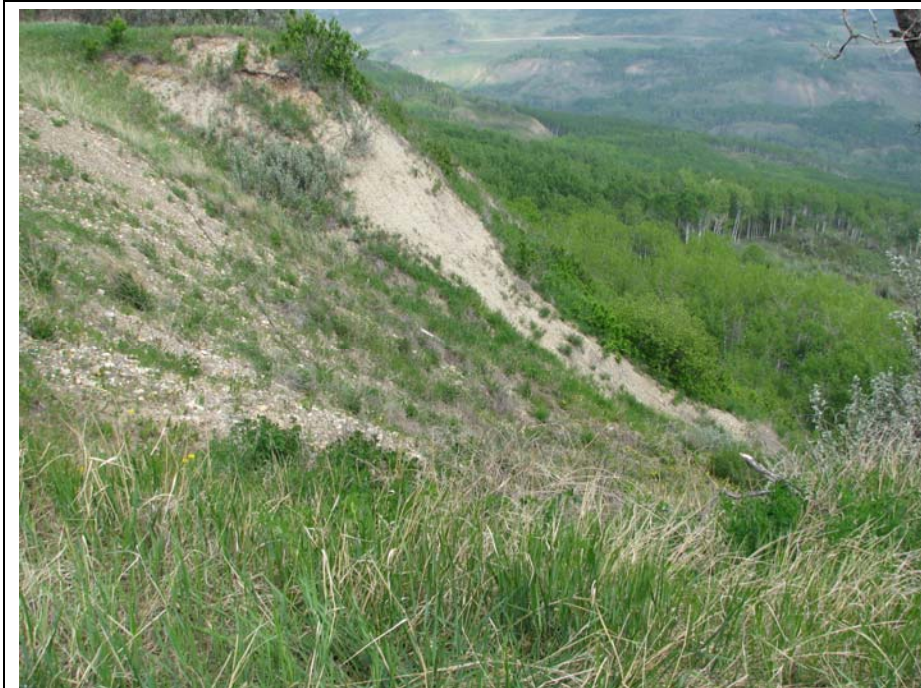
Photo 2.
No change in the backscarp of Slide 1 since 2010 – the repair continues to be effective.

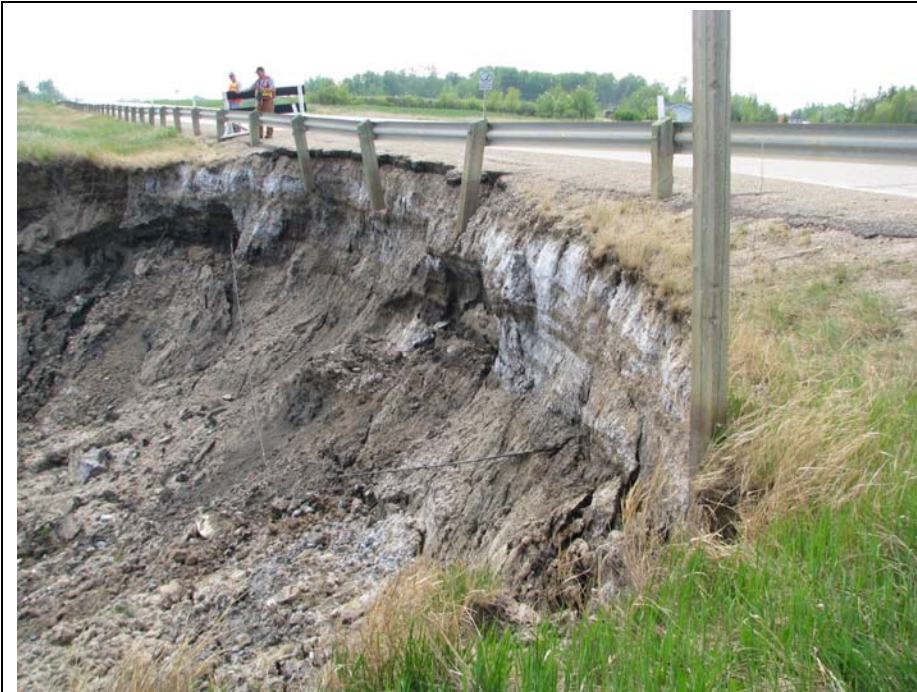
Photo 3.
Significant additional movement in the backscarp of Slide 2. The backscarp is now extending as far as 0.7 m past guardrail into pavement, three guardrail posts are now hanging and curve ahead sign is ready to fall over.

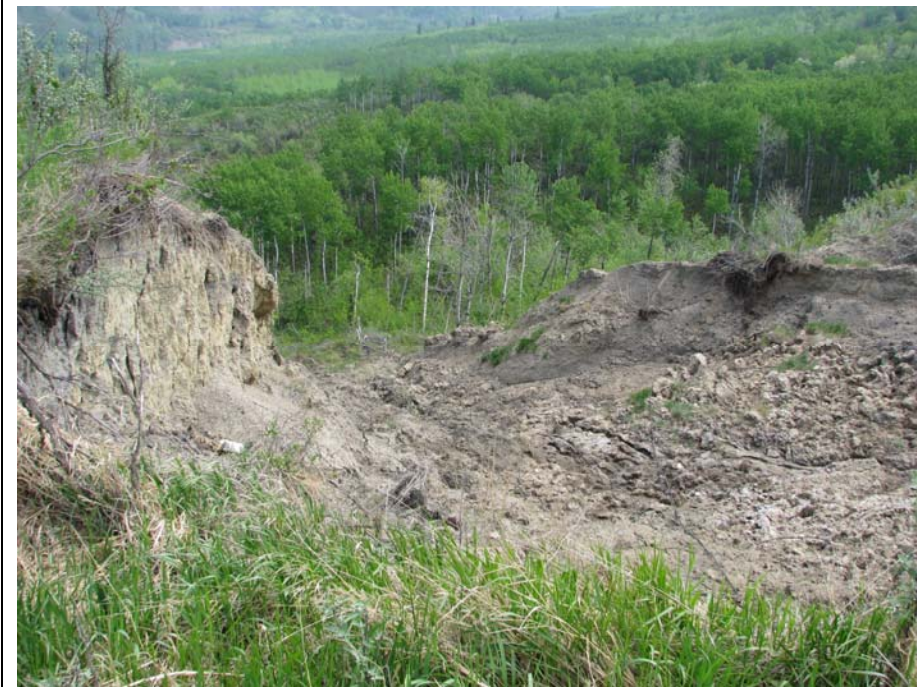
Photo 4.
Slide bowl of Slide 2 – significant additional debris has been added.

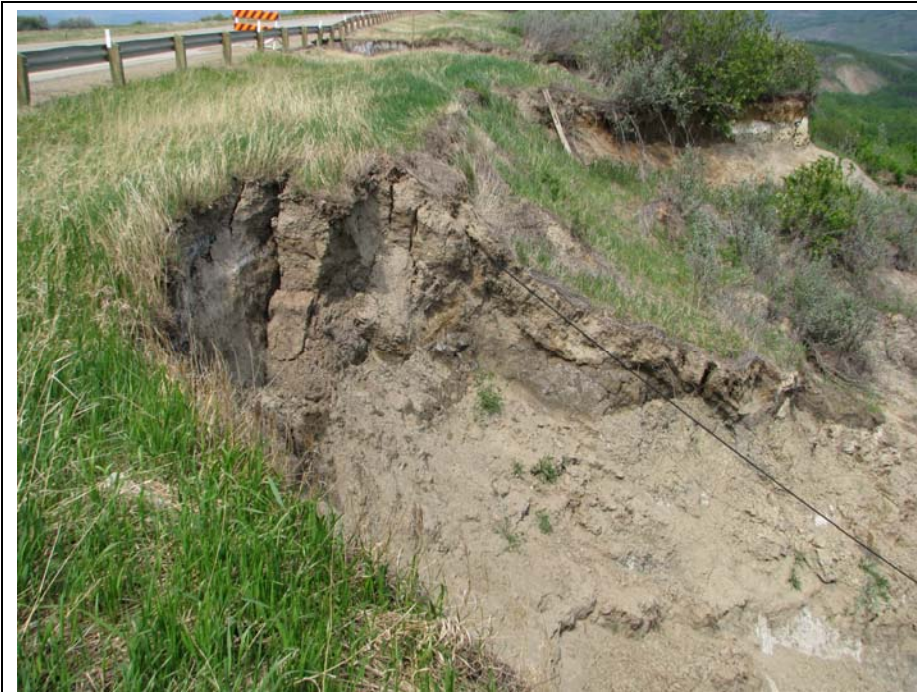
Photo 5.
North side of Slide 3. Backscarp geometry is similar to 2010, with slightly more debris flow observed below the backscarp.

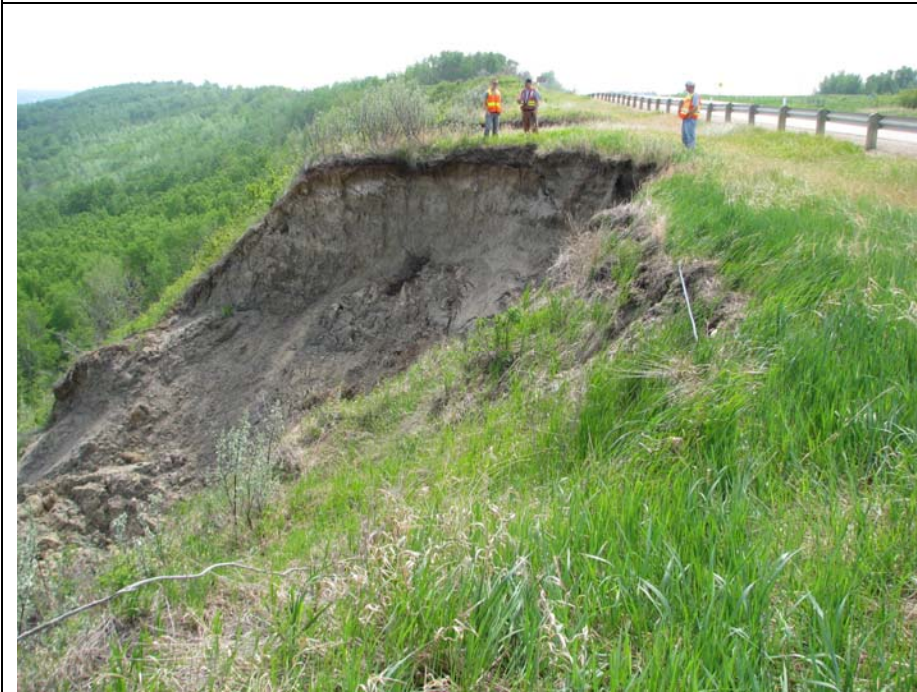
Photo 6.
Significant movement on the south flank of the backscarp of Slide 3, now at 4.8 m from guardrail, and about 30 m in width, with fresh cracking and sliding visible,

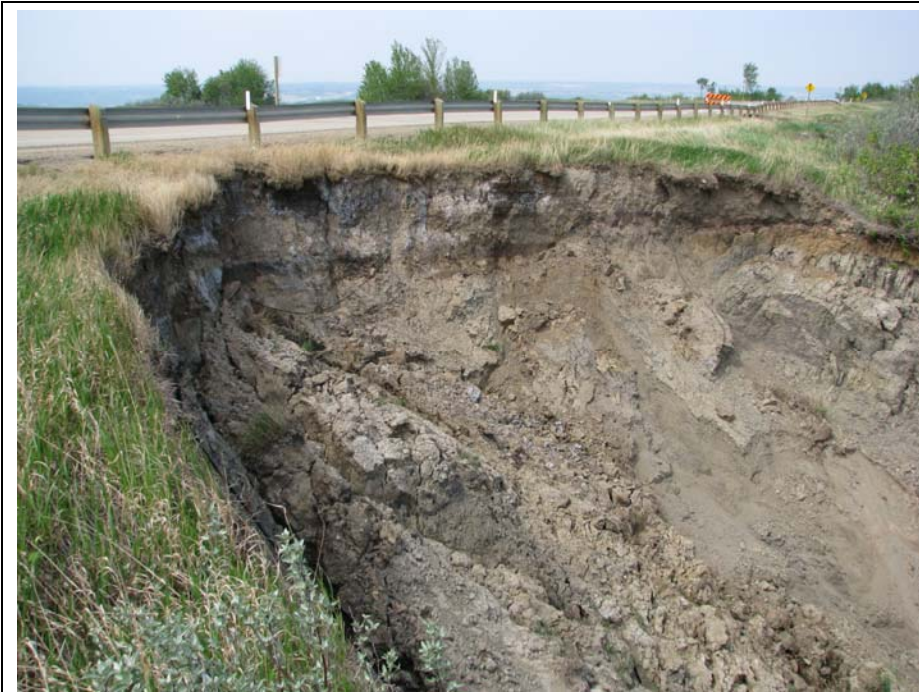
Photo 7.
Looking northwards across the backscarp of Slide 4. There has been retrogression since 2010 and some movement in the slide bowl, which is now 30 m in width. The backscarp height is roughly the same as in 2010.

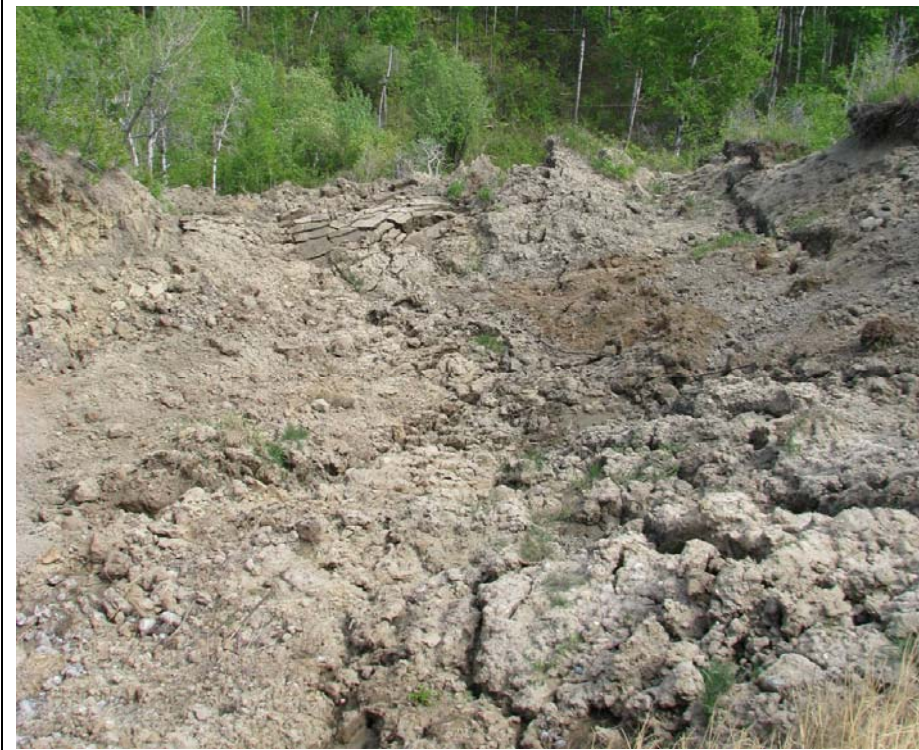
Photo 8.
Looking downslope at additional debris surface flow from Slide 4.
