**Judah Trunk (58+700)**

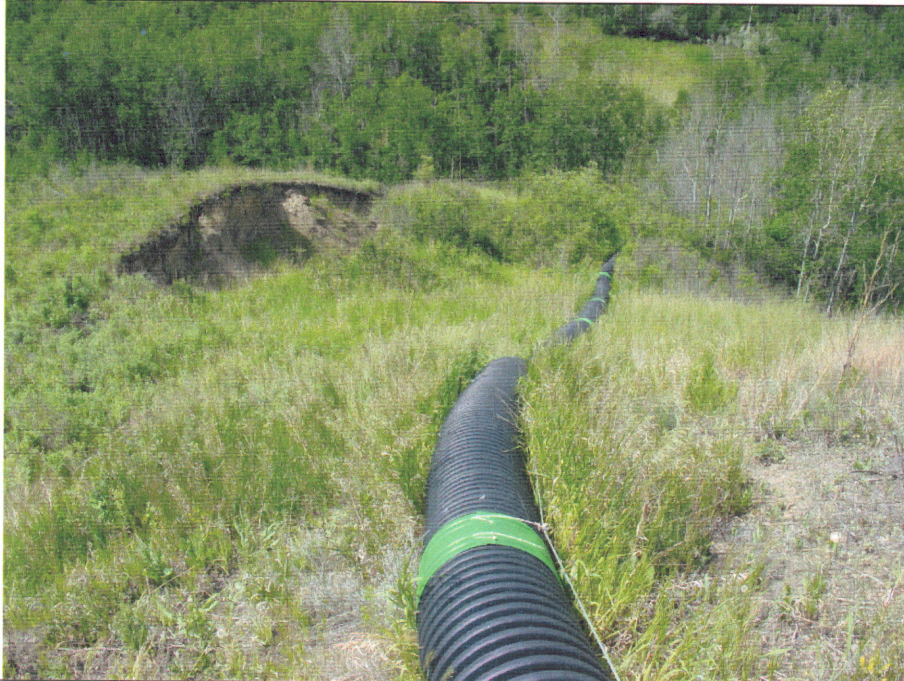
**Photo 19.**

A 450 mm CPP takes drainage from the in-slope ditch down the slope past a previously eroded area. Some of the joints are failed and leaking, requiring repair.

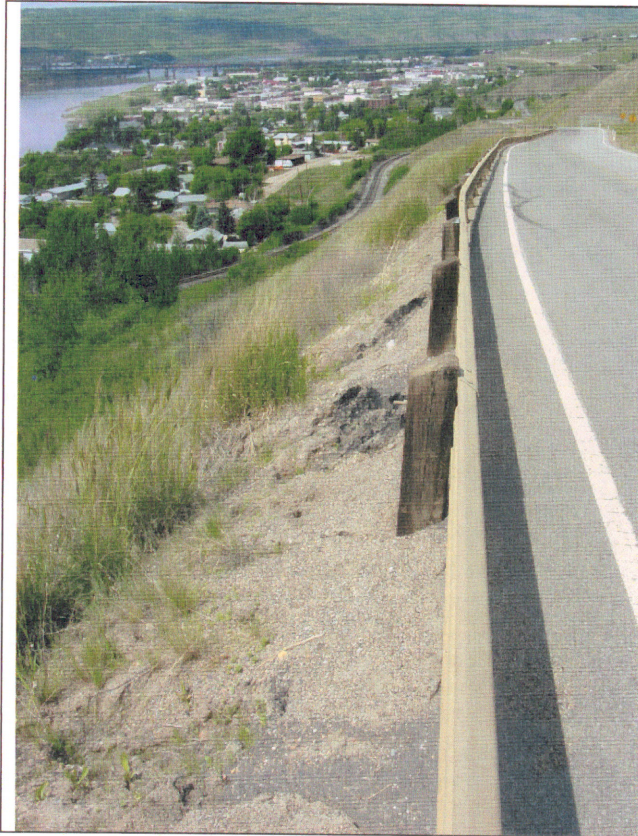
**Photo 20.**  
The edge of the road to the north of the trunk shows signs of surface water erosion.

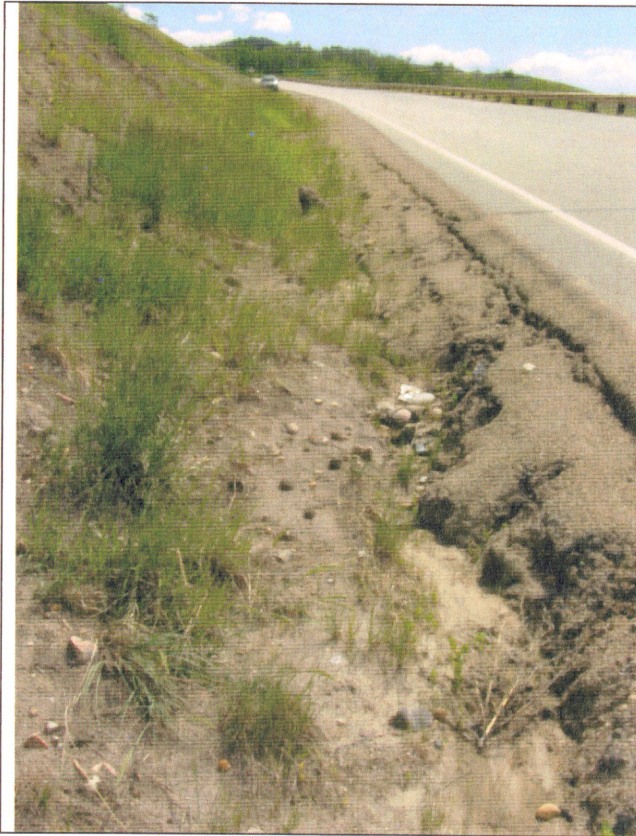
**Photo 21.**  
The in-slope ditch downstream of the culvert inlet for the Judah Trunk appears to be geomembrane lined locally. In some places, the geomembrane appears to have been ripped.
