Fence Slide (59+000)

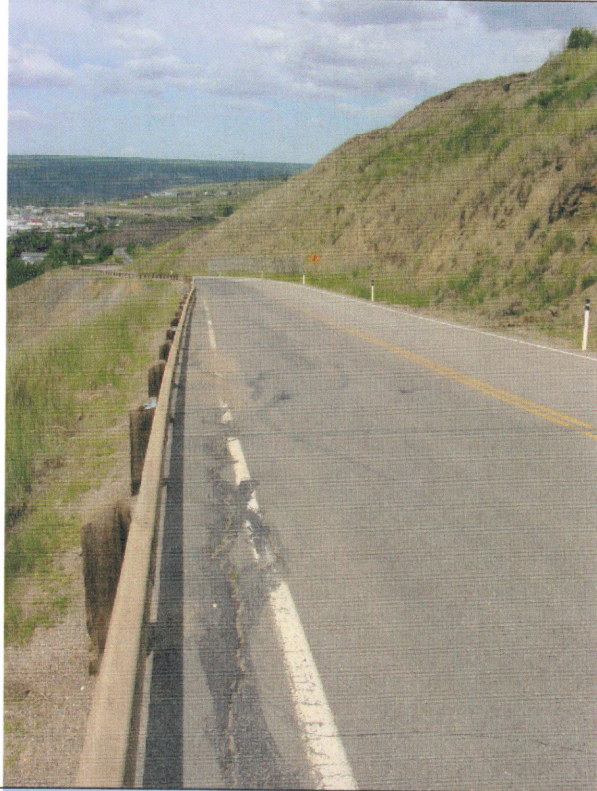
Photo 22.

Downslope edge of the road just south of the stone column stabilisation. Note the cracking / mastic patching in the south-bound lane.

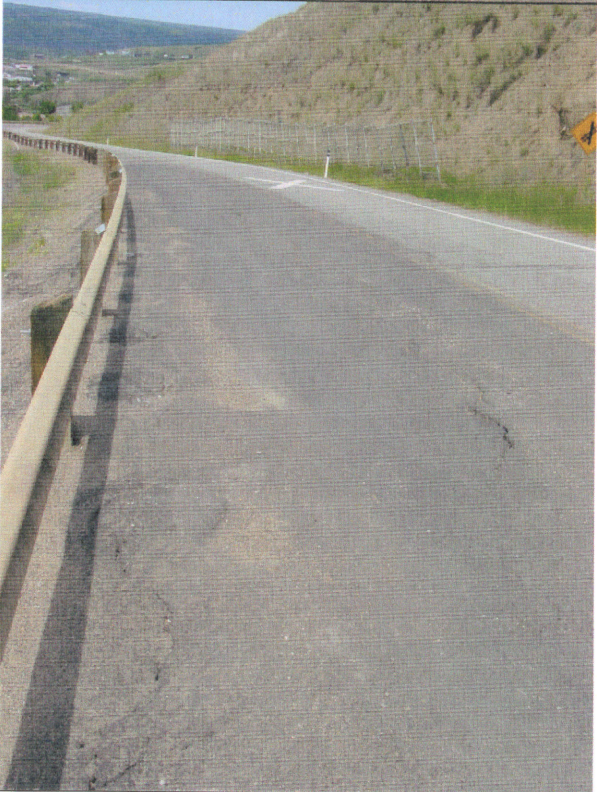
Photo 23.

Area of road stabilised with stone columns. Note the column heads are protruding through the pavement surface by up to 25 mm. There are significant cracks and voids in an arcuate pattern – the cracks are up to 200 mm deep and 50 mm wide.

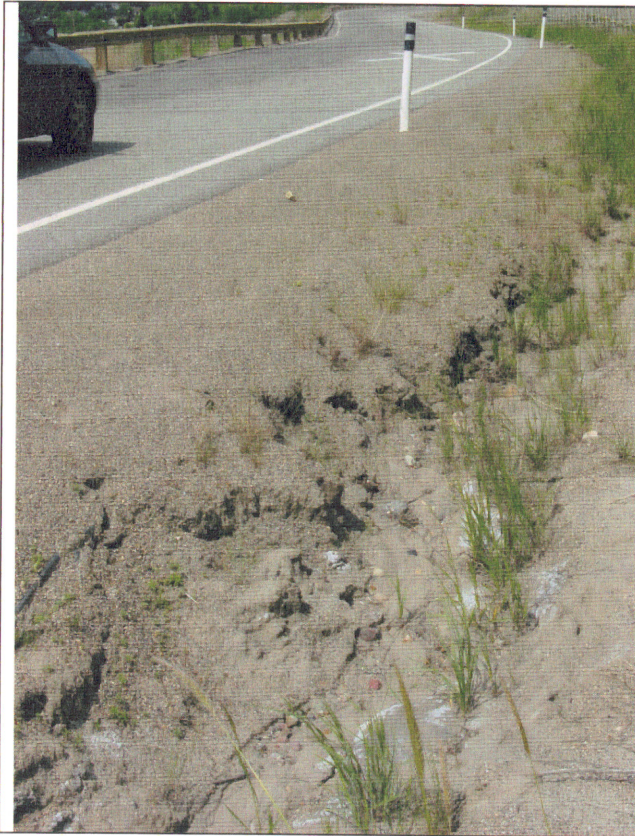
Photo 24.
In-slope ditch adjacent to the stone column repair. The geomembrane liner in the ditch appears to have been ripped in places.

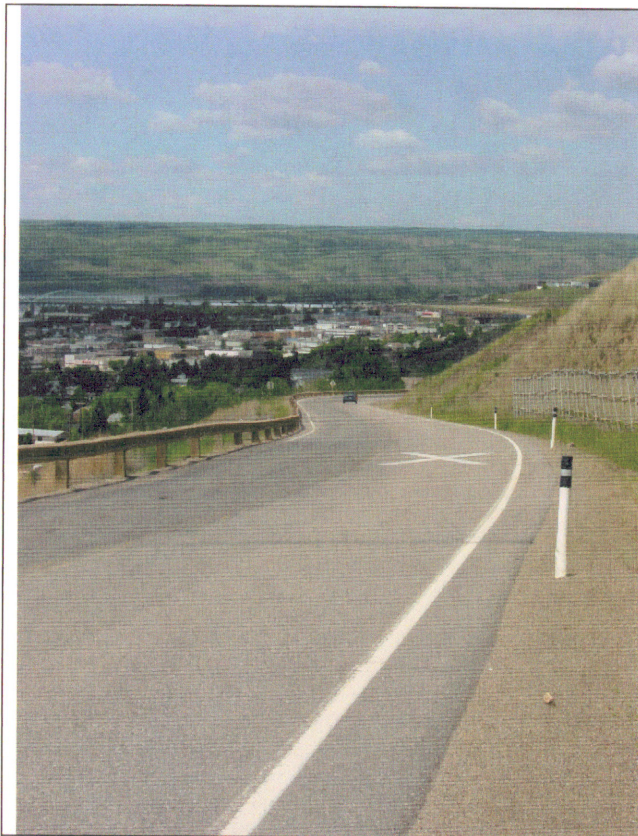
Photo 25.
Area north of the stone columns. There is some minor cracking in the southbound / out-slope lane, mostly in the road shoulder, extending over 40 m of the road.
