Makeout Slide (58+300)

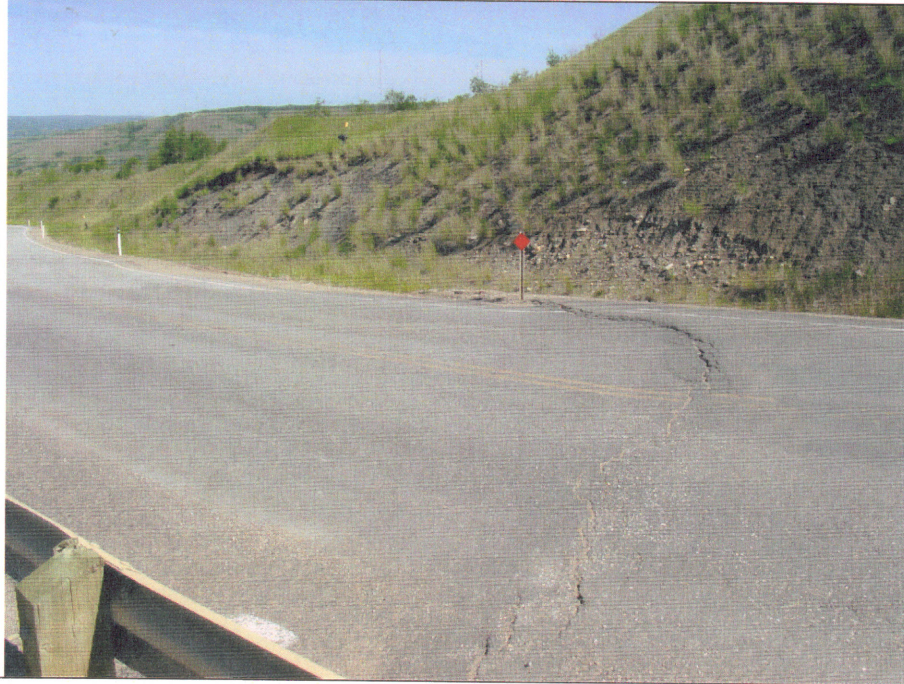
Photo 15.
Backscarp of the
Makeout Slide. Note
the significant
cracking and vertical
offset in the asphalt.

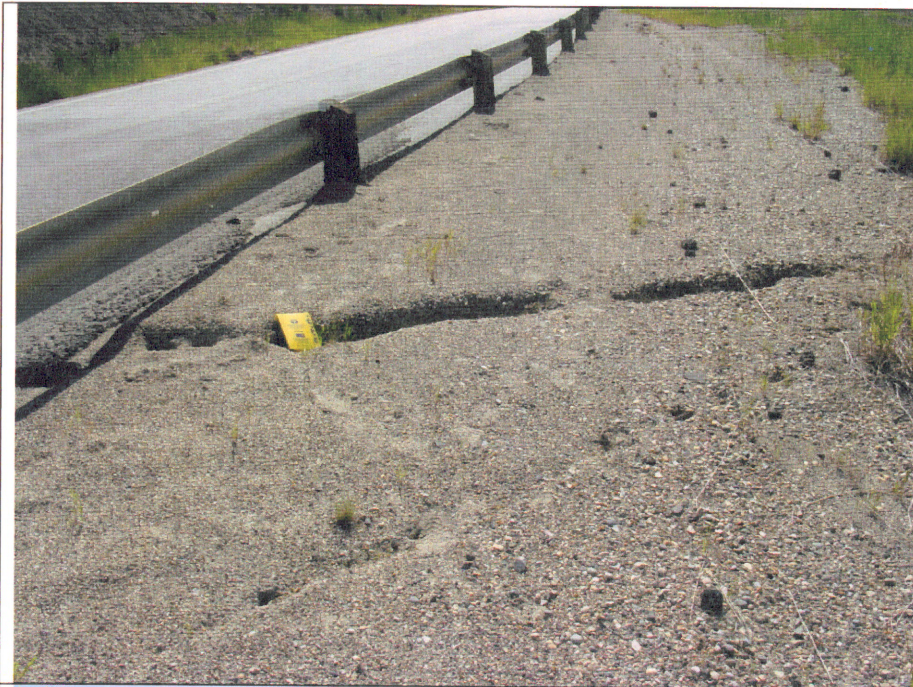
Photo 16.
Cracking in the margin of the road at the Makeout Slide. The crack has a roughly 50 mm vertical offset, and is roughly 100 mm wide.

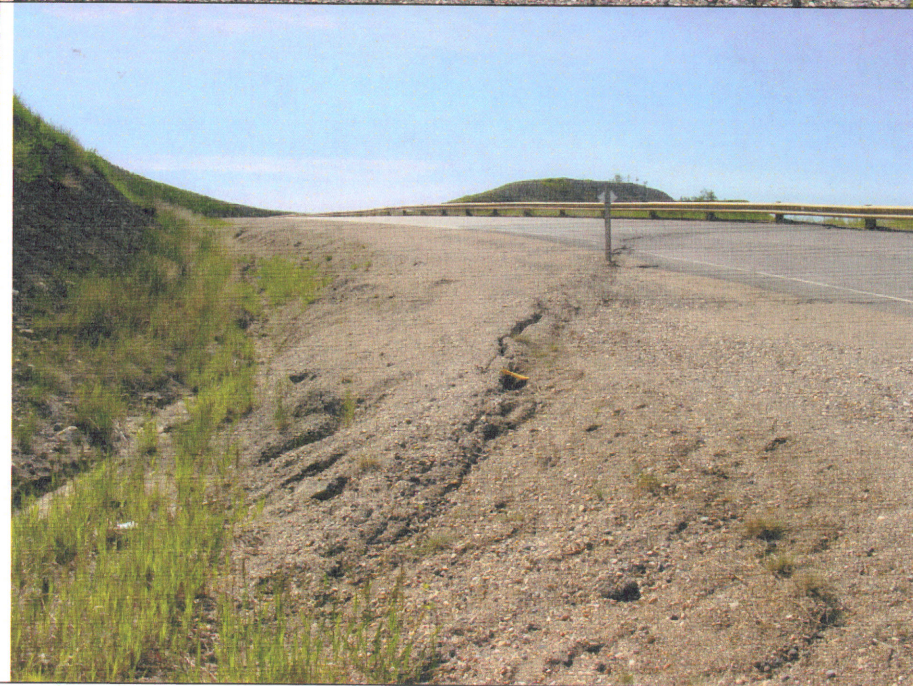
Photo 17.
The backscarp cuts across both lanes and enters the upslope ditch. The backscarp is approximately 10 m wide in the ditch. Sandy gravel is exposed locally in the slope above the ditch. There has been past significant flow in the ditch, based on erosion and channel width.

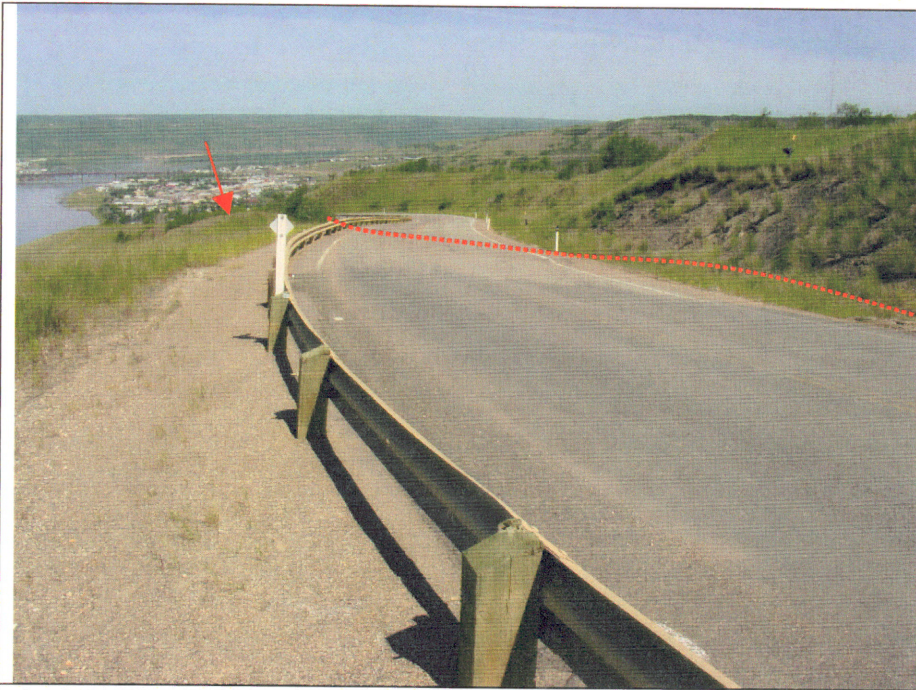
Photo 18.
 The backscarp is more subtle on the north side of the slide. There is little evidence for the scarp beyond the guardrail, and there is no evidence for a scarp cutting through the berm that directs road drainage (arrow).

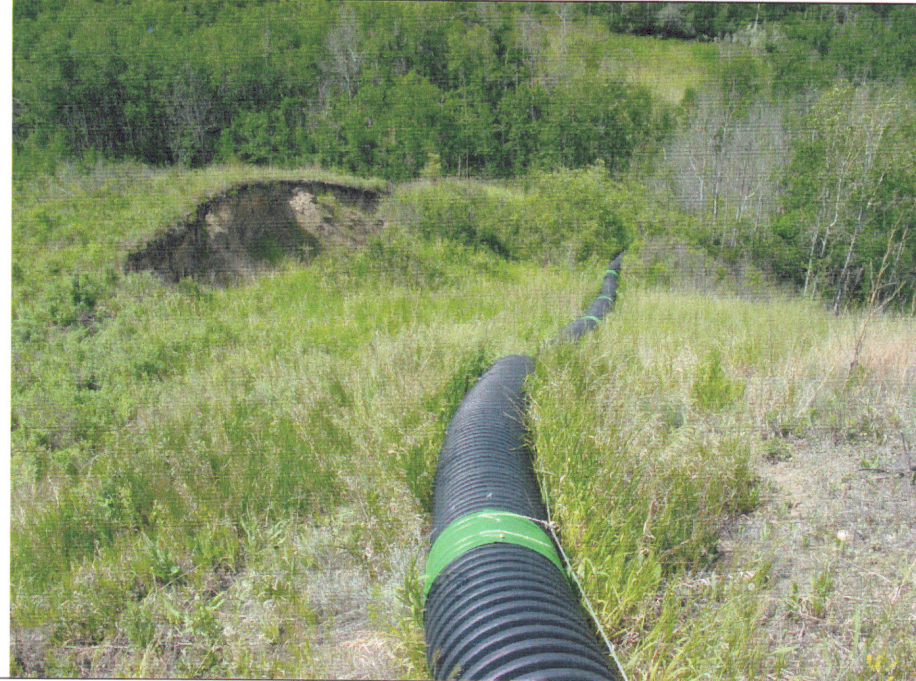
Judah Trunk (58+700)

Photo 19.
 A 450 mm CPP takes drainage from the in-slope ditch down the slope past a previously eroded area. Some of the joints are failed and leaking, requiring repair.
