Michelin Slides (57+600 to 58+100)

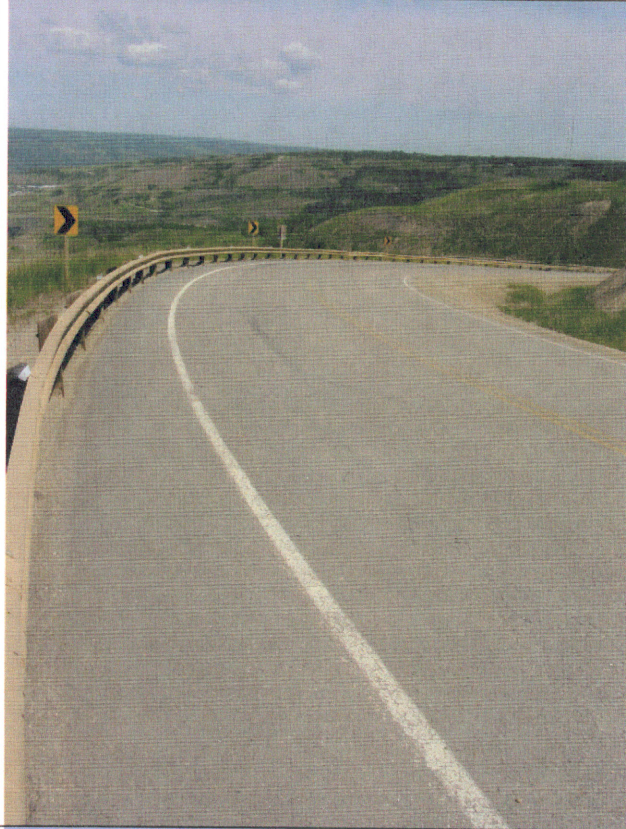
Photo 10.
Cracking at the outside of the corner at the south end of the Michelin slide.

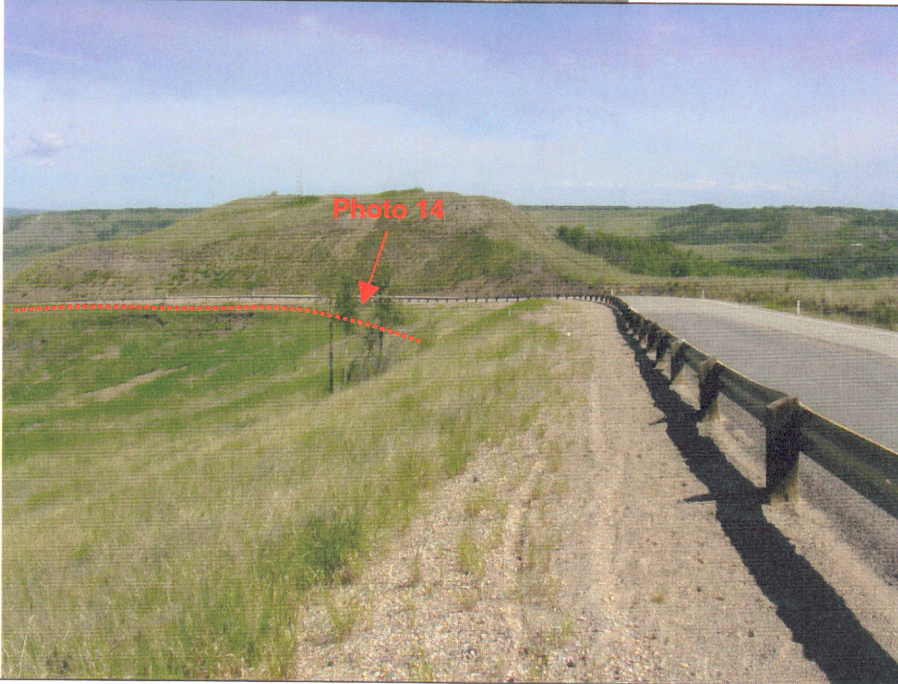
Photo 11.
Overview of the Michelin slide. An anchored retaining wall was constructed downslope of the road in 1997, starting roughly at the road curve in the middle of the picture (dashed line).

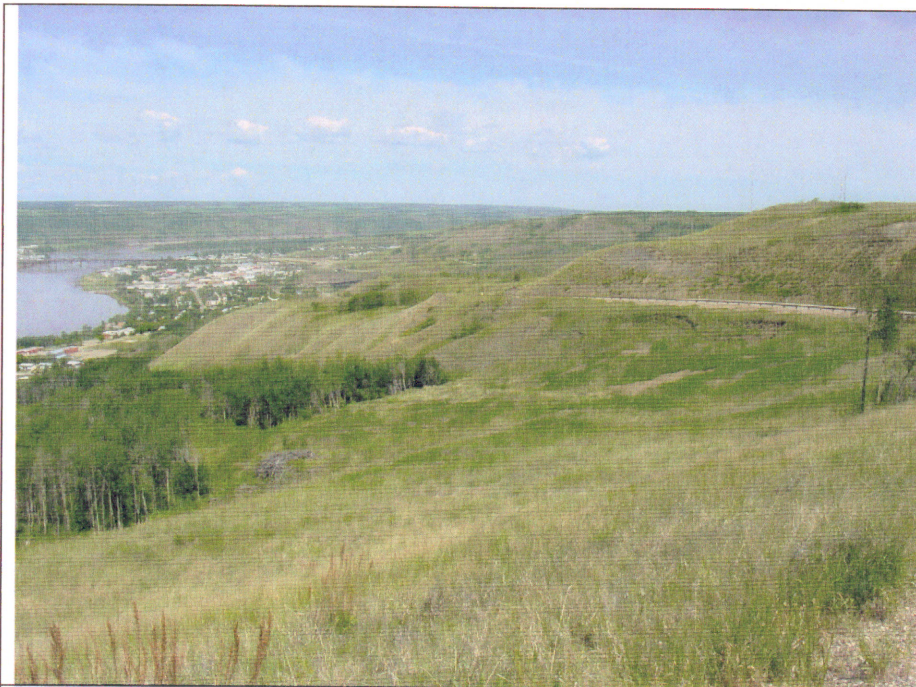
Photo 12.
Slide stabilisation
work in the runout
zone below the
Michelin Slide.

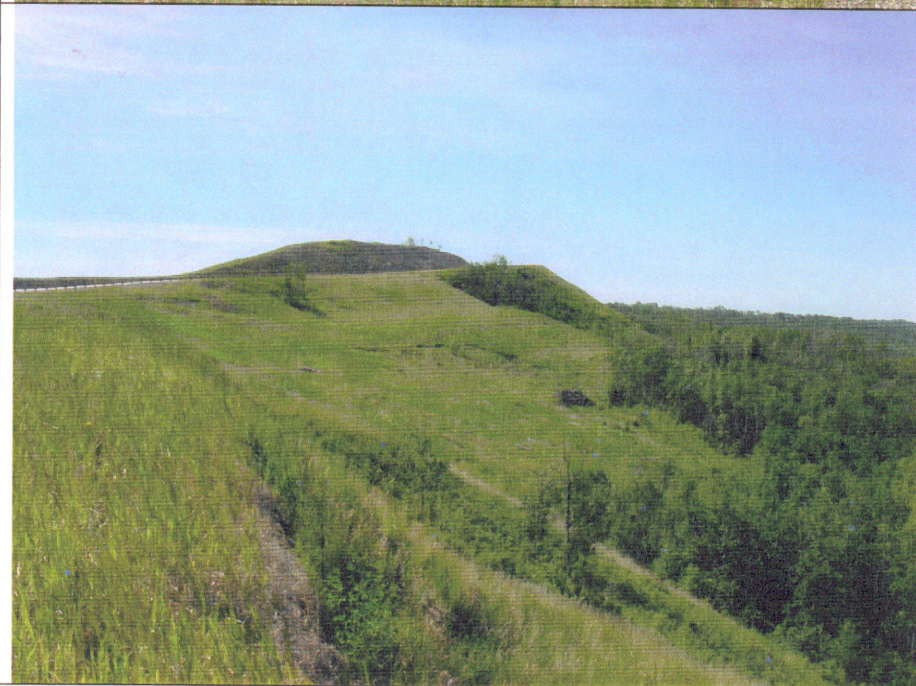
Photo 13.
Benches forming
stabilisation works for
the Michelin Slide.

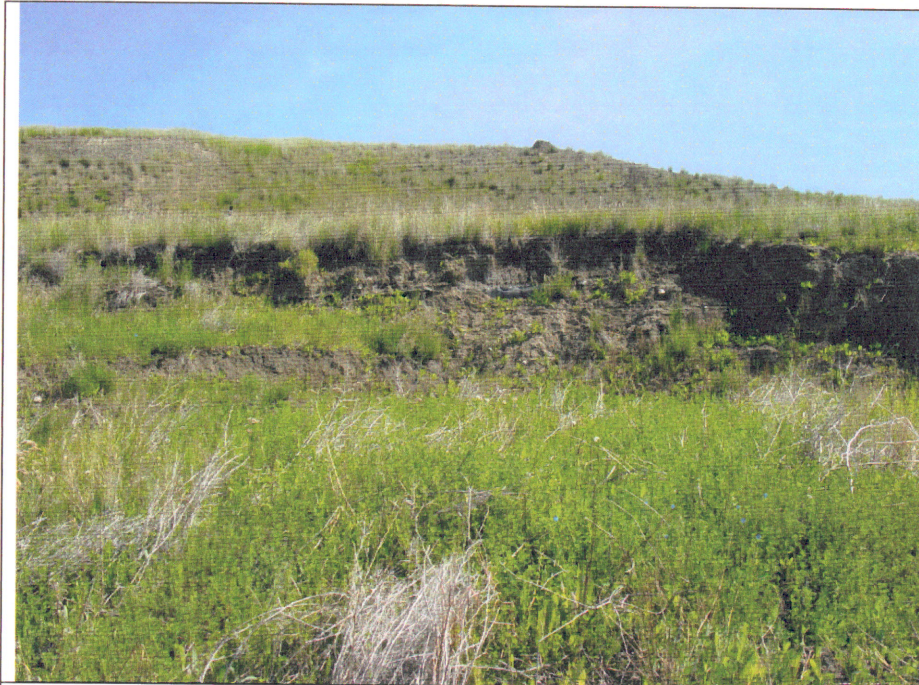
Photo 14.
Slump below the
road, exposing
geotextile in
backscarp. Located
at approx. 58+000.
