THURBER ENGINEERING LTD.

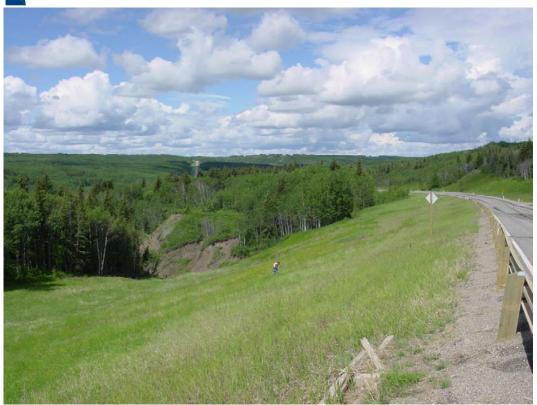
PHOTO 1: Looking west at south sideslope of highway embankment

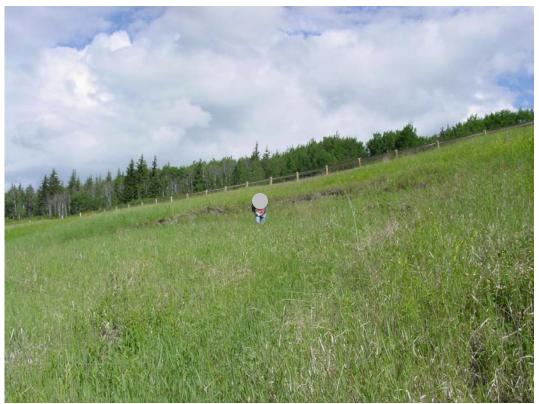
PHOTO 2: Shallow slump near top of highway sideslope

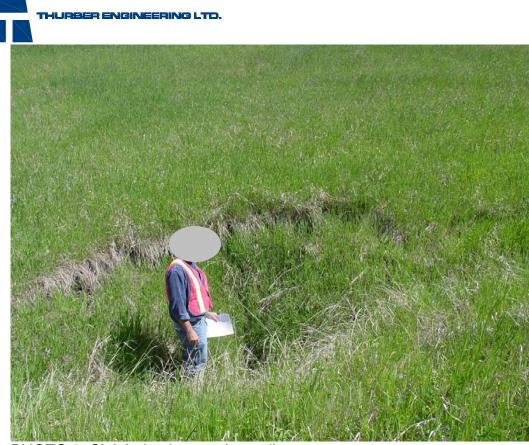
PHOTO 3: Sink hole above culvert alignment

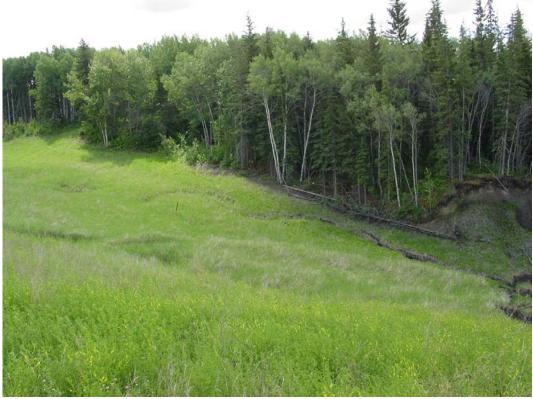
PHOTO 4: Erosion channel along flank of slide block

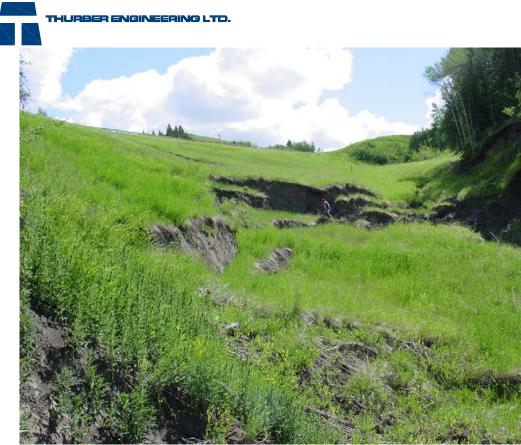
PHOTO 5: Looking northeast at severe slumping above culvert extension outlet

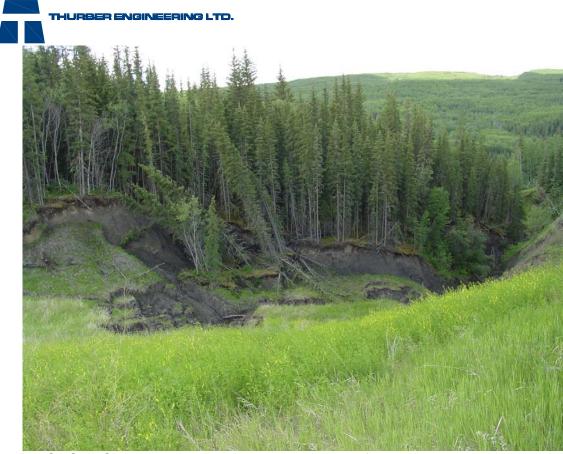
PHOTO 7: Severe slumping at and downslope of culvert extension outlet
