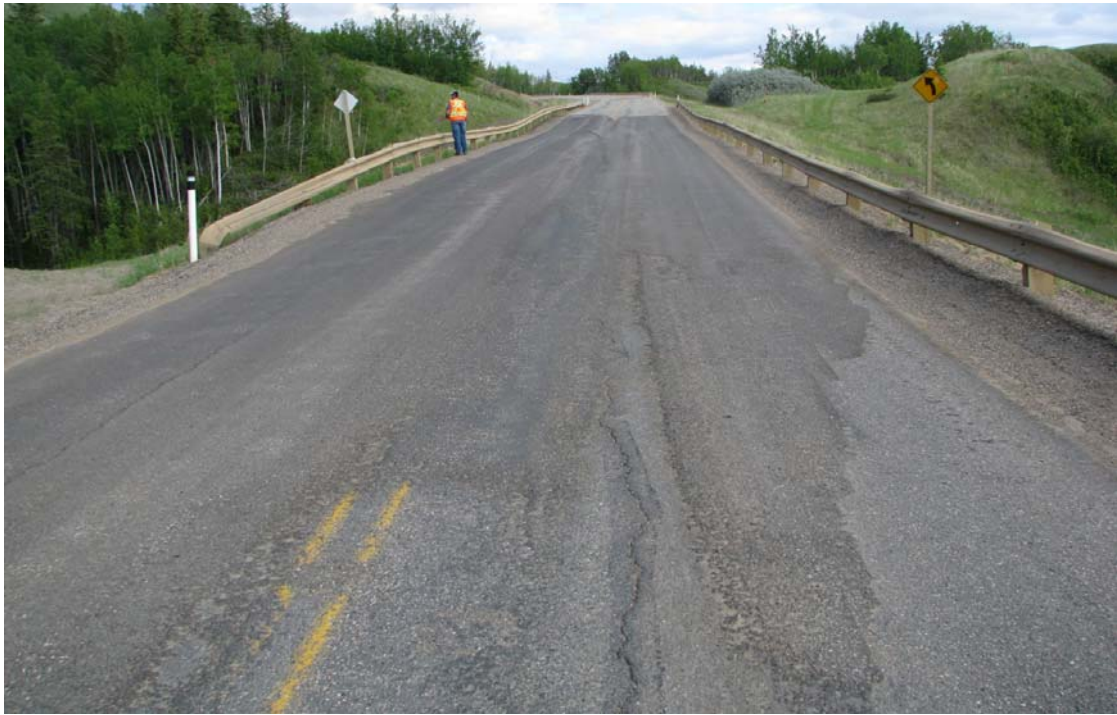
Photo 1 - Looking east along the highway over the Grimms Creek site area. Note the ACP patch and the dip in the highway.

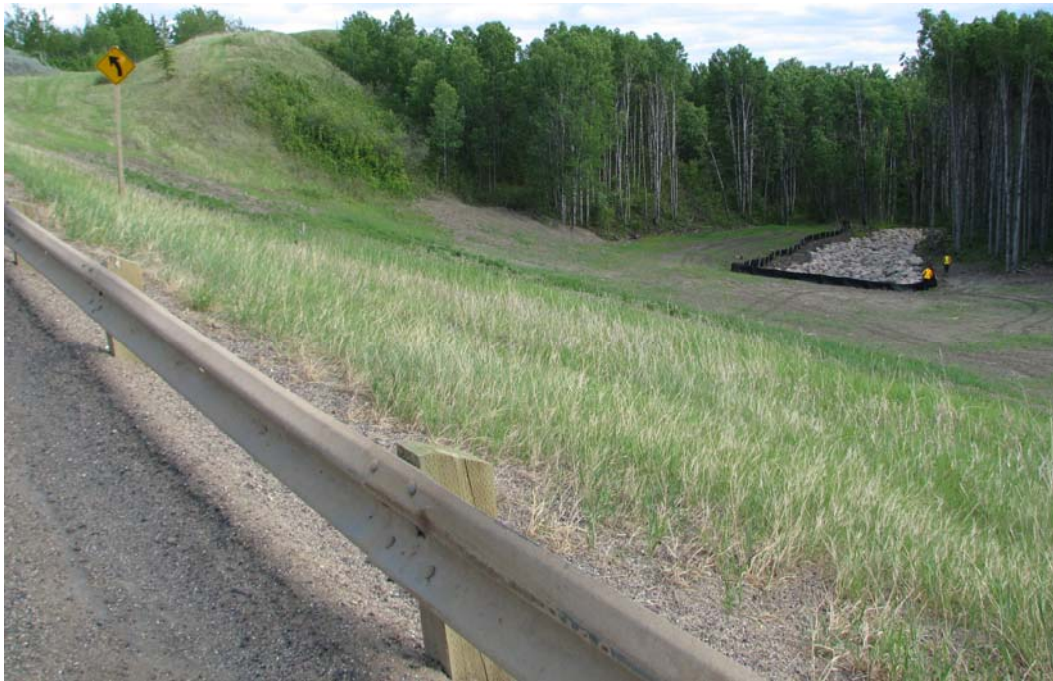
Photo 2 – Looking southeast at the new culvert outlet area.

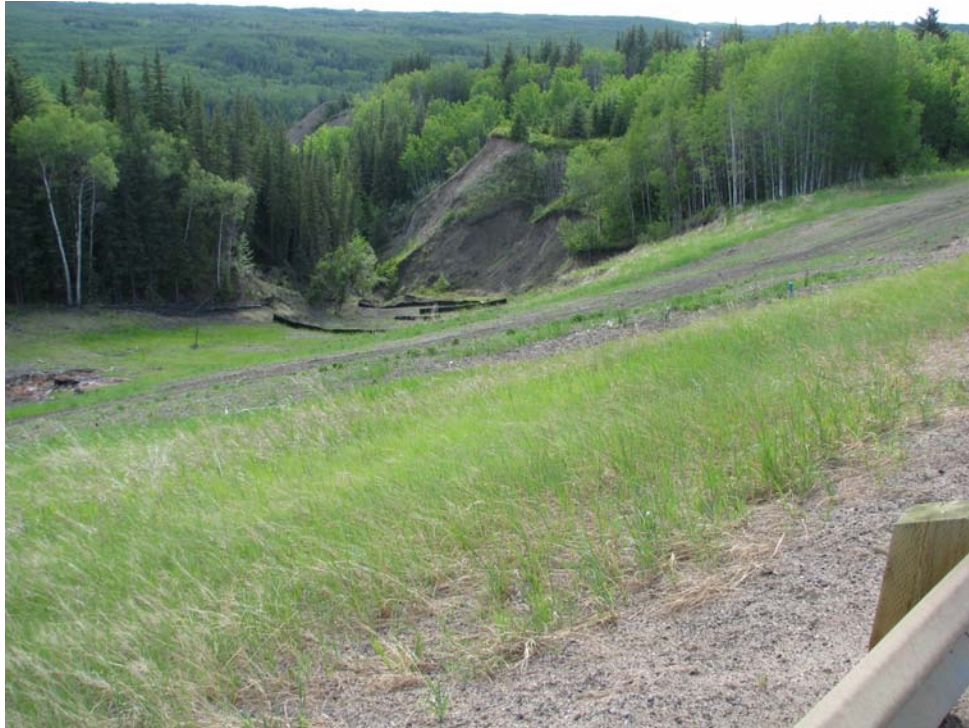
Photo 3 - Looking southwest at the old culvert outlet area.

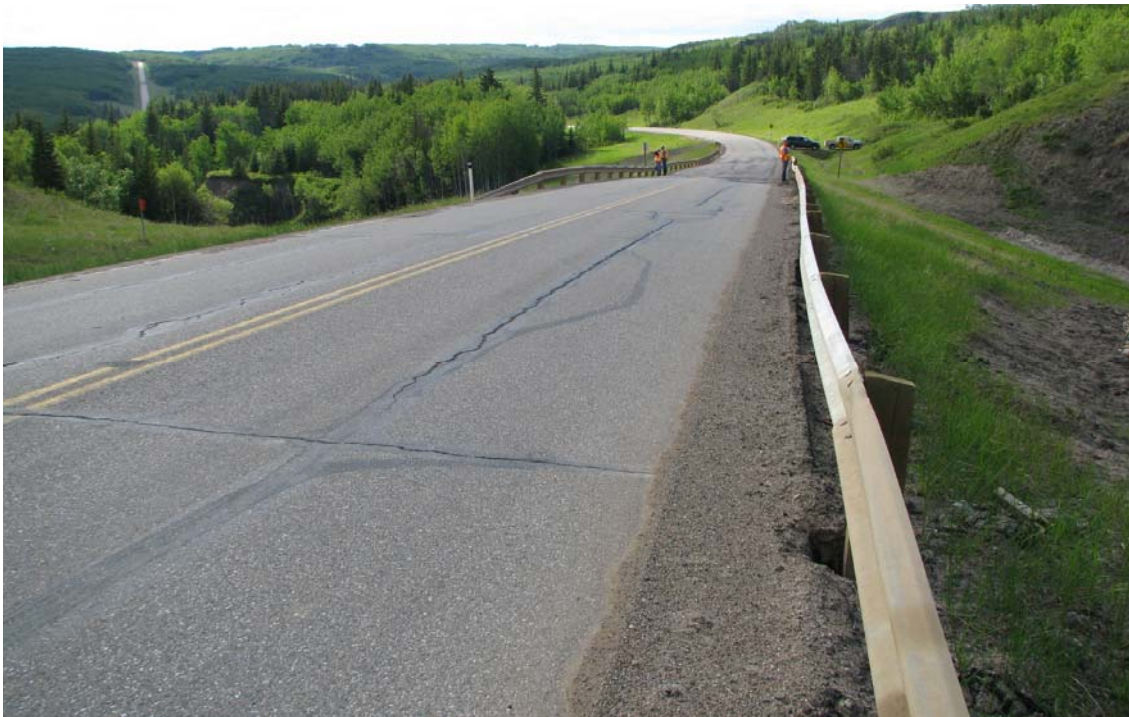
Photo 4 - Looking west along the highway over the site area.

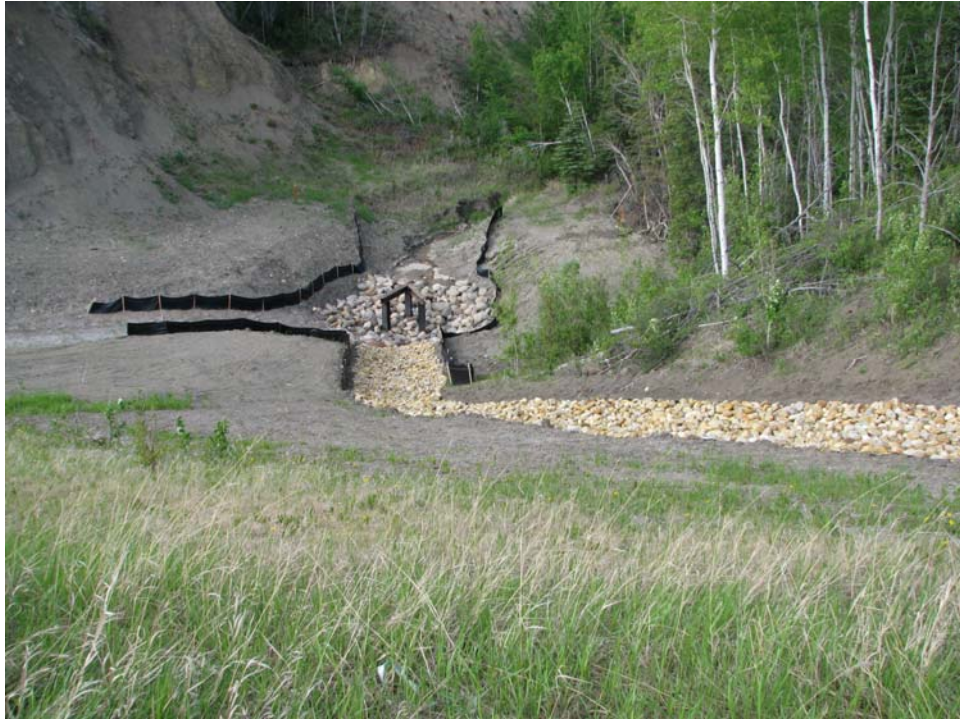
Photo 5 - Looking north at the culvert inlet area.

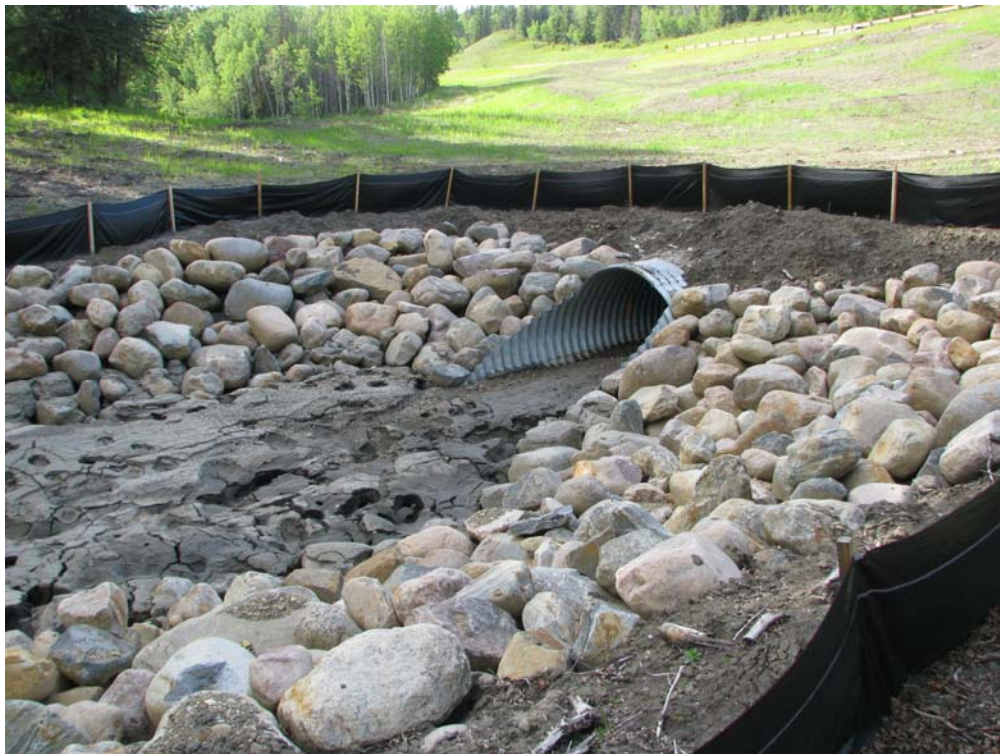
Photo 6 - Looking west across the new culvert outlet. It is about 20% full of sediment.

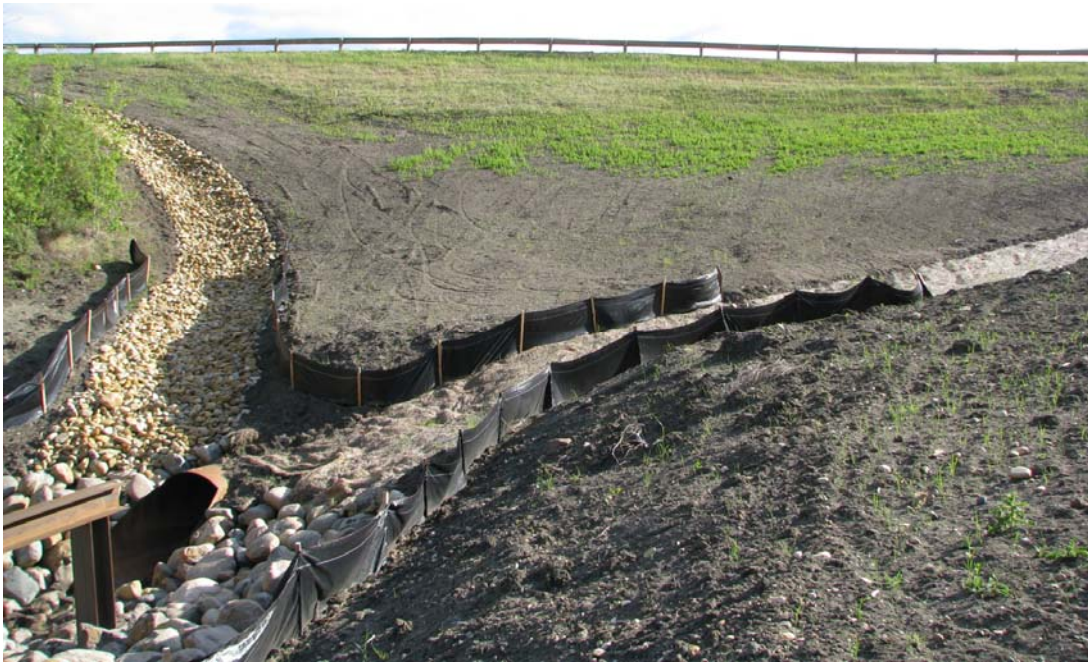
Photo 7 – Looking south at the inlet area and upstream embankment slope.

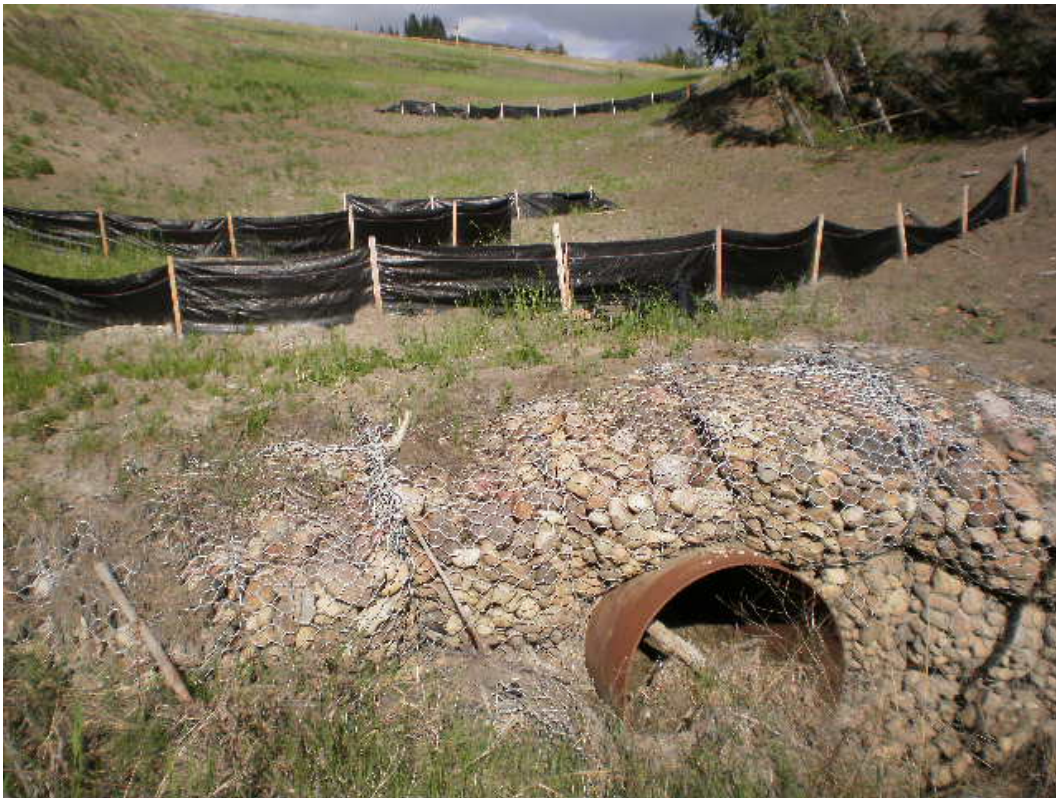
Photo 8 - Looking northeast at the old culvert outlet.
