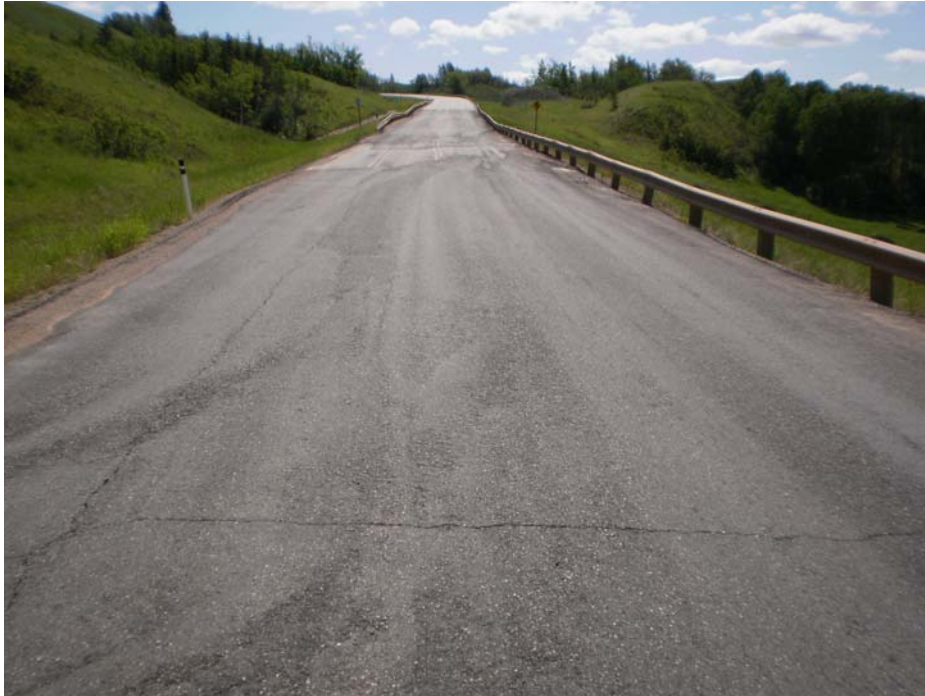
Photo 1 - Looking east along the highway over the Grimms Creek site area.
Note the ACP patches and the dip in the highway.

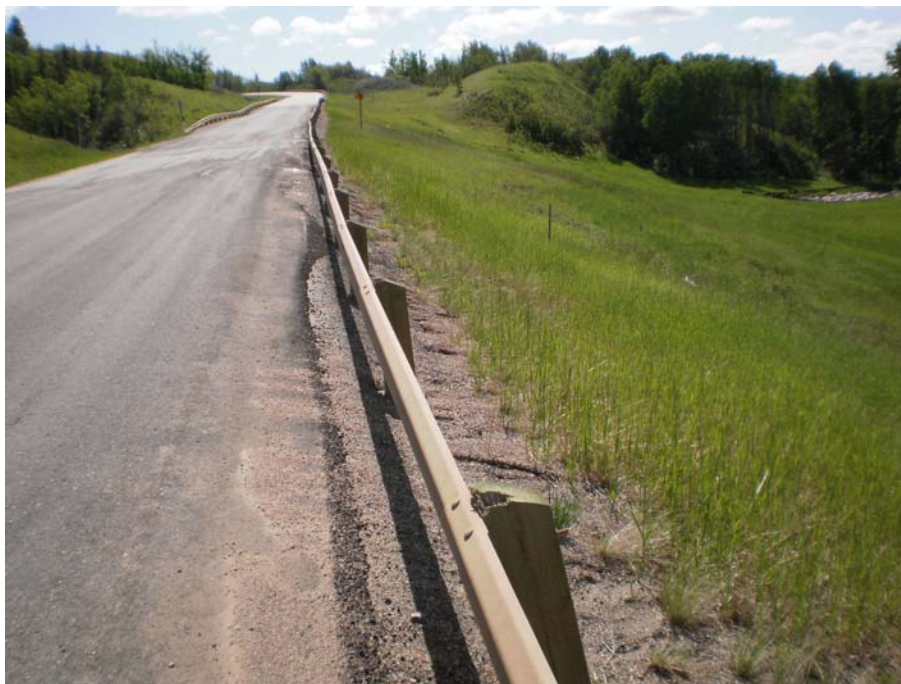
Photo 2 – Looking southeast over the downstream embankment and the new culvert outlet area.

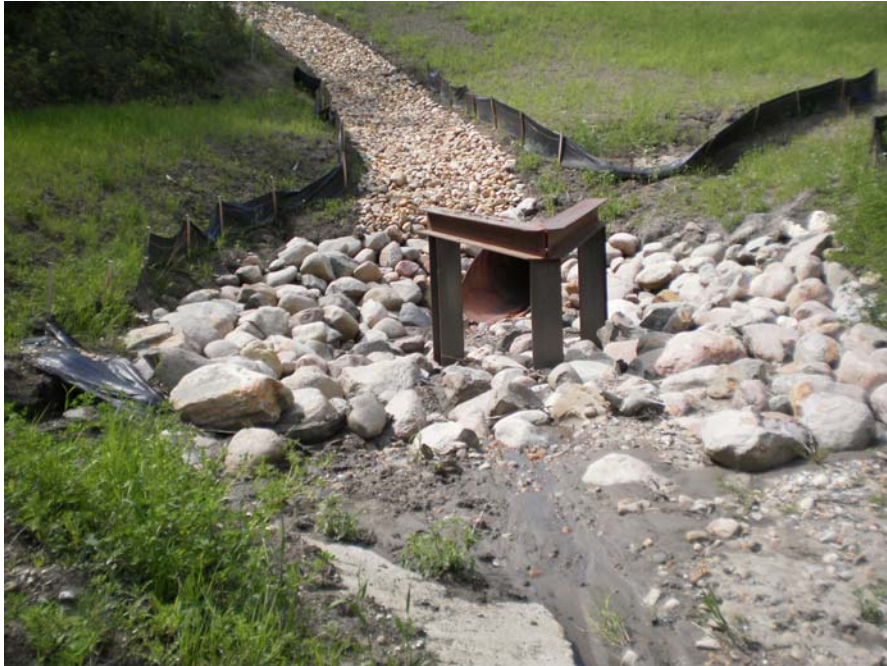
Photo 3 - Looking southeast at the culvert inlet area.

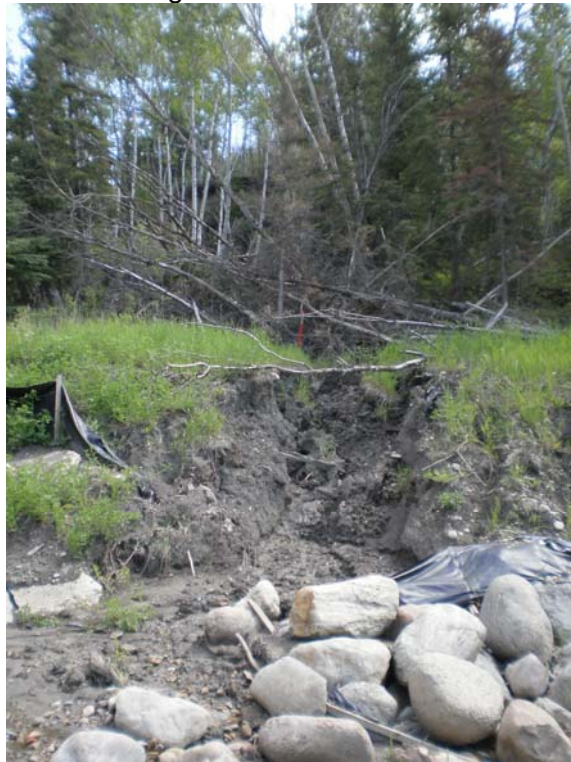
Photo 4 - Looking east at a 5 m long x 1 m deep erosion gully that has formed on the east of the channel in front of the culvert inlet.

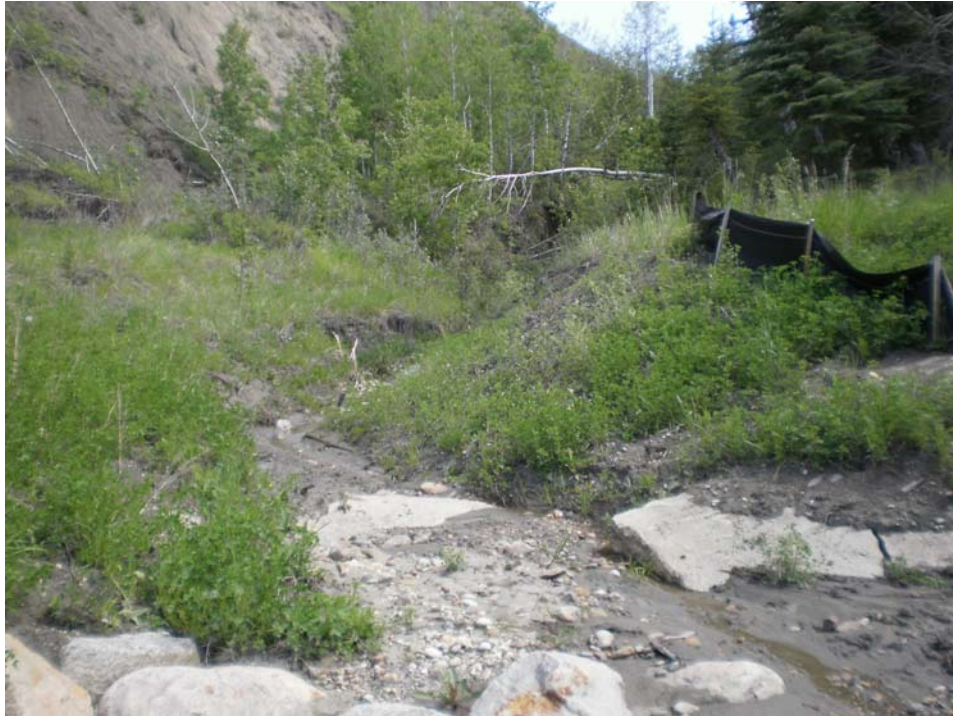
Photo 5 - Looking north along the eroded channel upstream of the culvert inlet.

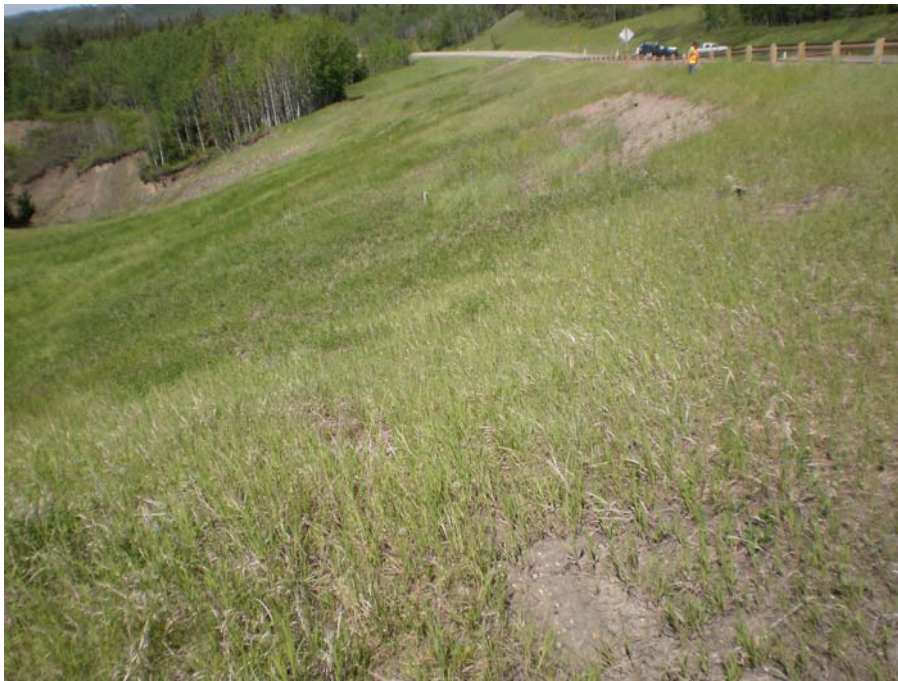
Photo 6 – Looking west across the downstream highway embankment.
Note the lack of grass growth along the shallow slide scarp.

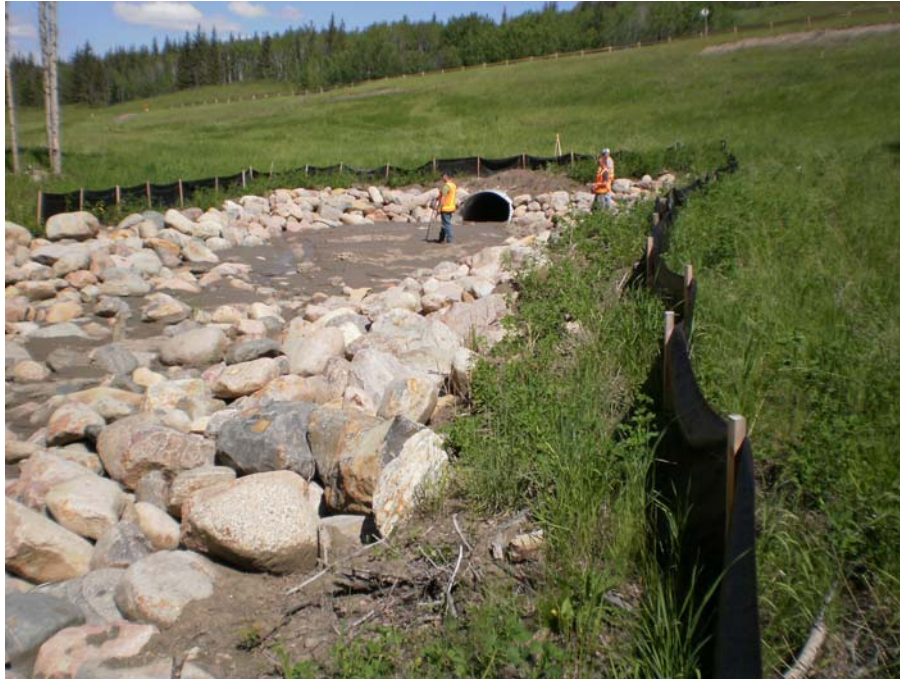
Photo 7 - Looking west across the new culvert outlet. It is about 30% full of sediment.

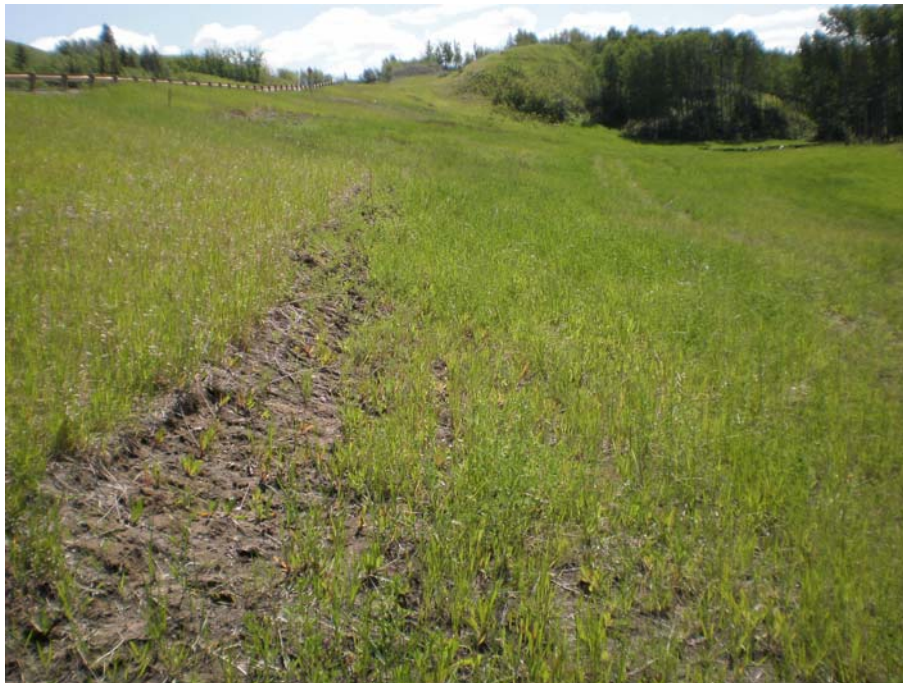
Photo 8 - Looking east across the downstream embankment.
