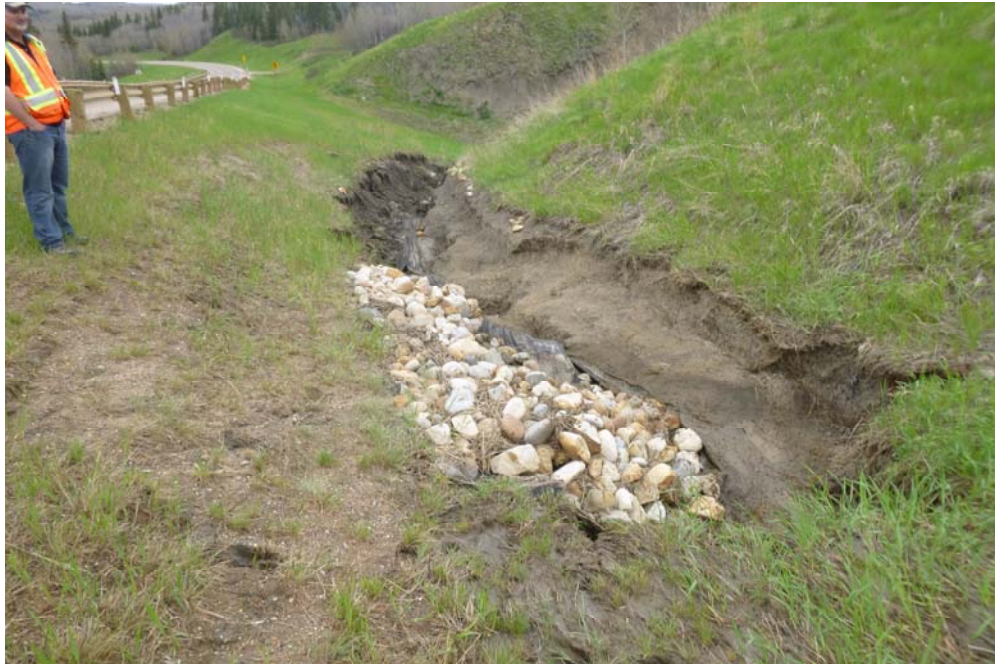
Photo 1 – Looking west at the erosion caused by highway runoff in the northeast quadrant of the site.

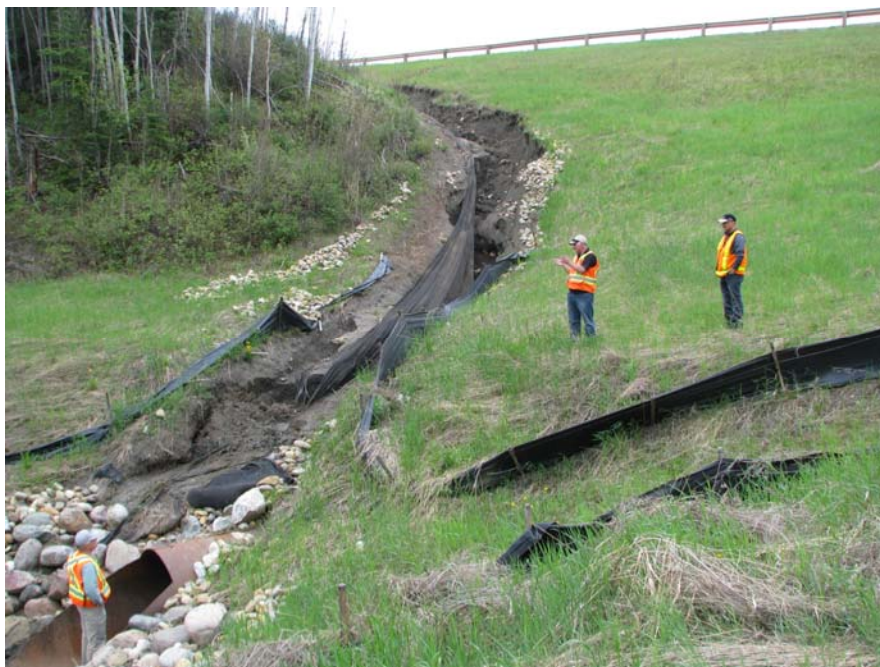
Photo 2 - Looking southeast at the culvert inlet area. Note the severe erosion that has damaged the liner installed to carry north ditch erosion – this was intact last year.

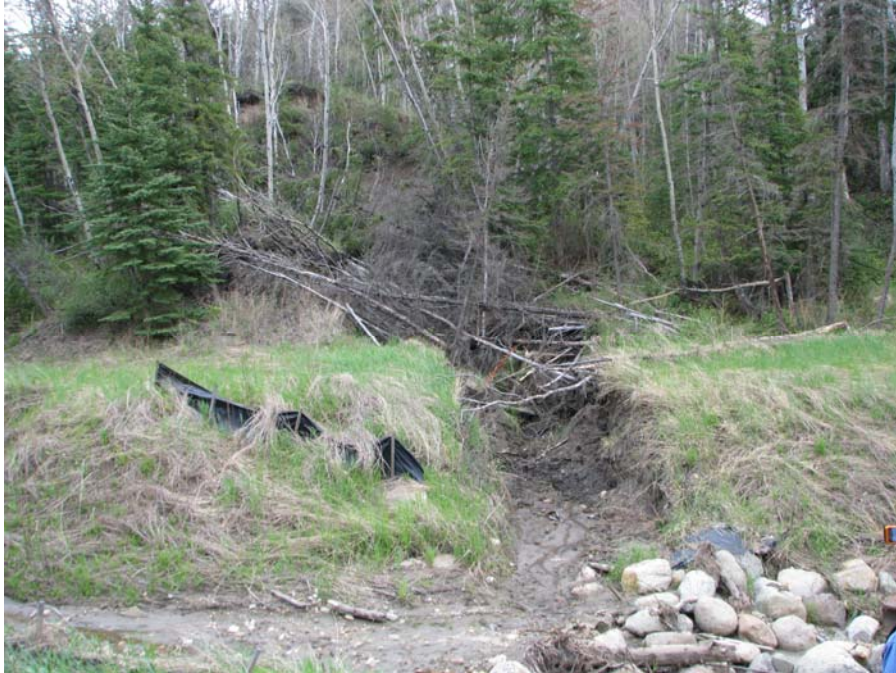
Photo 3 - Looking east at the enlarged gully and fresh erosion on the east side of the channel in front of the culvert inlet.

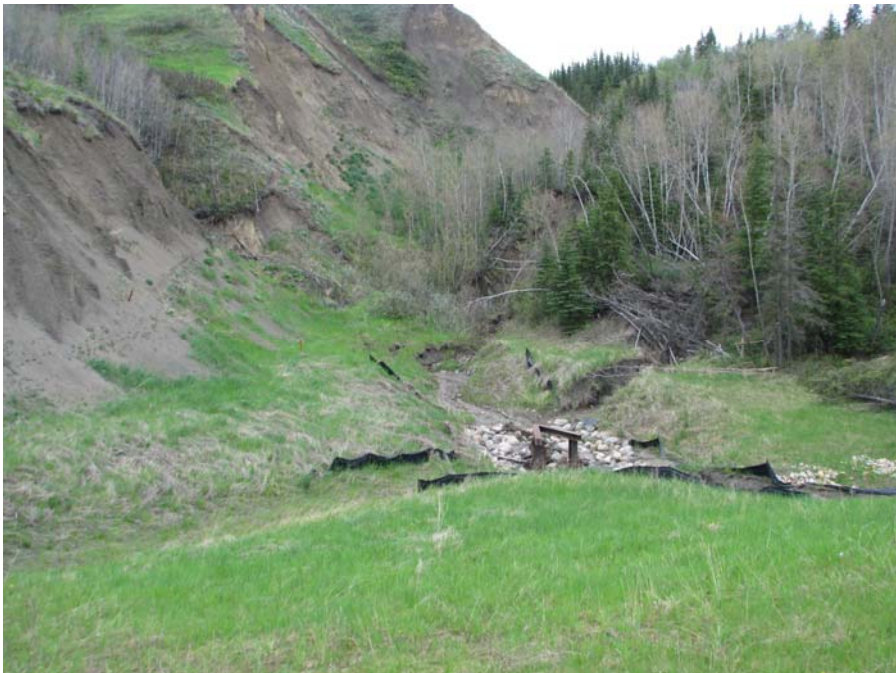
Photo 4 - Looking north at the culvert inlet and channel upstream.

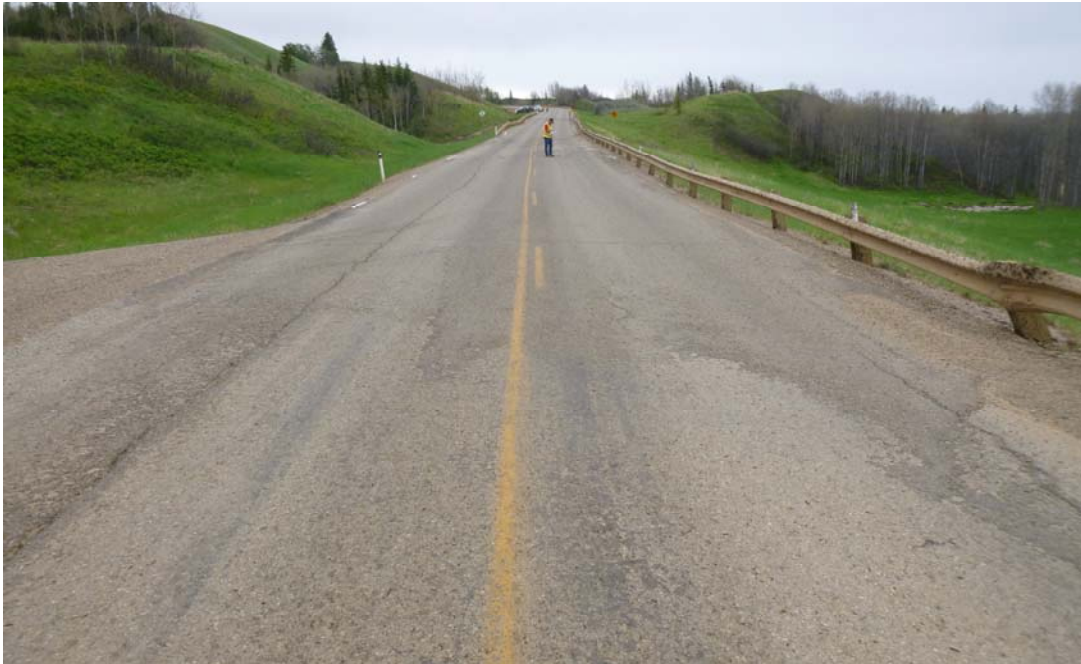
Photo 5 – Looking east along the highway over the Grimms Creek site area.
Note the ACP patches, cracks and dips in the highway.

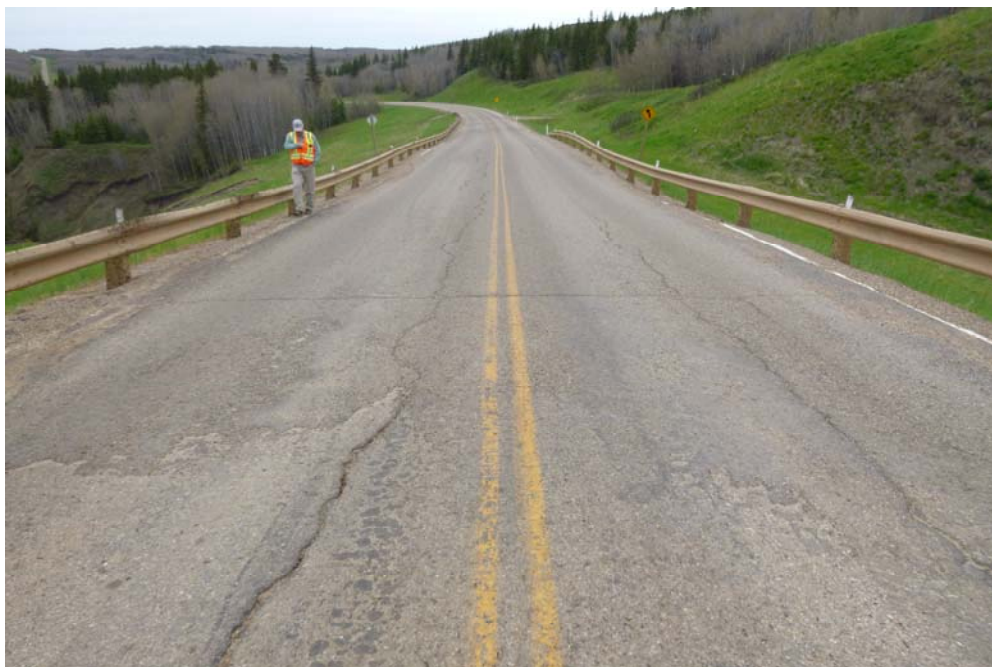
Photo 6 – Looking west along the highway. The ACP patches, cracks and dips in the highway indicate a large scarp crack may be developing along the south side of the hwy.

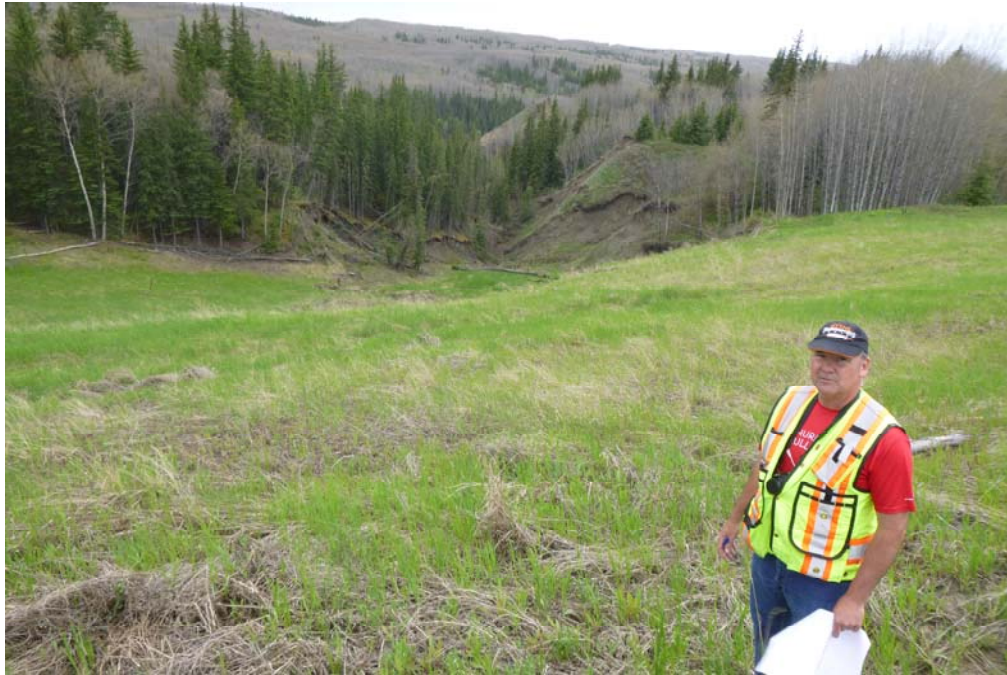
Photo 7 - Looking southwest across the downstream highway embankment at the previous culvert outlet area

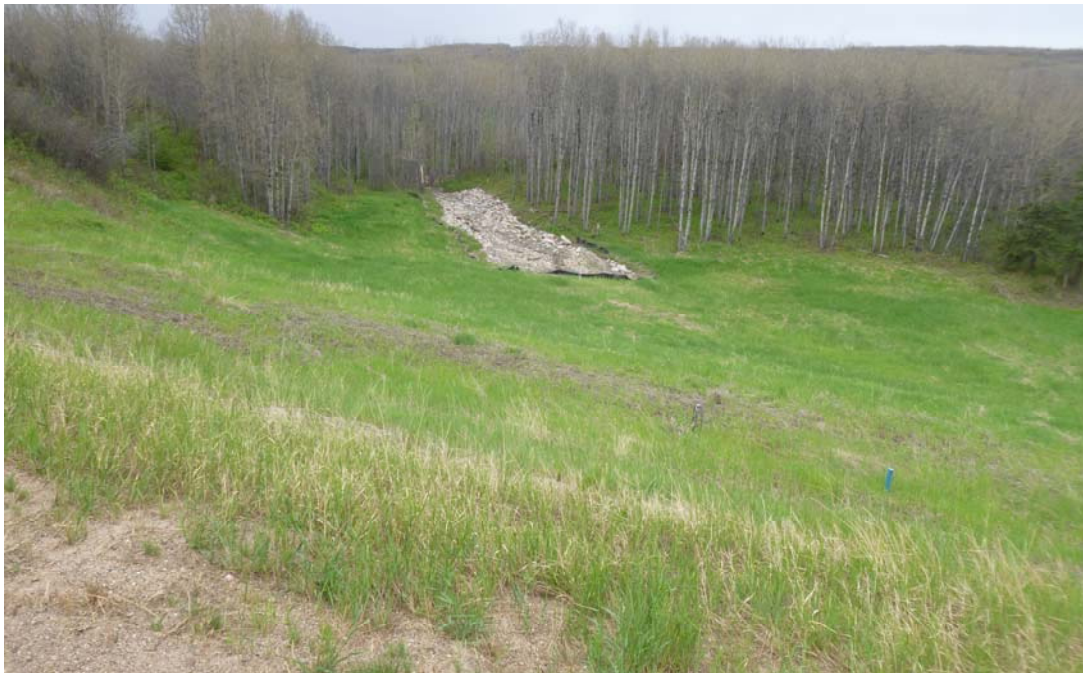
Photo 8 - Looking southeast from the highway at the culvert outlet area.

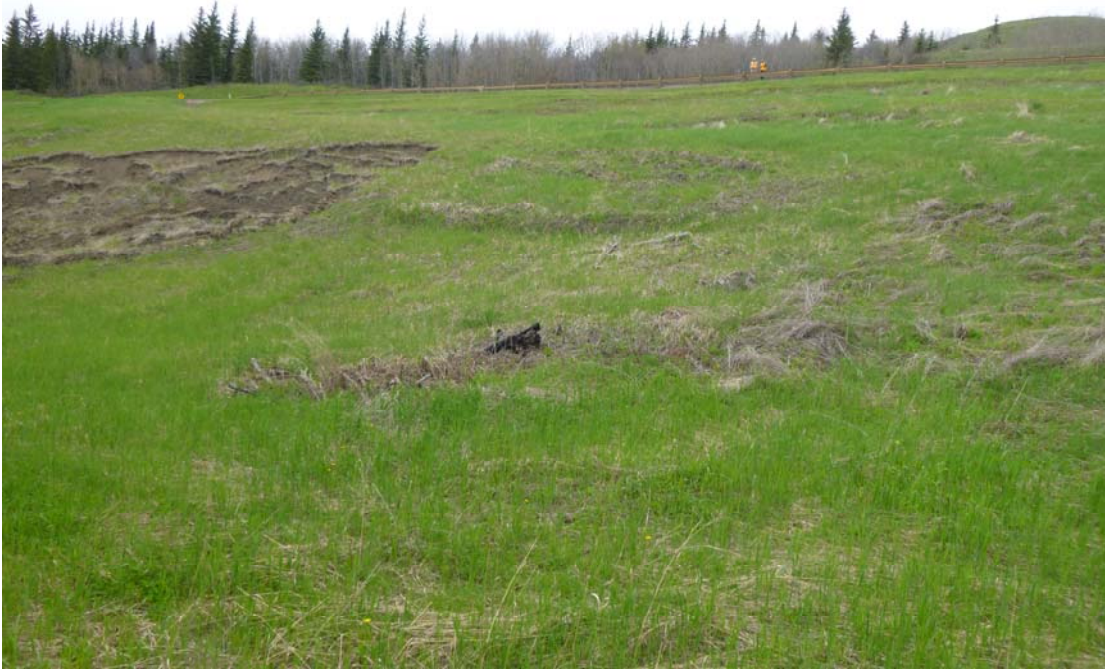
Photo 9 - Looking north at the active slumping on the south embankment slope.

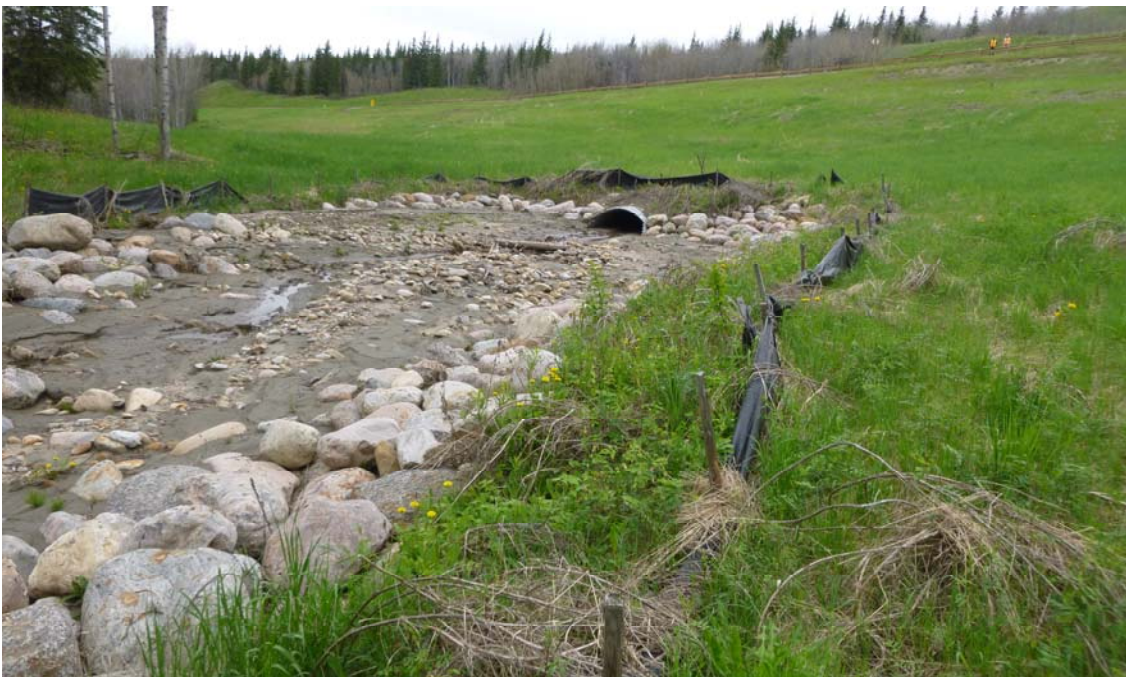
Photo 10 - Looking northwest at the new culvert outlet. It is about 60% full of sediment.
