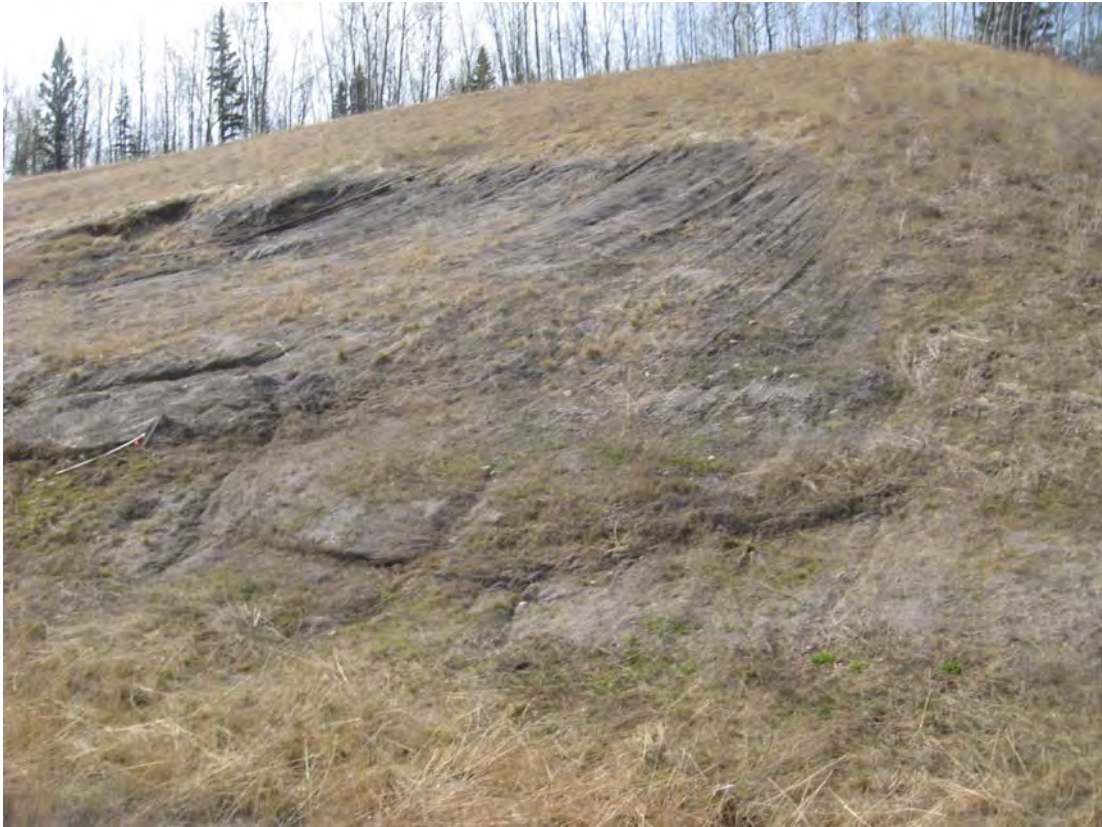
Photo 1 - View of slope failure, looking south.

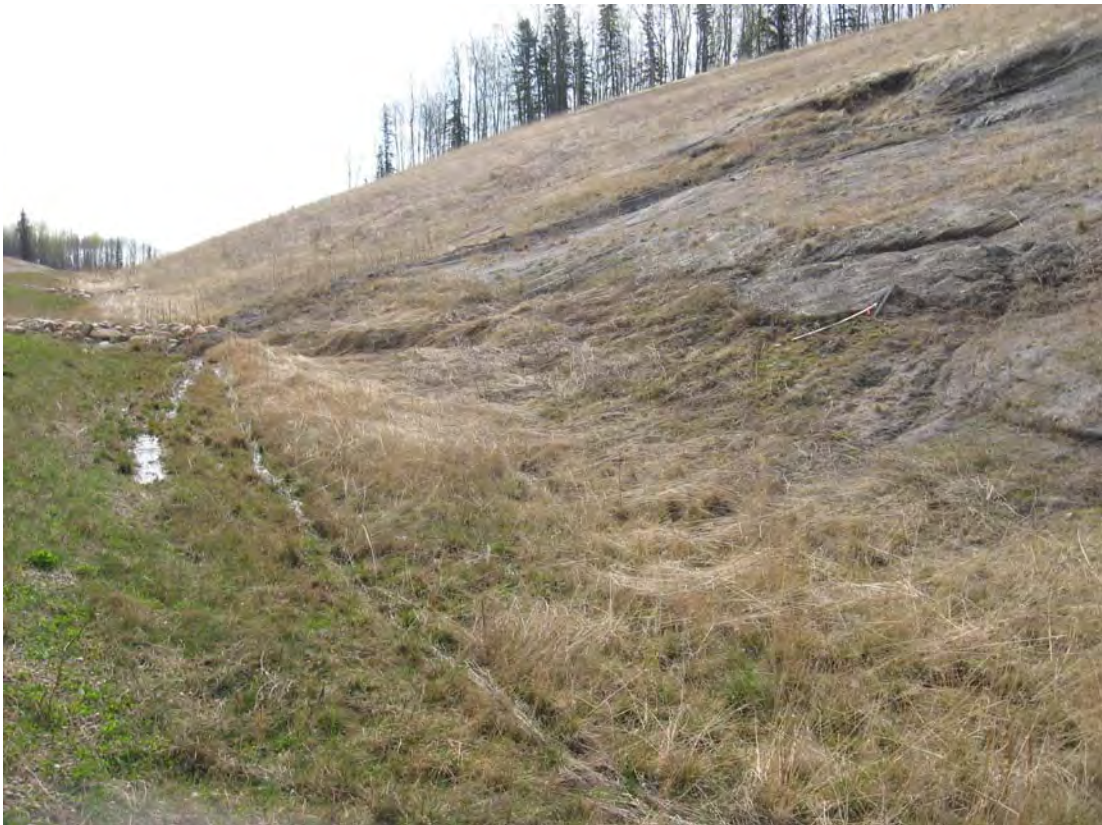
Photo 2 - View of slope failure including toe roll and ditch, looking southeast.

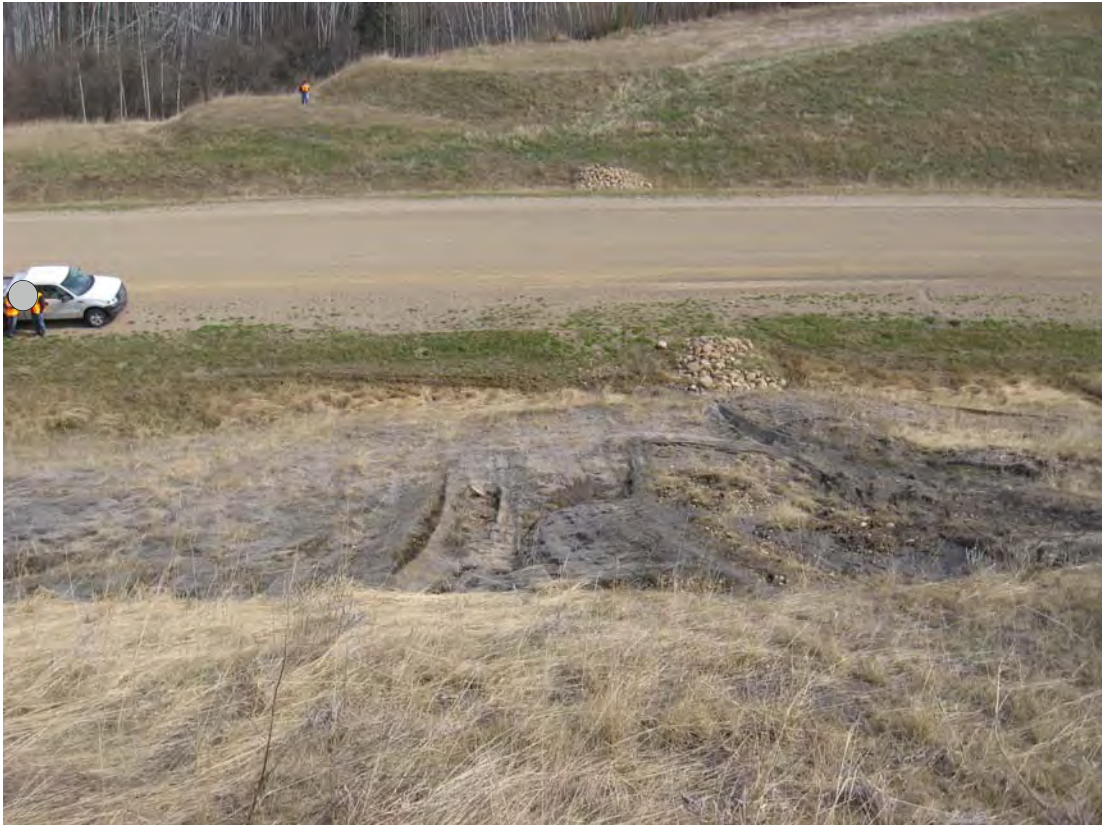
Photo 3 - View of slope failure, looking north.

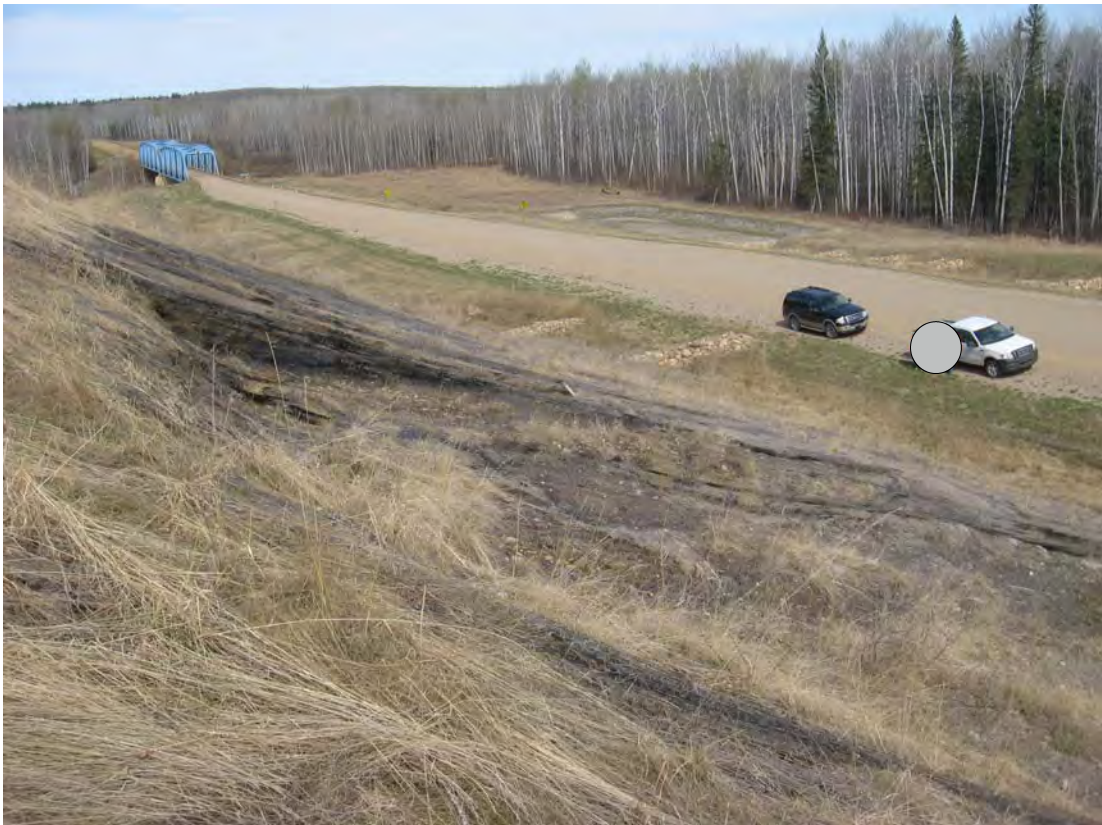
Photo 4 - View of slope failure showing geotextile mesh still in place, looking northwest.

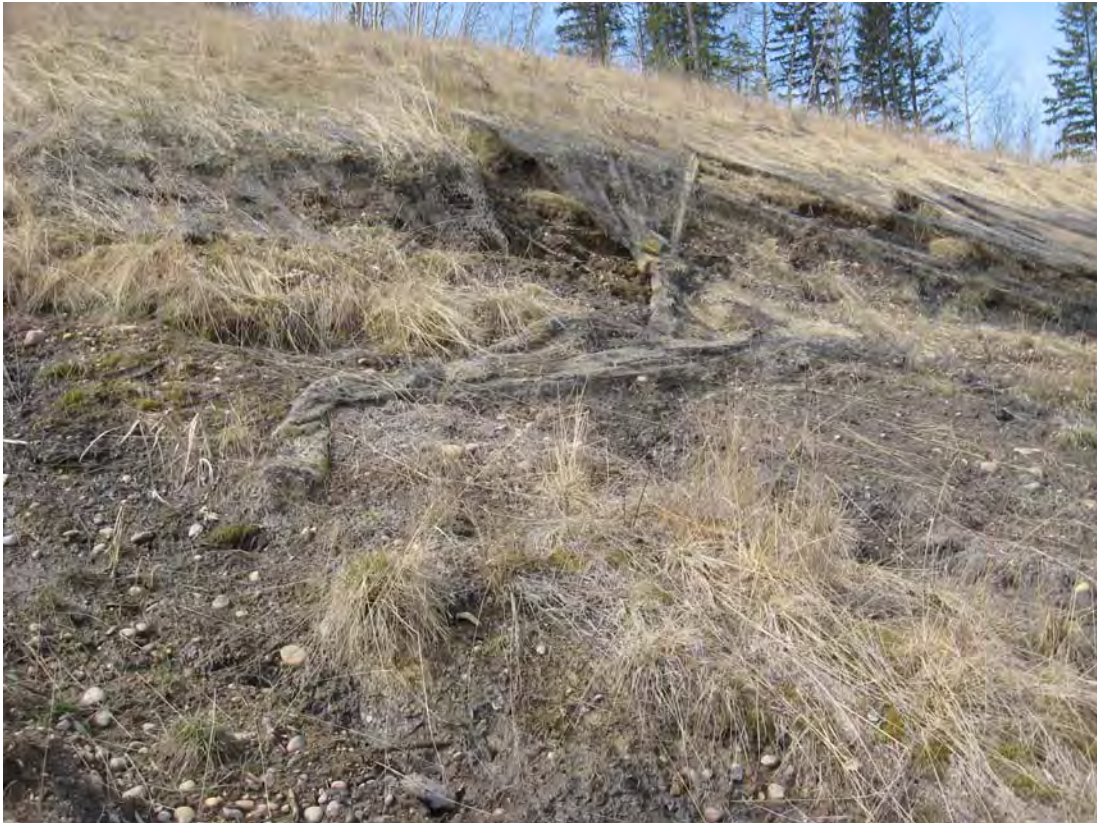
Photo 5 - View of backscarp showing continued seepage, looking southwest.

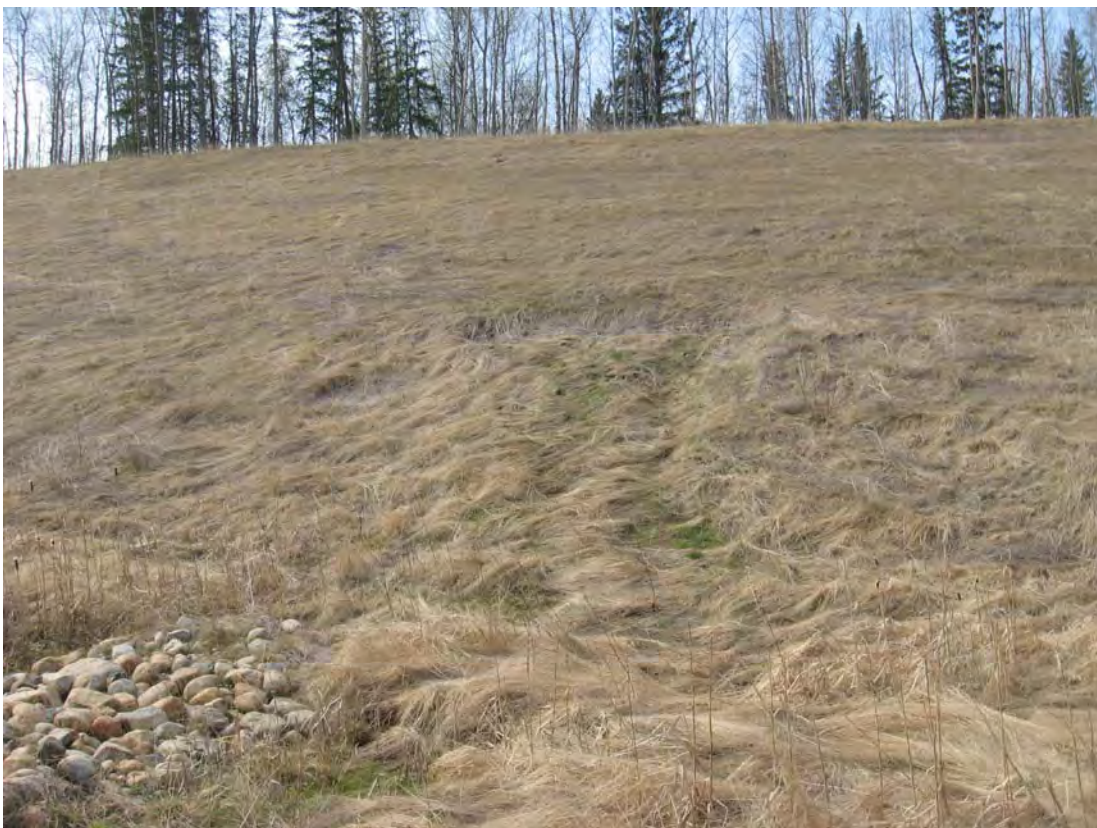
Photo 6 - View of crack located about 60 m east of main slope failure.
