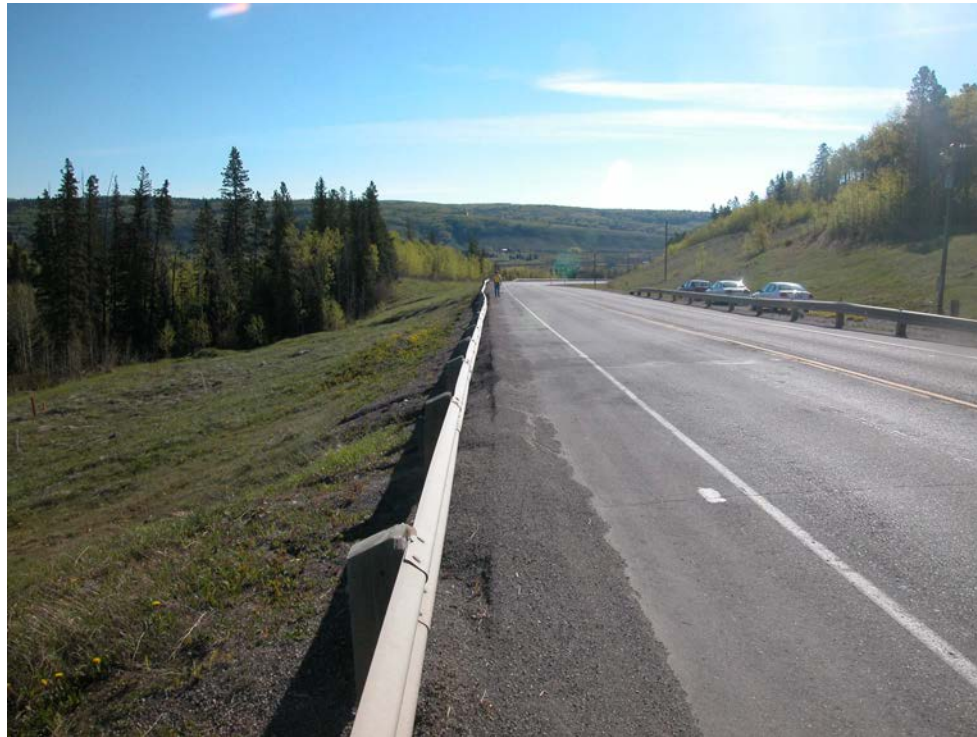
Photo S2-1 (upper left) – May 2004 – facing east across the S2-Priddis site. Note the slight bend in the guardrail visible at the far (east) end. The landslide area is visible on the slope below the road, on the left side of the photo. Photo S2-5 shows another view of the landslide area.

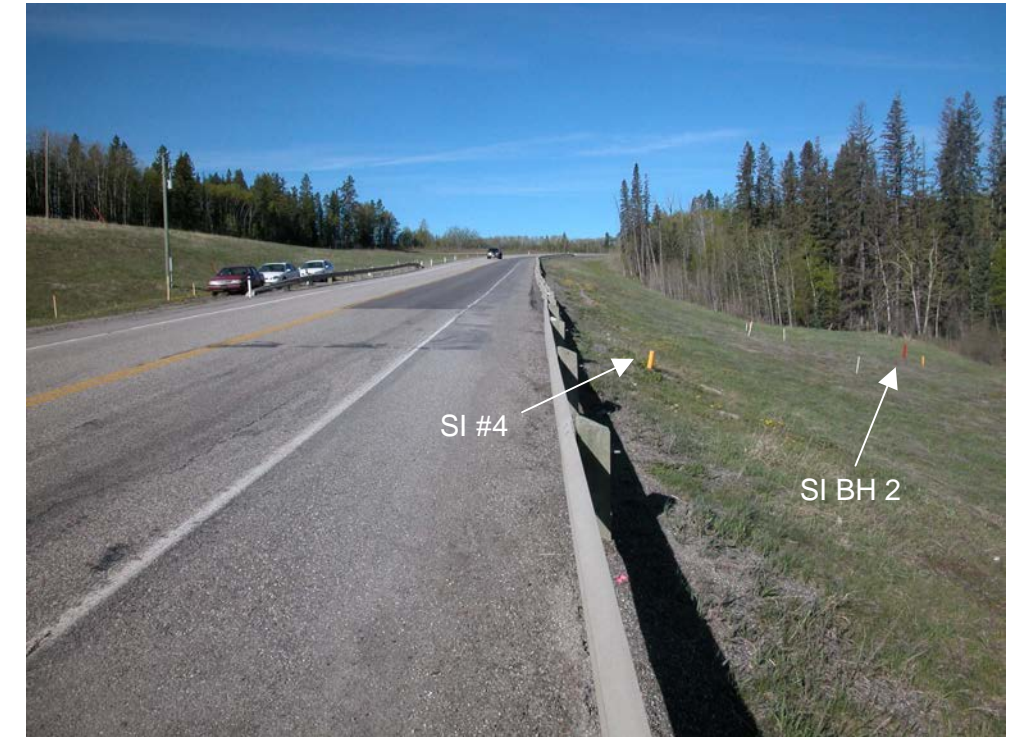
Photo S2-2 (upper right) – May 2004 – facing west across the S2-Priddis site. SI #4 (yellow casing) is visible to the right of the guardrail. SI BH-2 is also visible on the lower slope face. Since 2002, SI BH2 has been the only SI at this site that has shown significant and ongoing slope movement.

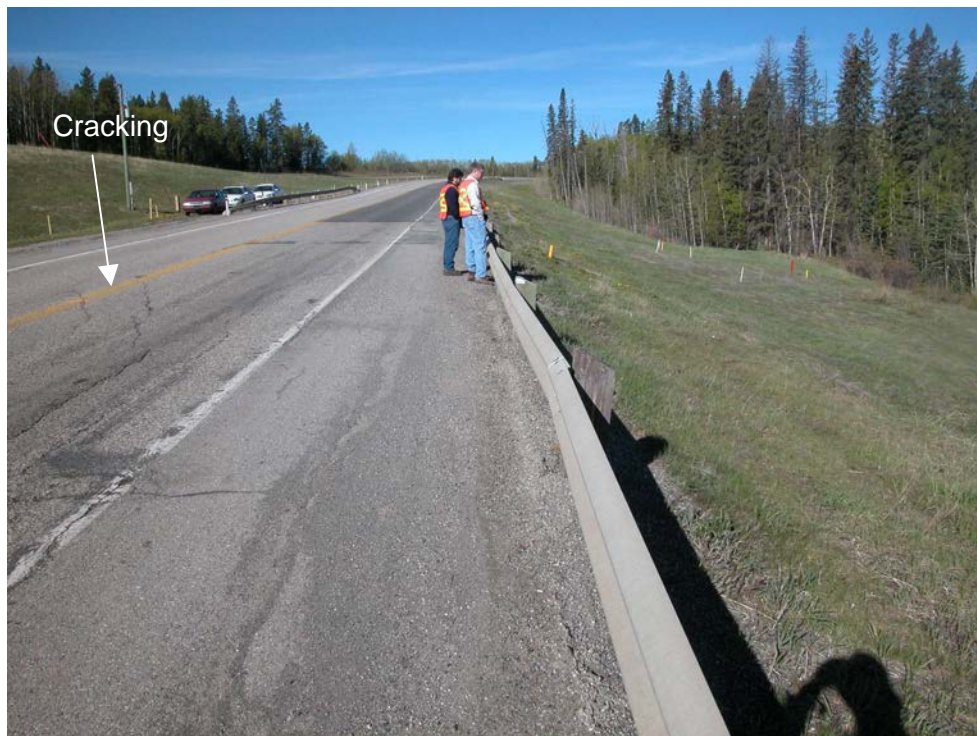
Photo S2-3 (lower left) – May 2004 – closer view of the bend in the guardrail at the east end of the site. Also note the cracking visible around the yellow centerline of the road on the left side of the photo – this cracking was also noted during the July 2003 inspection and has not changed significantly since that time. This cracking may delineate the east flank of road disturbance due to slope movement at this site.

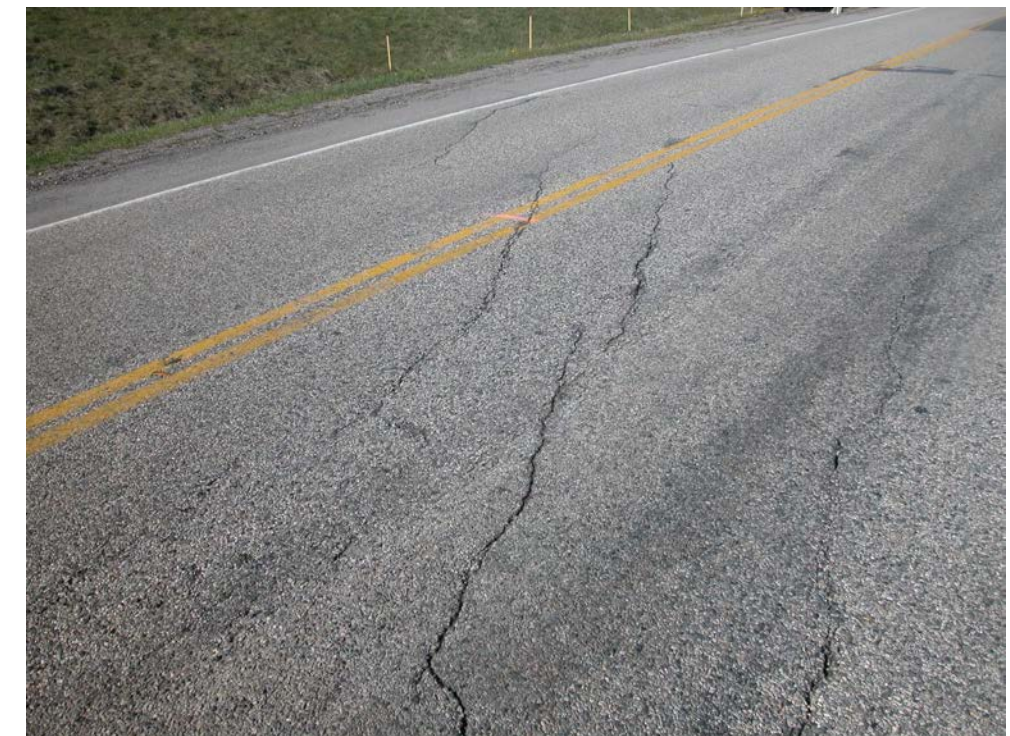
Photo S2-4 (lower right) – May 2004 – closer view of the cracking noted at the east end of the site. No significant change since the July 2003 inspection.

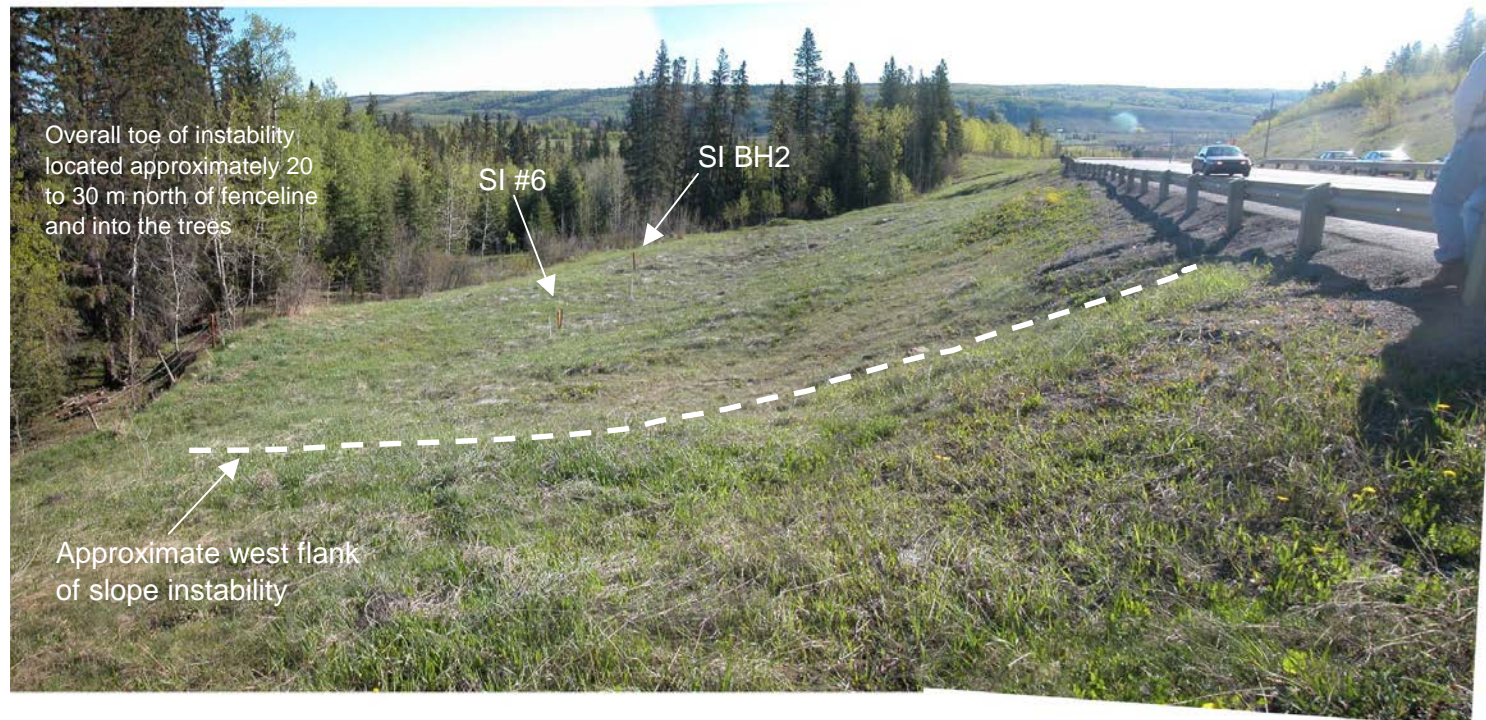
Overall toe of instability located approximately 20 to 30 m north of fenceline and into the trees

Approximate west flank of slope instability

Photo S2-5 (top) – May 2004 – slope face below the road at S2-Priddis, as seen facing east. Visual inspection of the slope face indicated that the west flank of the slope movement area is around the limit shown in the foreground of the photo.

SI BH2 is measuring approximately 6 to 7 mm of downslope displacement per year around 6 m depth and the toe area of the landslide (located approximately 20 to 30 m north of the fenceline, i.e. into the trees) has been showing active movement over the last several years.

As discussed on site, a pile wall could be installed on the slope face below the road in order to provide support for the road embankment in the event of continued movement around SI BH2 and further downslope that could ultimately destabilize the road embankment. The location and design details for the pile wall should be optimized with an analysis of various potential pile wall sizes and positions.

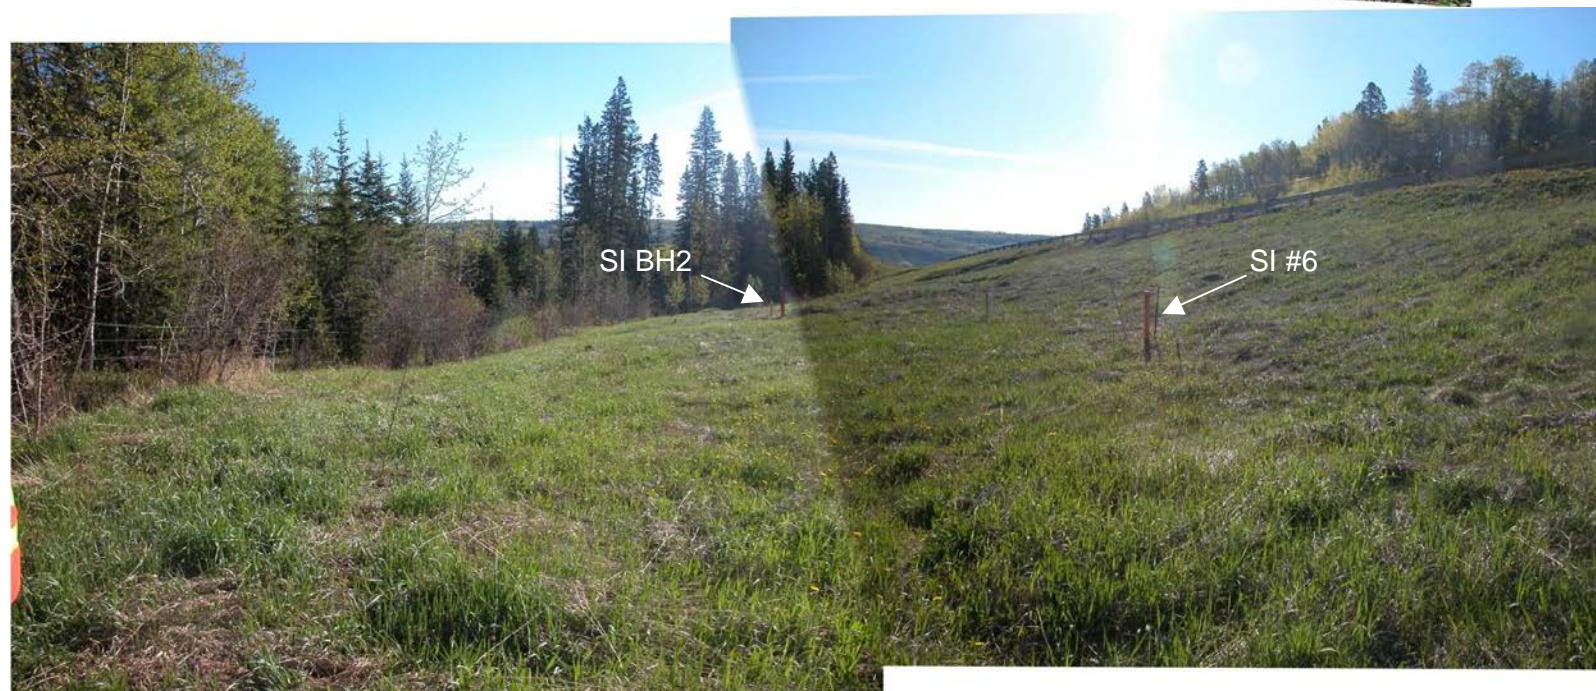
Photo S2-6 (bottom) – May 2004 – another view of the slope face below the road at S2-Priddis, as seen facing east.

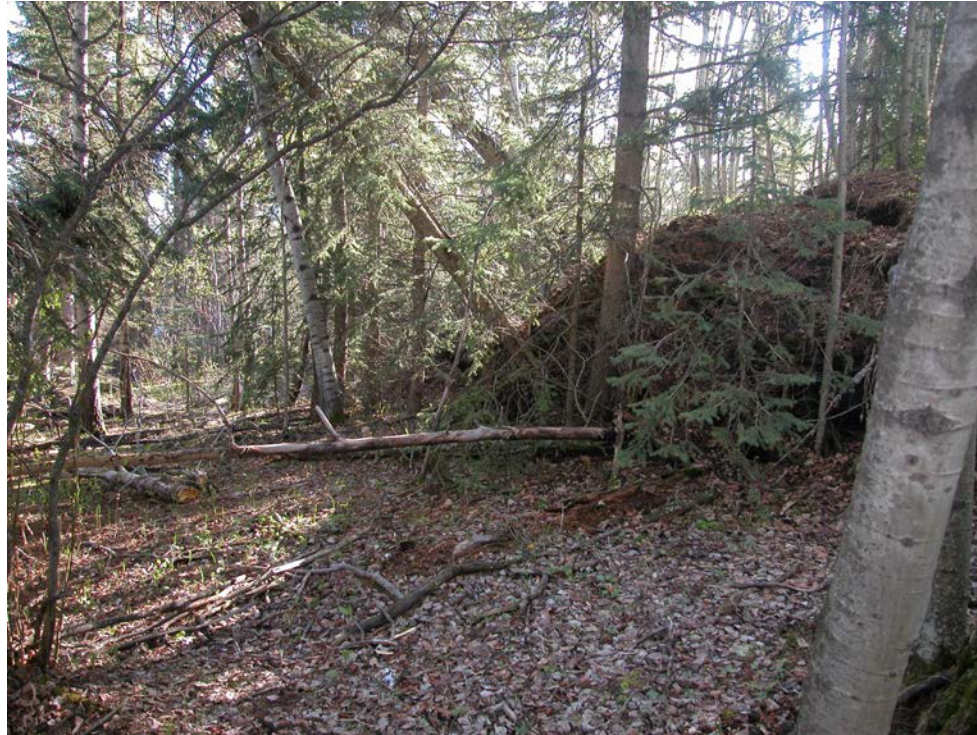
Photo S2-7 (left) – May 2004 – toe area of landslide approximately 20 to 30 m north of the fenceline below the road. Upthrust and displaced soil as a result of landslide movement. There appeared to be additional displacement since the July 2003 inspection.

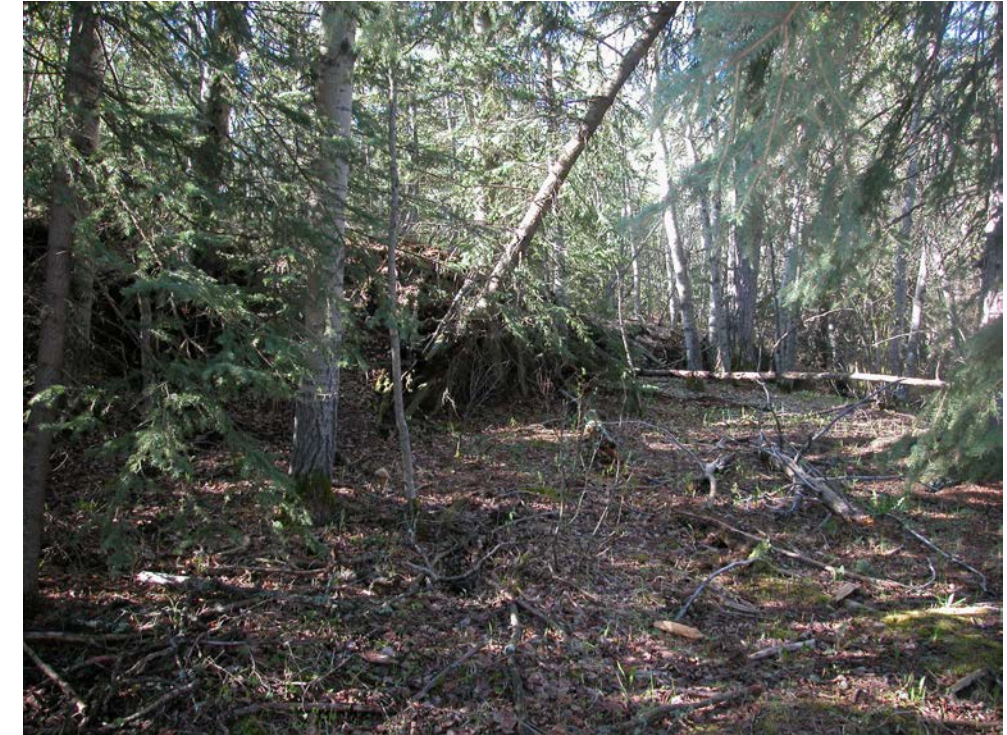
Photo S2-8 (right) – May 2004 – another view of the toe area of landslide, north of the fenceline below the road.
