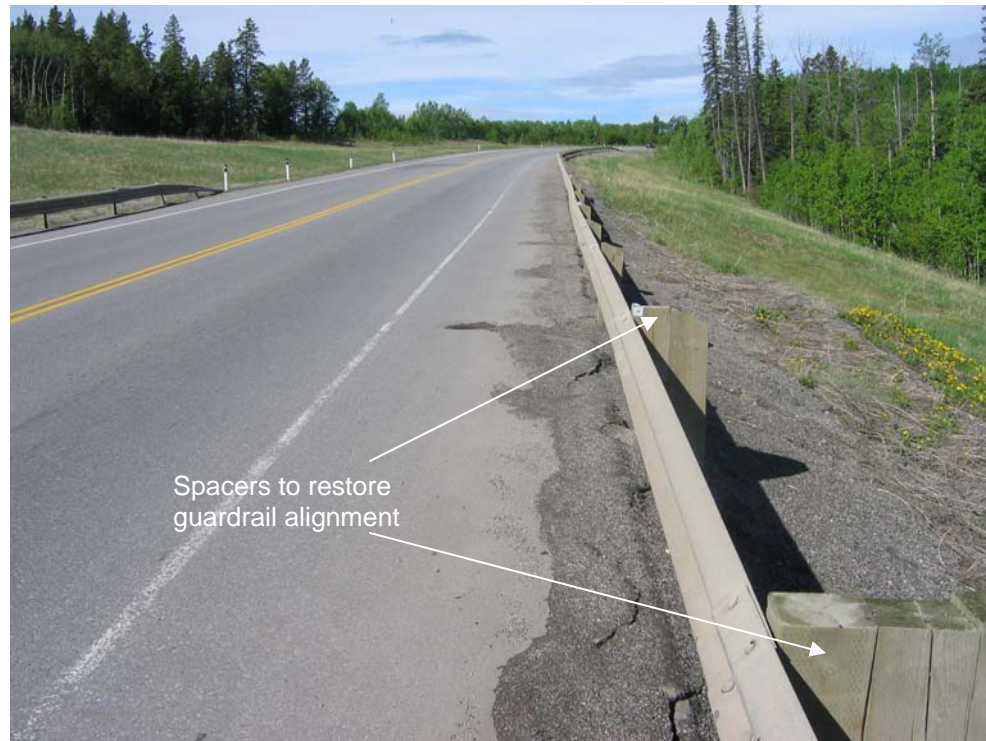
**Photo S2-1** (upper left) – May 2006 – Cracking in the westbound lane. The cracking appears to delineate the existing pile wall. This shoulder of the road has been experiencing ongoing cracking and settlement since before the first geotechnical inspection in 2000. The currently-visible cracking has developed through a patch to the road surface that was placed in the summer of 2005.

Note the spacers that have been placed since 2005 to restore the guardrail alignment after it had dropped down and away from the road.

Compare with Photo S2-2 (upper right) showing the same area in June 2005.

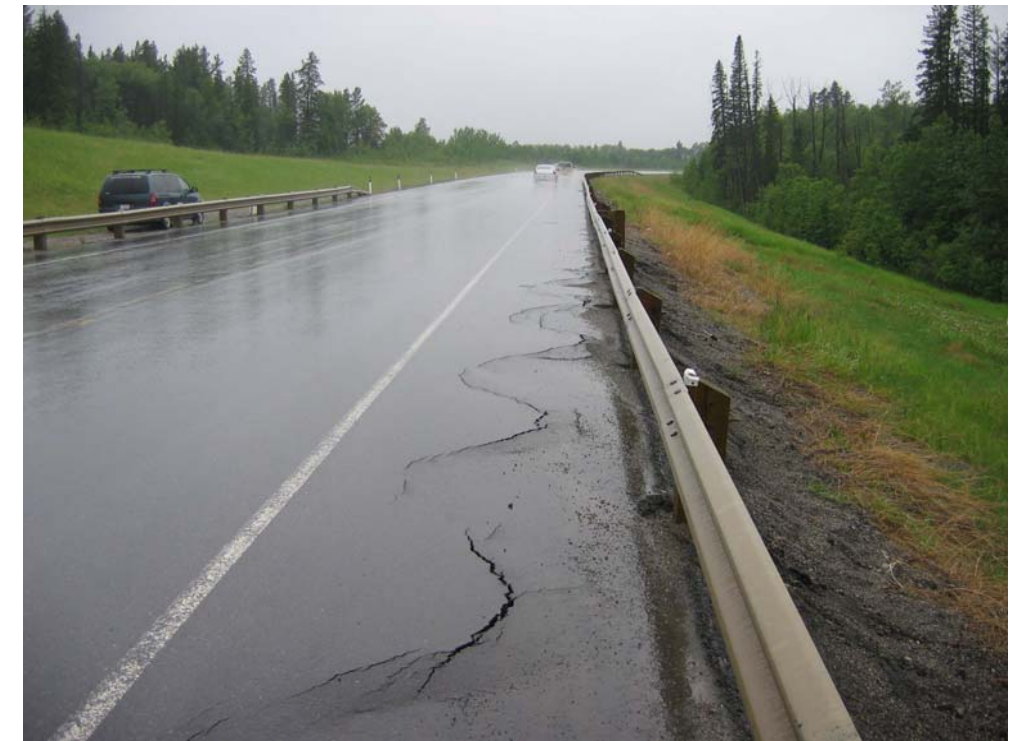
**Photo S2-2** (upper right) – June 2005 – same area as shown in Photo S2-1.

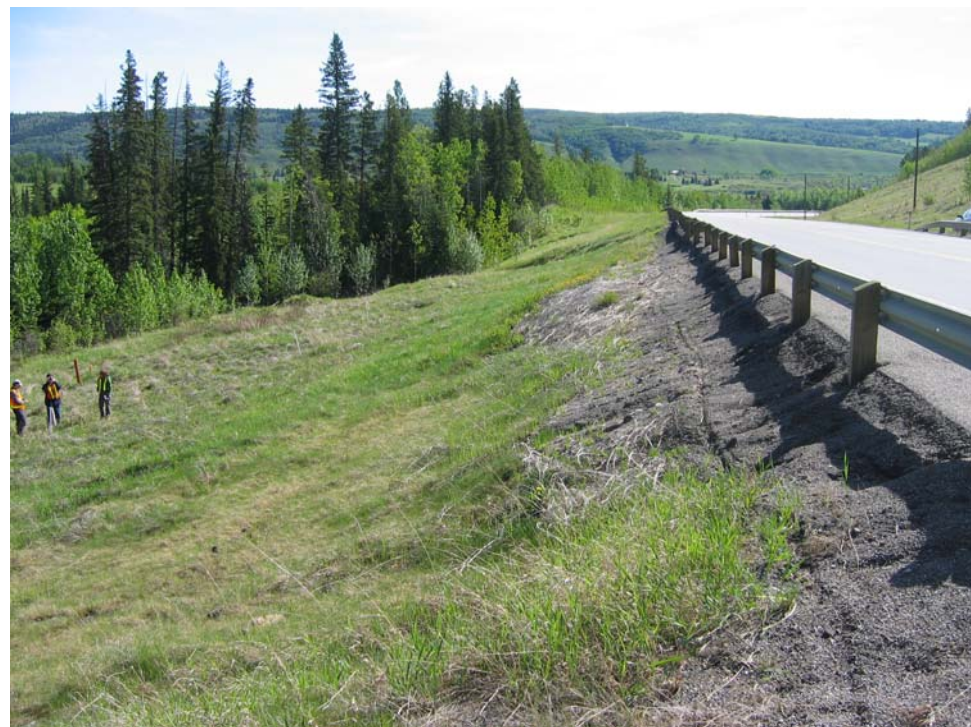
**Photo S2-3** (lower left) – May 2006 – View of slope face below the road along the guardrail.

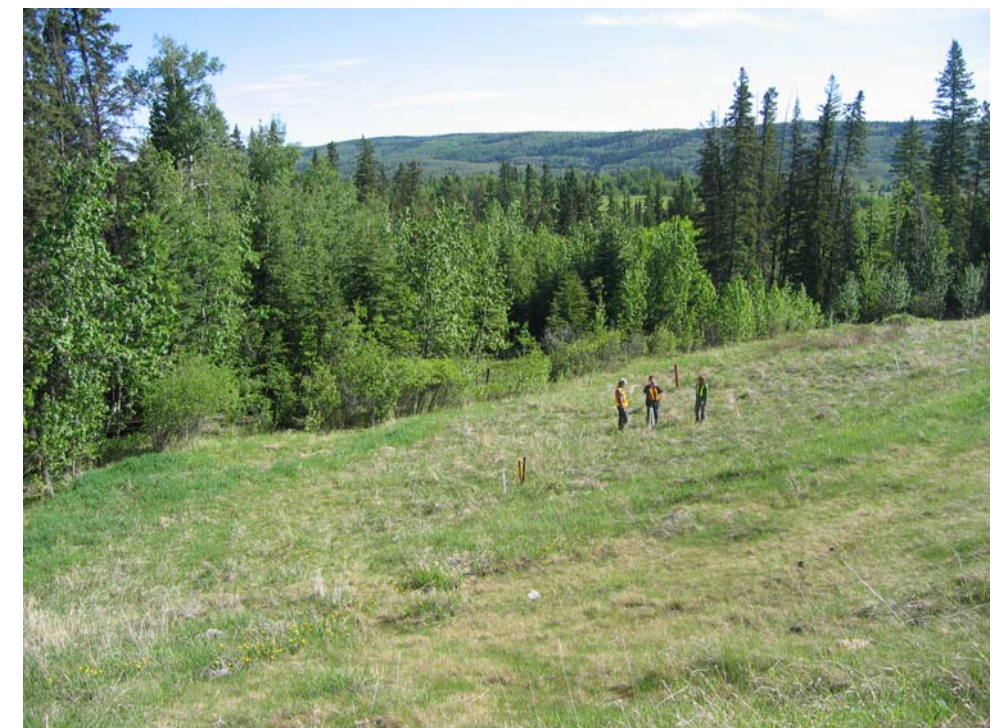
**Photo S2-4** (lower right) – May 2006 – General view of the slope face below the road with instruments visible near the toe of the slope. The visual appearance of this area is essentially unchanged since the 2005 inspection, however the Fall 2005 and Spring 2006 instrumentation readings have shown that slope movement continues around the toe of the slope. The toe thrust of the landslide is within the treed area north of the road (in the left background of this photo).
