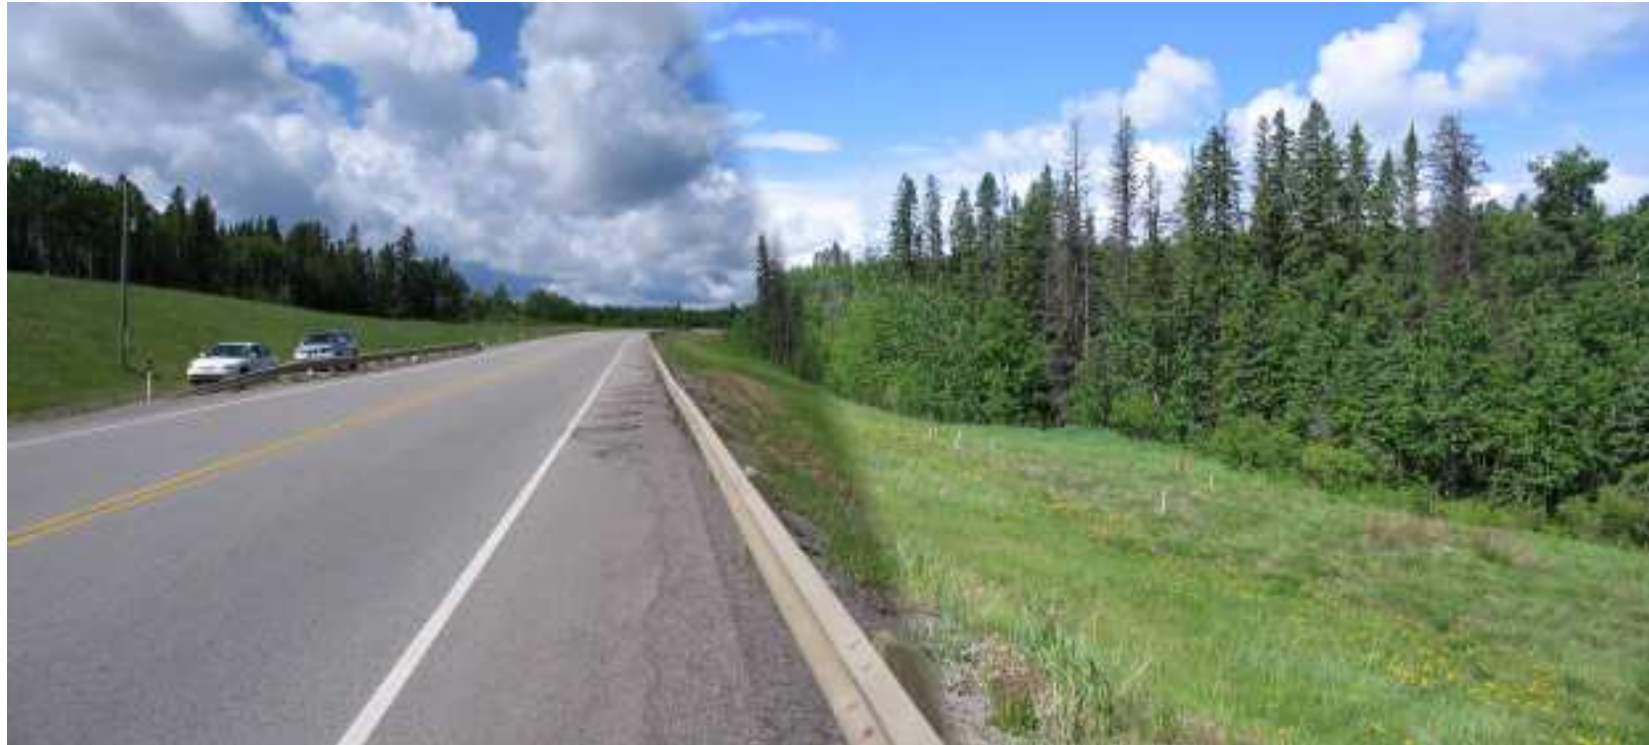
Photo S2-1 – June 2007 (top)

Facing west along the north shoulder of the highway through the landslide area. The cracking along the north shoulder appears to delineate the existing pile wall. Otherwise, there did not appear to be any fresh cracking or significant recent downdrop/settlement of the road surface or guardrail at the time of the inspection.

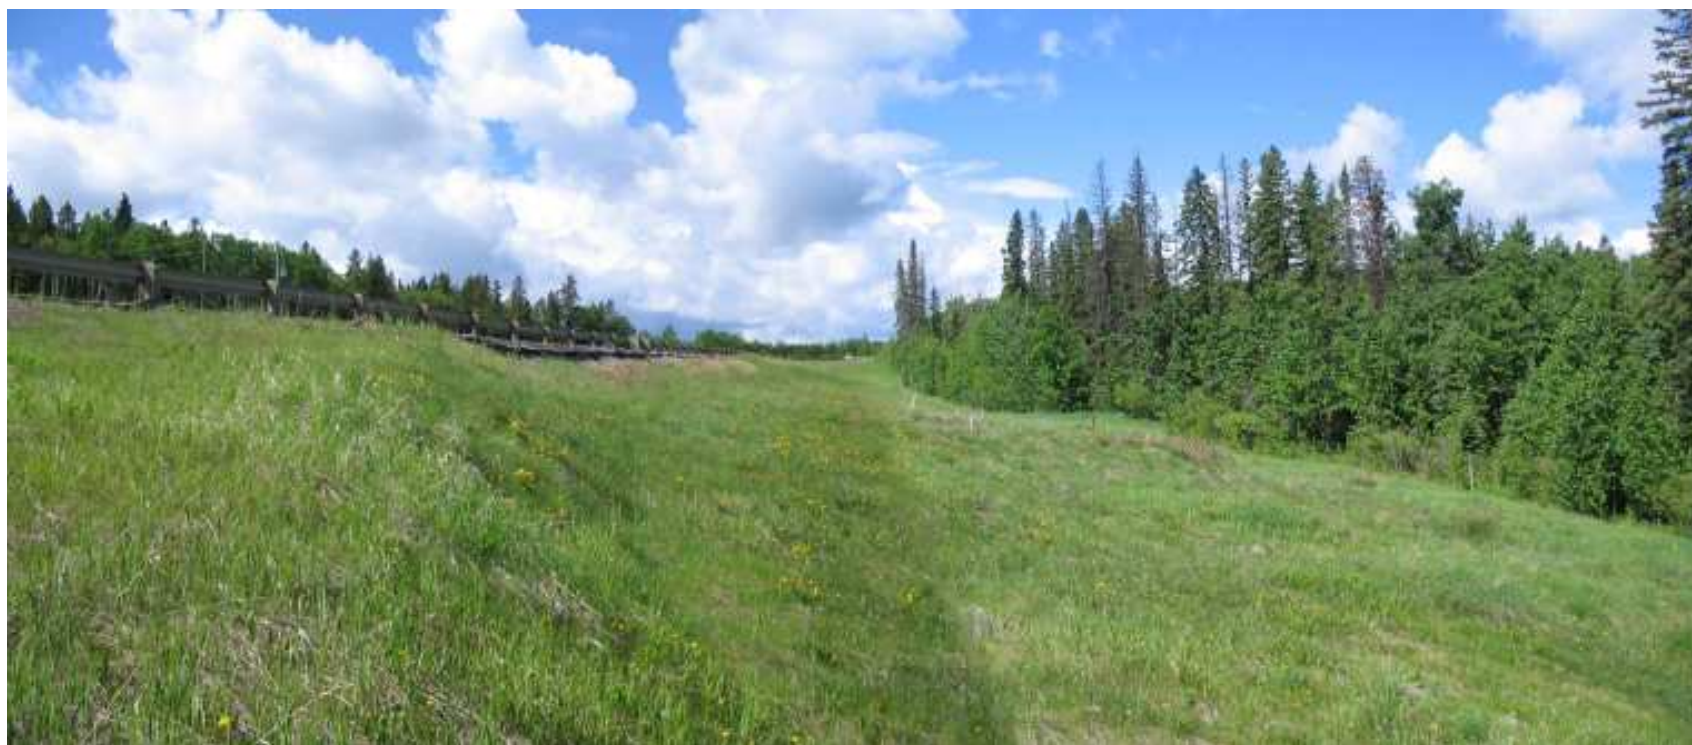
Photo S2-2 – June 2007 (bottom)

Facing west across the landslide area on the slope below (north of) the road. There were no significant changes in the appearance of this area since the previous inspections.

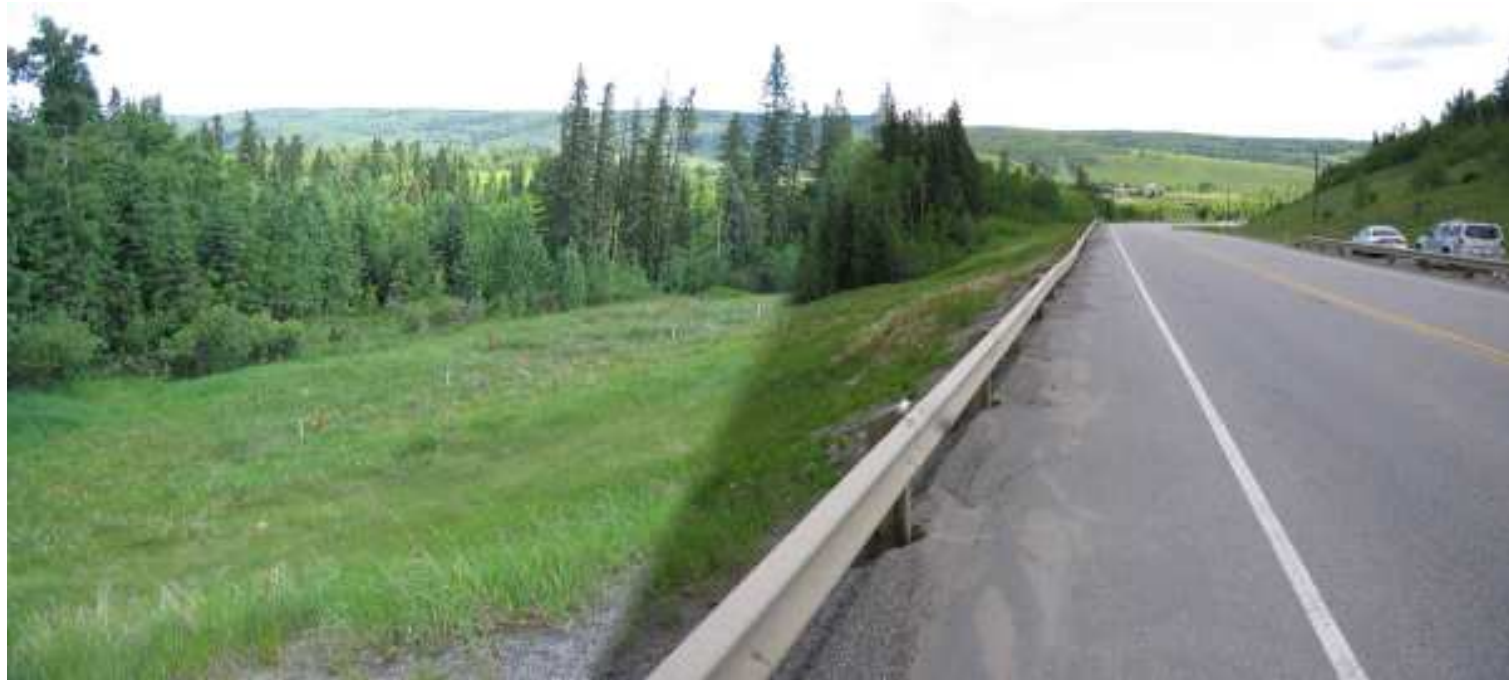
Photo S2-3 – June 2007 (top)
Facing east along the north shoulder of the highway through the landslide area.

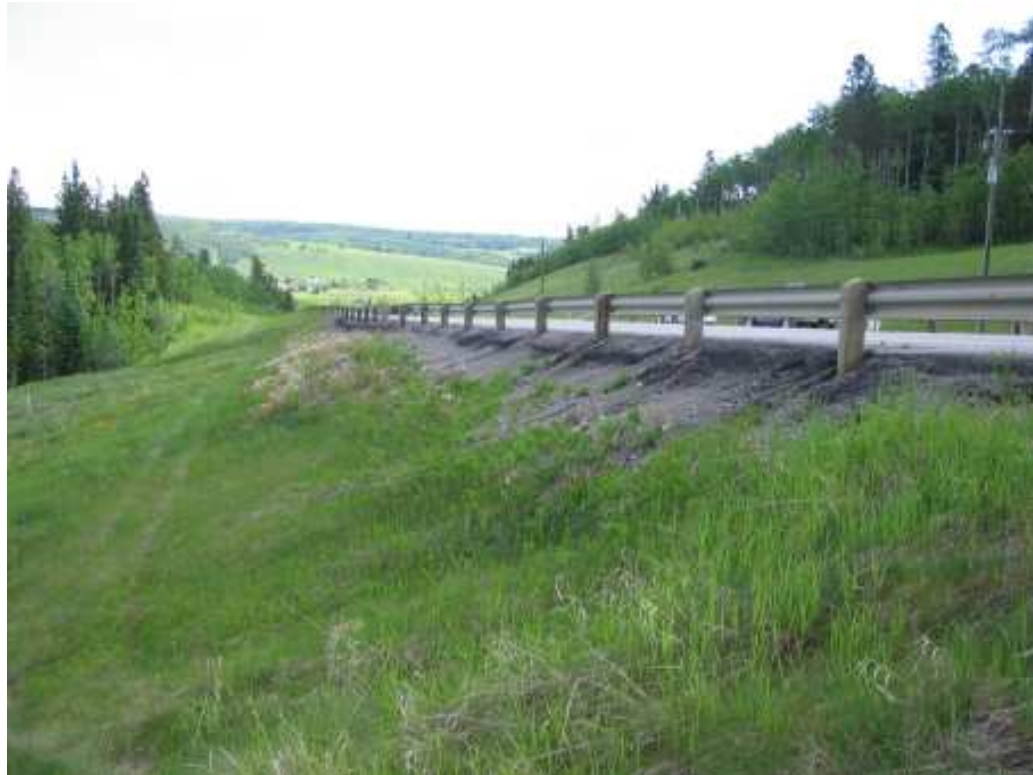
Photo S2-4 – June 2007 (bottom)
Closer view of the crest of the slope below/north of the highway. Note the steep drop-off on the downslope side of the guardrail due to the landslide movement.
