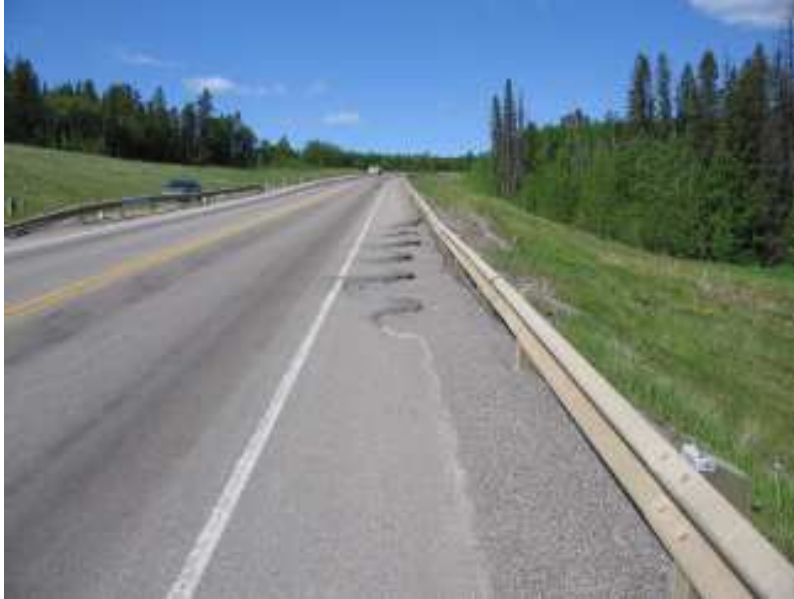
Photo S2-1 – June 2008 (top)
Facing westbound across the S2-Priddis site. The settlement and cracking along the north/downslope edge of the highway is visible, along with the corresponding dip in the guardrail. Note how the pattern of damage on the road surface appears to delineate the existing concrete pile wall.

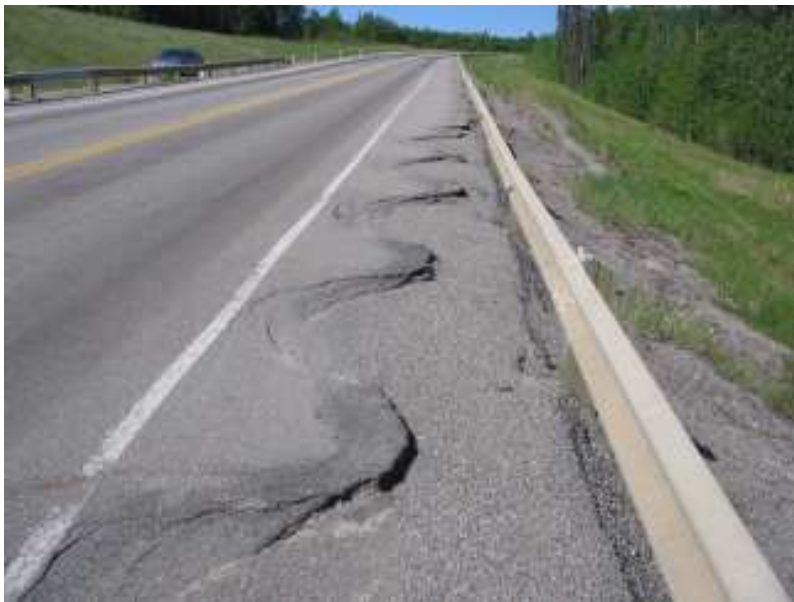
Photo S2-2 – June 2008 (bottom)
Closer view of the damage to the road surface. The aperture of the cracks and the amount of down-drop were in the order of 50 mm or even greater at the time of the inspection. Note how the guardrail is relatively low, likely due to ongoing settlement of the ground downslope of the pile wall.

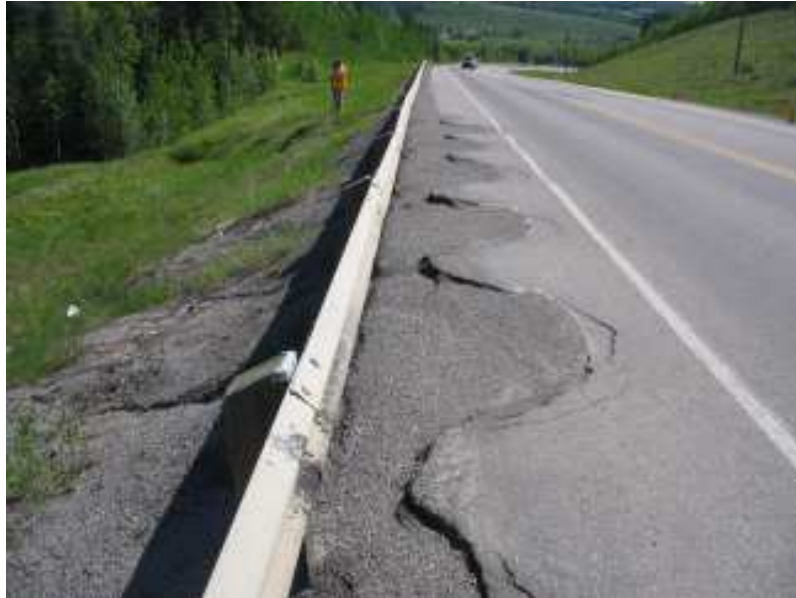
Photo S2-3 – June 2008 (top)
Another view of the damage to the road surface, facing eastbound. The apparent east flank of the landslide is visible on the slope face below the road and in the left background of this photo.

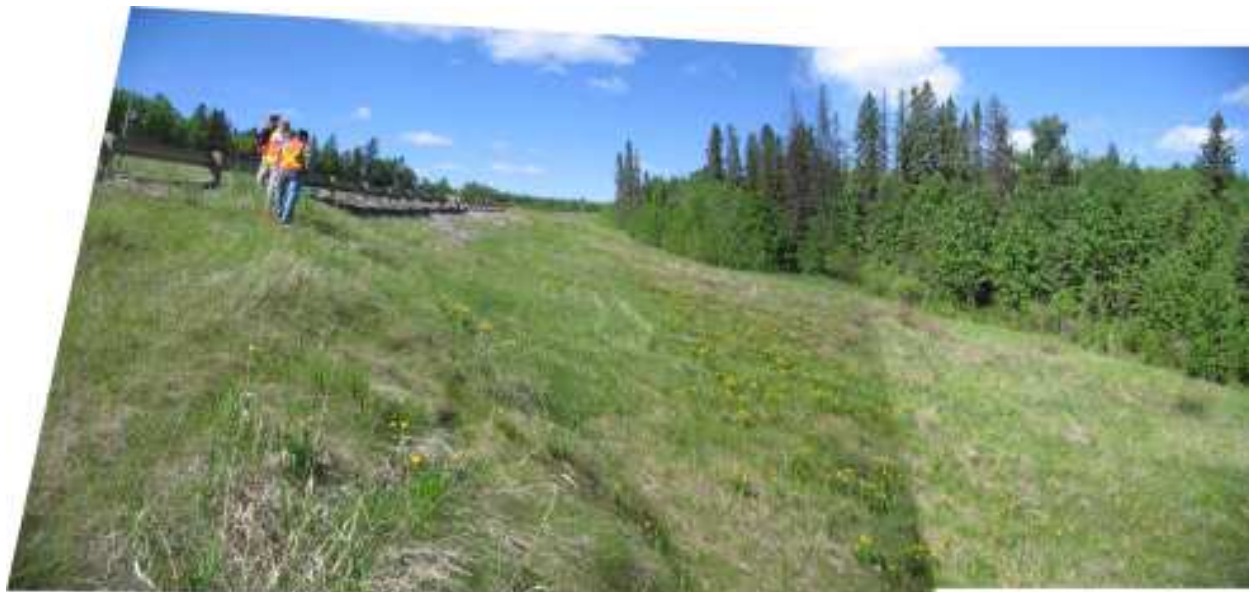
Photo S2-4 – June 2008 (bottom)
Facing west along the apparent east flank of the landslide below the highway. The segment of the road surface that shows settlement and cracking and is supported by the pile wall is adjacent to the near-vertical scarp visible on the downslope side of the guardrail in this photo. Each of the SI's on the slope below the highway that are downslope of/within the apparent east and west flanks of the landslide are out of service due to accumulated landslide deformation of the casings. Previous inspections have noted a toe bulge of the landslide area approximately 15 to 20 m into the treed area at the base of the slope.
