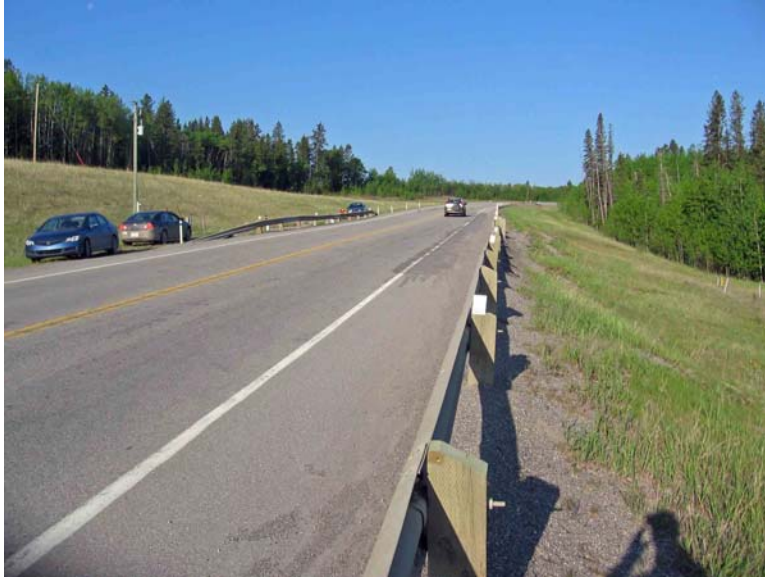
**Photo S2-1 – June 2009**

Facing westbound across the S2-Priddis site. The settlement and cracking along the north/downslope edge of the highway has been repaved since the 2008 inspection, however the some cracking appears to be re-forming again.

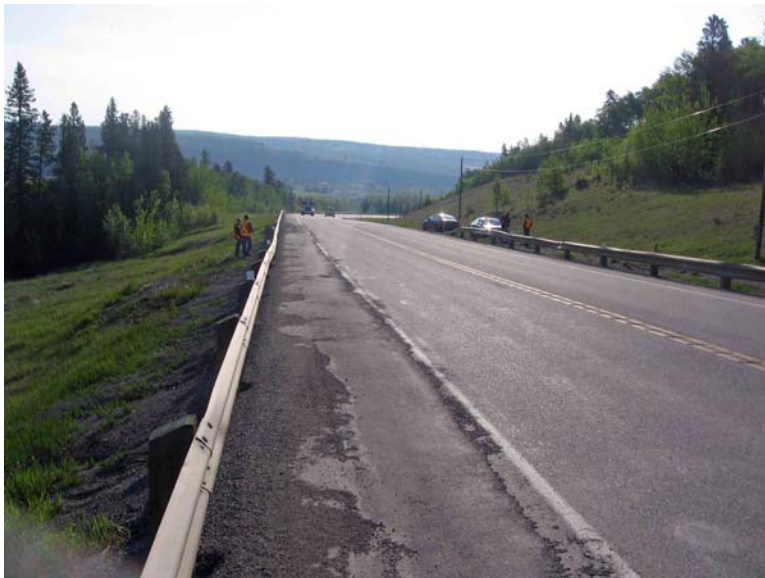
**Photo S2-2 – June 2009**

Facing eastbound across the S2-Priddis site. The settlement and cracking along the north/downslope edge of the highway is visible as is the vertical deflection of the guardrail.

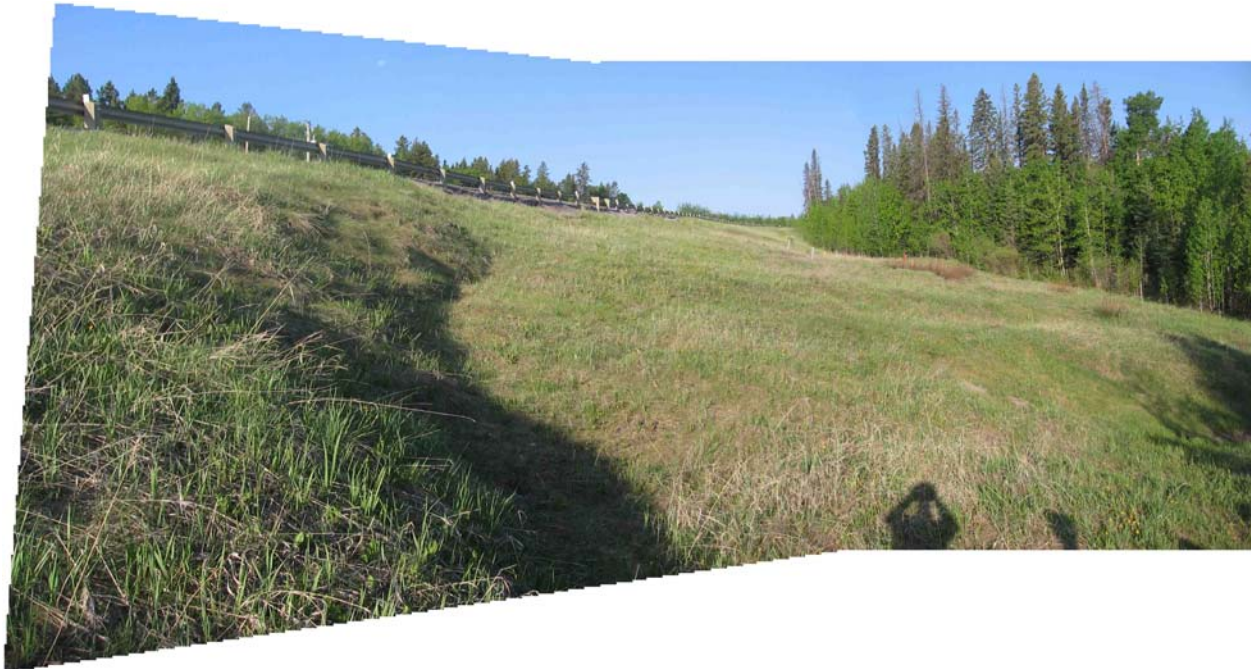
**Photo S2-3 (top) – June 2009**

Facing westbound from the east flank of the slide. No significant changes from the 2008 inspection.

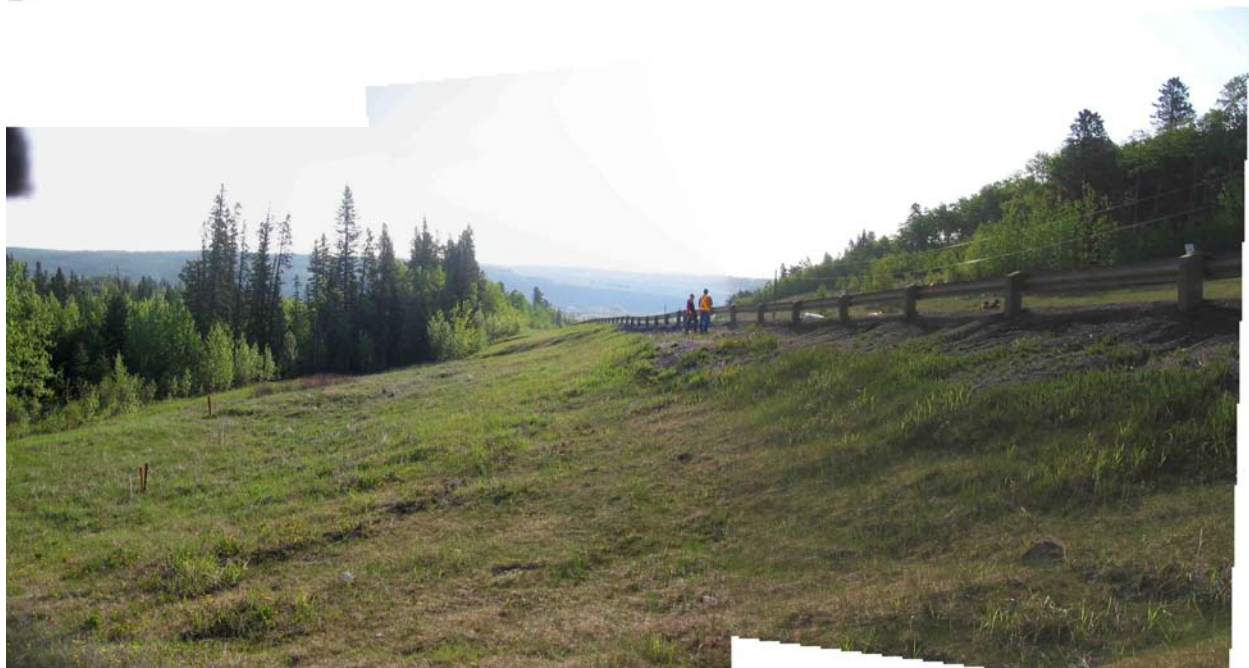
**Photo S2-4 (bottom) – June 2009**

Facing eastbound from the west flank of the slide. No significant changes from the 2008 inspection.

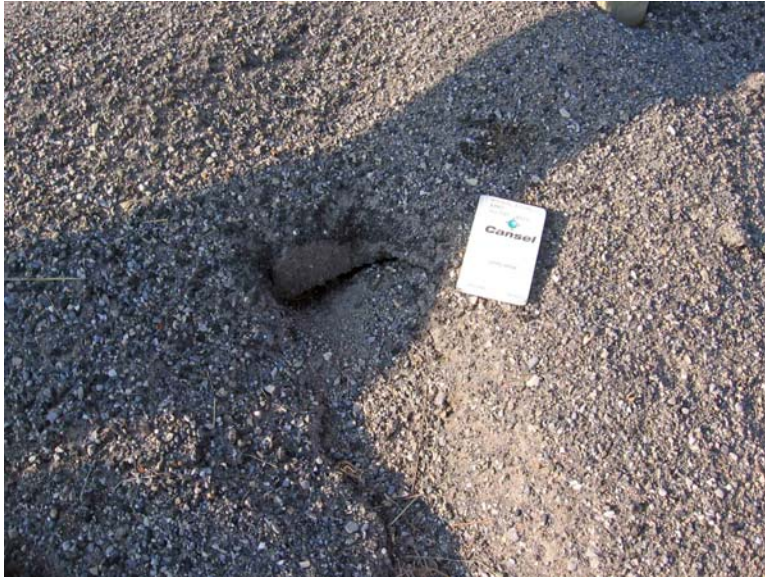
**Photo S2-5 – June 2009**  
An erosion gully that has formed beneath the guardrail and runs towards the downslope. The upslope extent has revealed a pile or other retaining structure.
