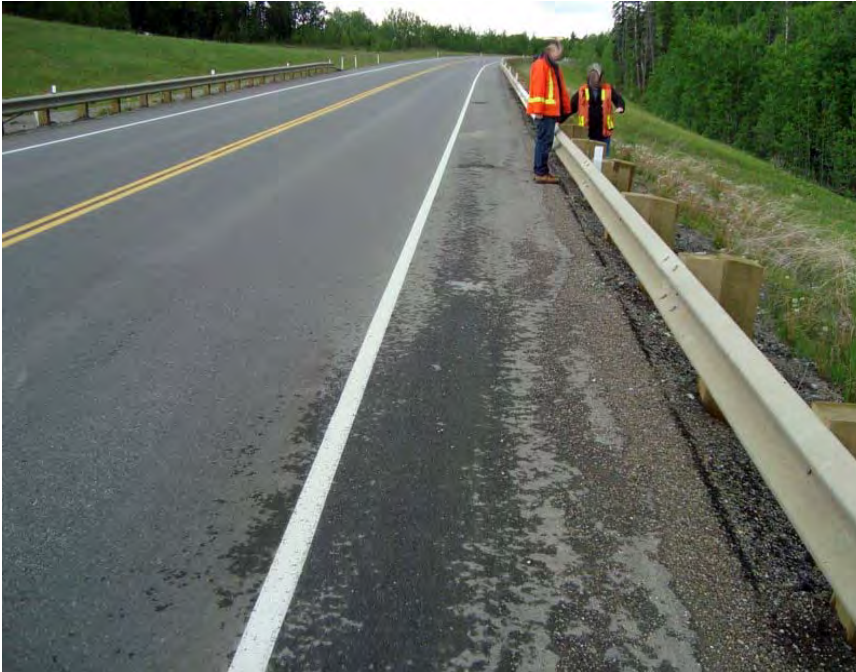
Photo S2-1 (June 2012)
– Facing westbound along the downslope edge of the road along the pile wall area. The highway surface here has been recently paved and the guard rail replaced.

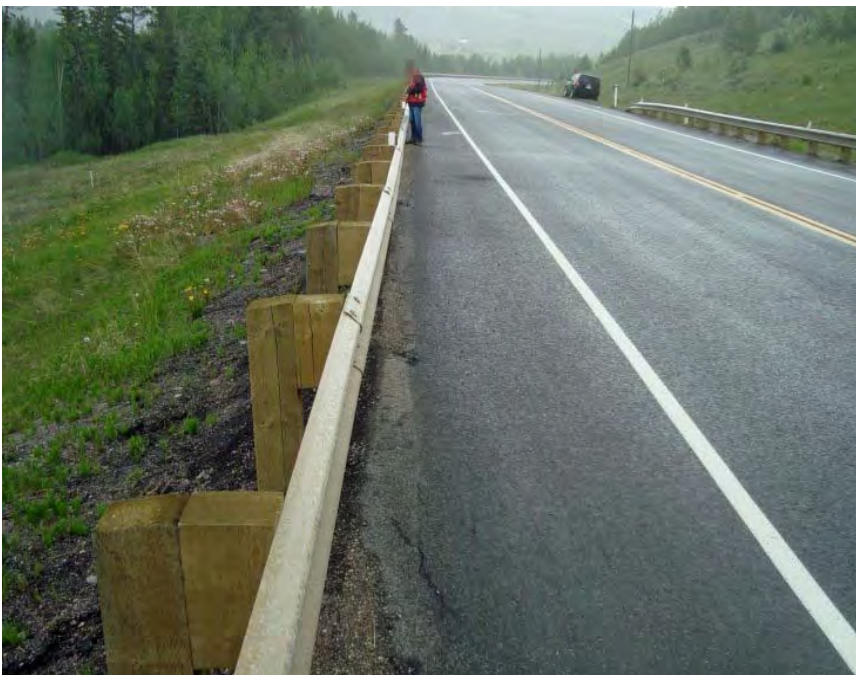
Photo S2-2 (June 2012) – Facing eastbound along the pile wall area. Minor cracking is visible on the shoulder edge of the recent overlay.

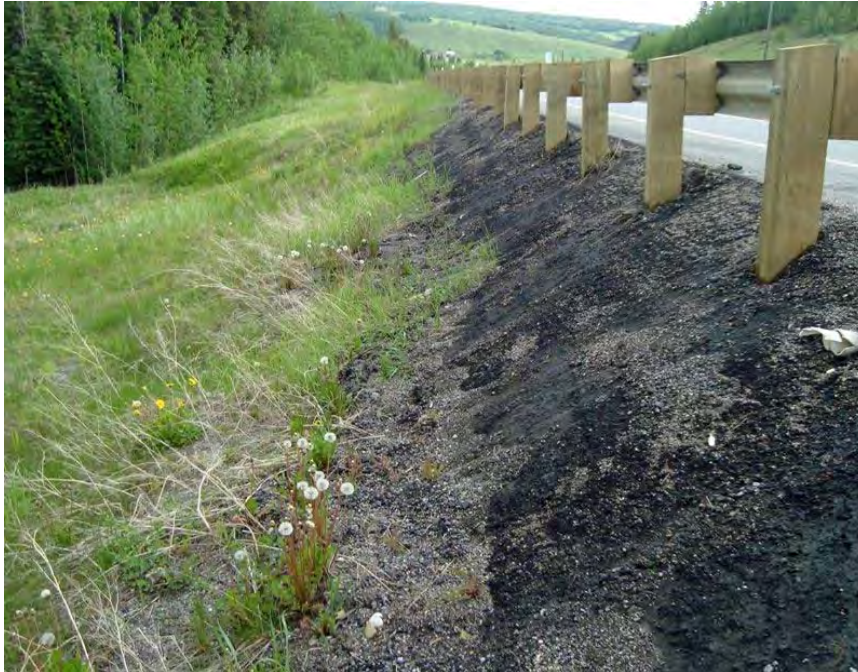
Photo S2-3 (June 2012) –
Facing eastbound along
the downslope shoulder of
the highway from the west
end of the landslide area.

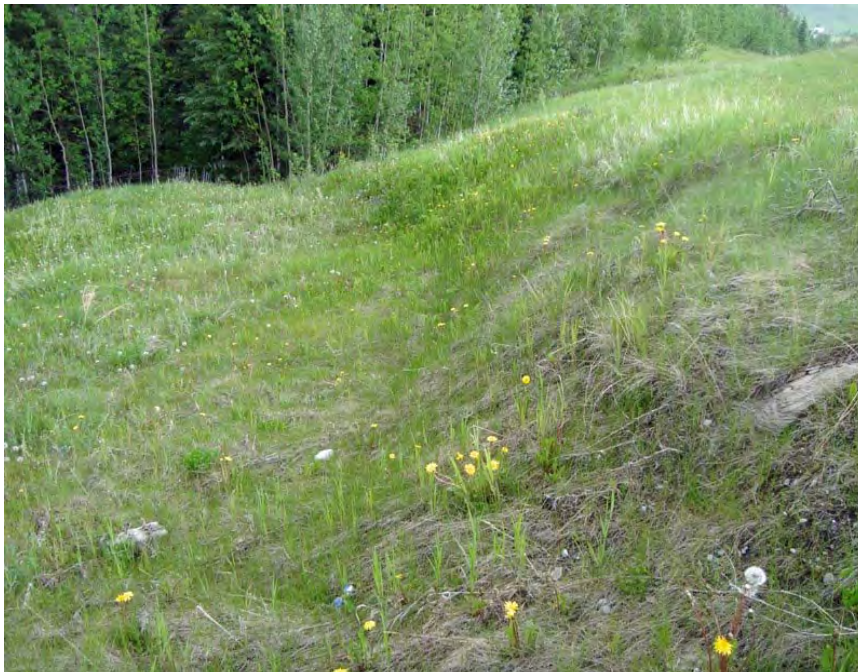
Photo S2-4 (June 2012) –
Facing eastbound at the
slope below the highway in
the landslide area. The
slope appears to be in
similar condition as was
observed in 2011.
