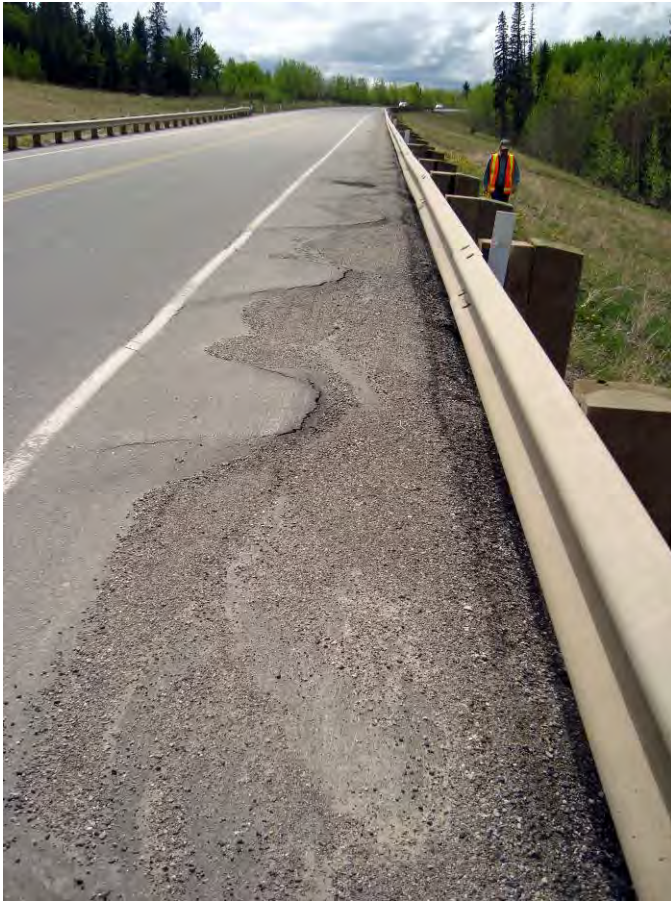
**Photo S2-1 (May 2013)** – Facing westbound along the downslope edge of the road along the pile wall area. Cracks in the asphalt had formed through the 2013 overlay between the guardrail and white line.

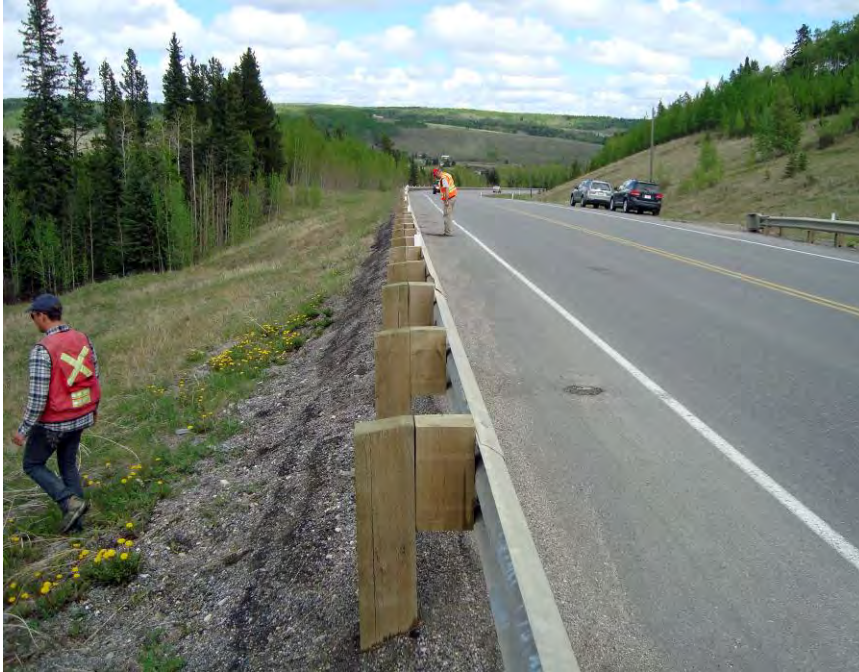
**Photo S2-2 (May 2013) –**  
Facing eastbound along  
the pile wall area.

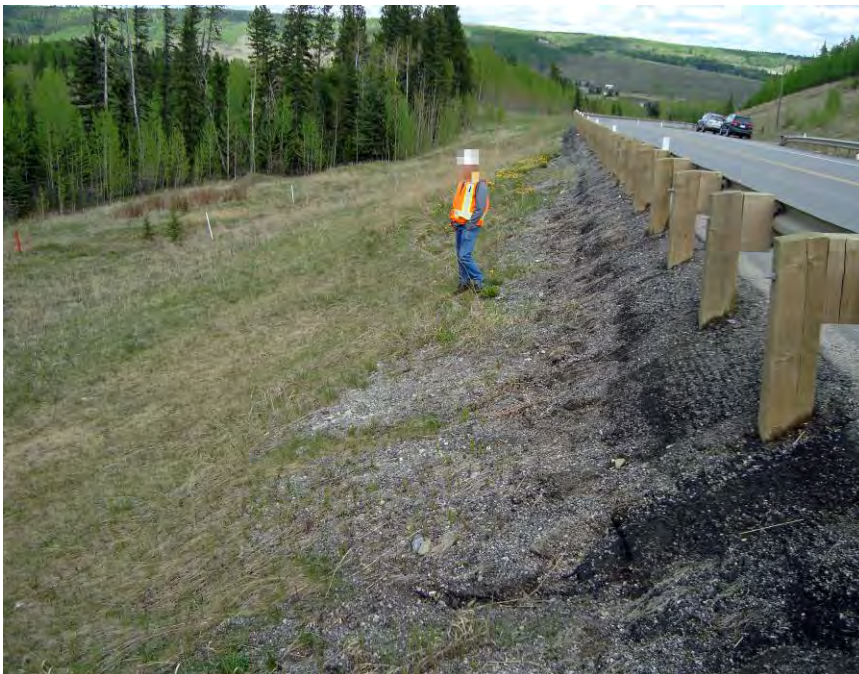
**Photo S2-3 (May 2013) –**  
Facing eastbound along  
the downslope shoulder of  
the highway from the west  
end of the landslide area.

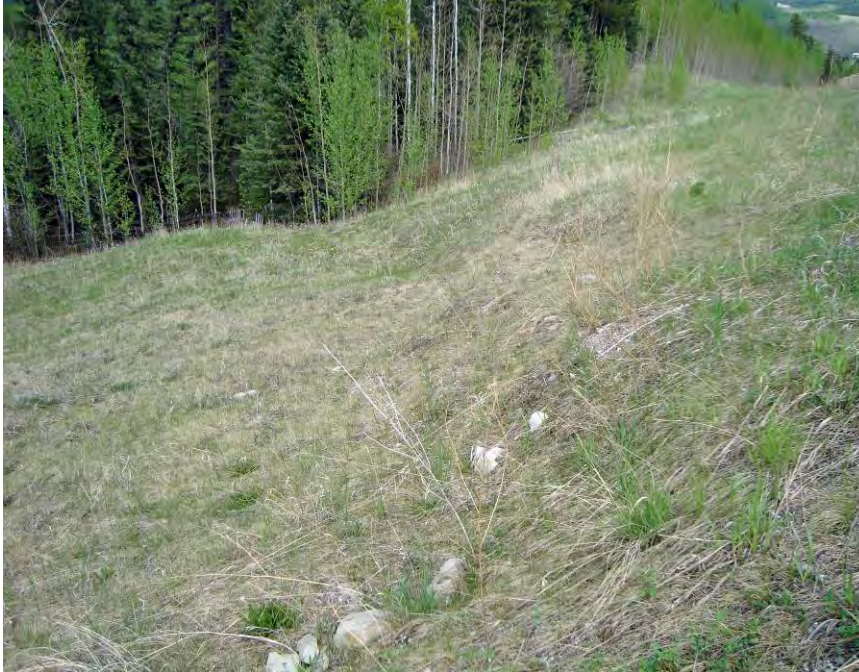
**Photo S2-4 (May 2013) –** Facing eastbound at the slope below the highway in the landslide area. The slope appears to be in similar condition as was observed in 2012.
