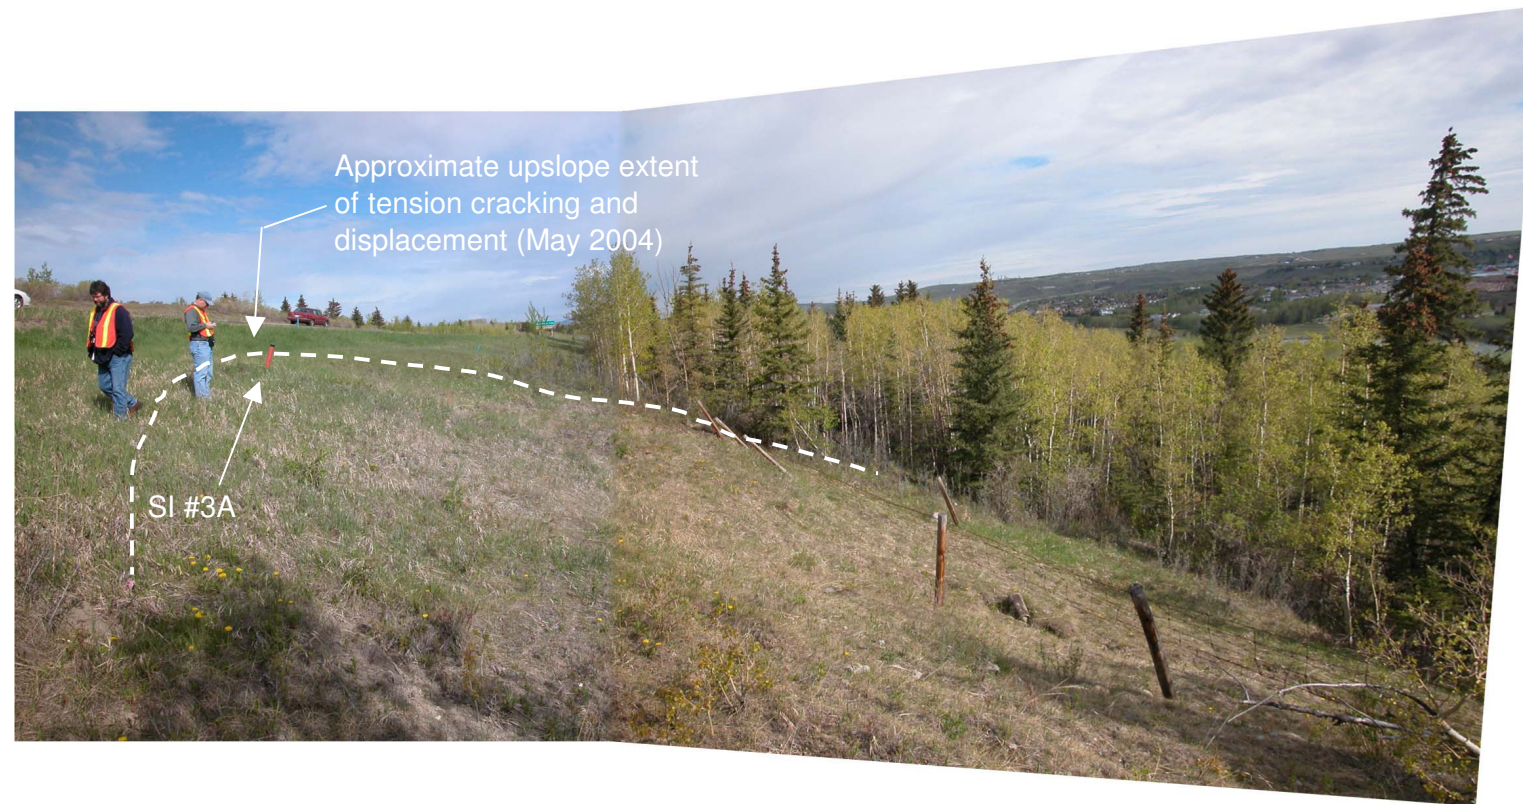
Photo S3-1 (upper left) – May 2004 – facing west across the S3 – Cochrane site. The downslope shoulder of Highway 22 is visible in the upper left portion of the photo. The fenceline has been displaced and stretched tight as a result of ongoing, shallow slope movement around and downslope of the fenceline. The slope condition does not appear to have changed significantly since the July 2003 inspection, however the scarp of the shallow instability appears to have retrogressed a few metres upslope since July 2003. Tension cracking now extends to approximately 1 m upslope of SI #3.

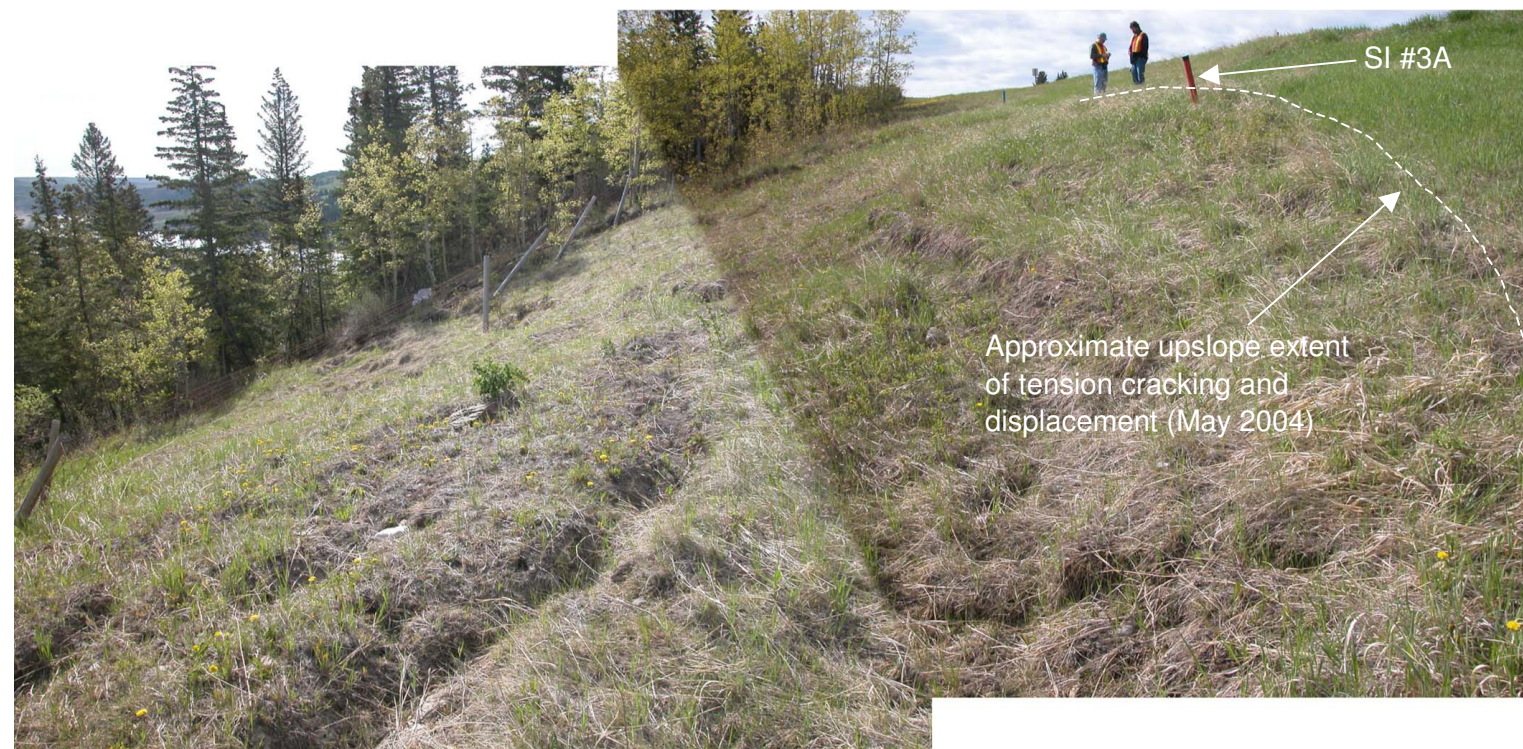
Photo S3-2 (lower left) – May 2004 – closer view of the shallow instability extending above the fenceline, downslope of SI #3A. It appears that the upslope extent of the tension cracking associated with this instability has retrogressed to just upslope of SI #3A since the July 2003 inspection. Note that downslope movement was previously measured in SI #3A until it sheared off at 4 m depth in the spring of 1997.

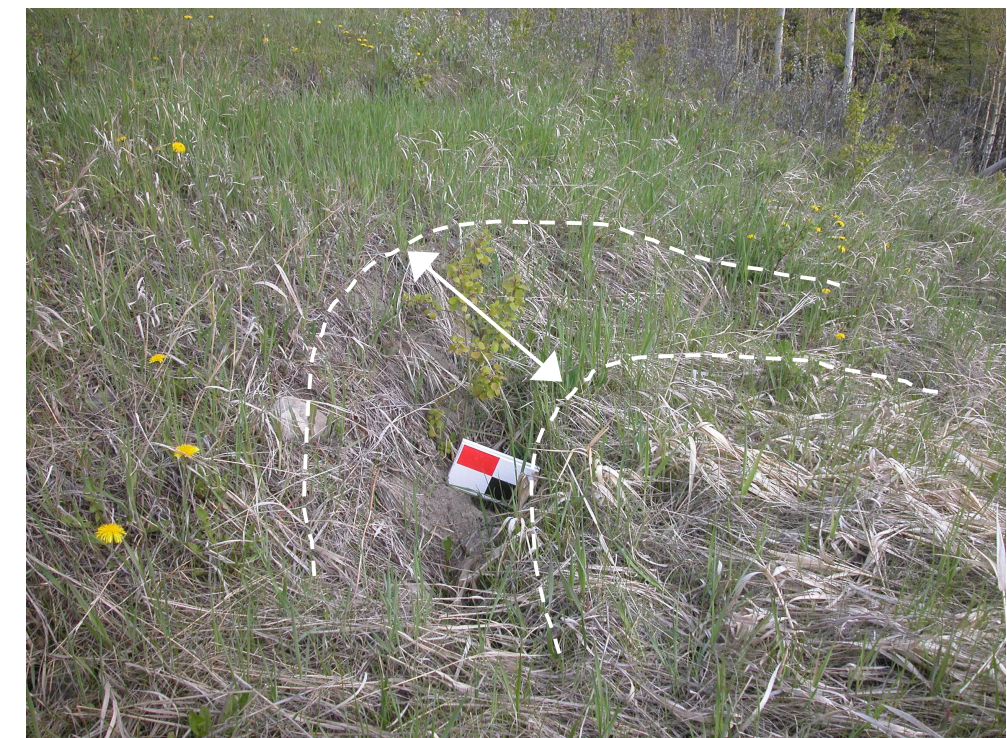
Photo S3-3 (lower right) – May 2004 – closer view of the tension cracking on the west flank of the shallow instability shown in Photos S3-1 and S3-2 with field notebook for scale.

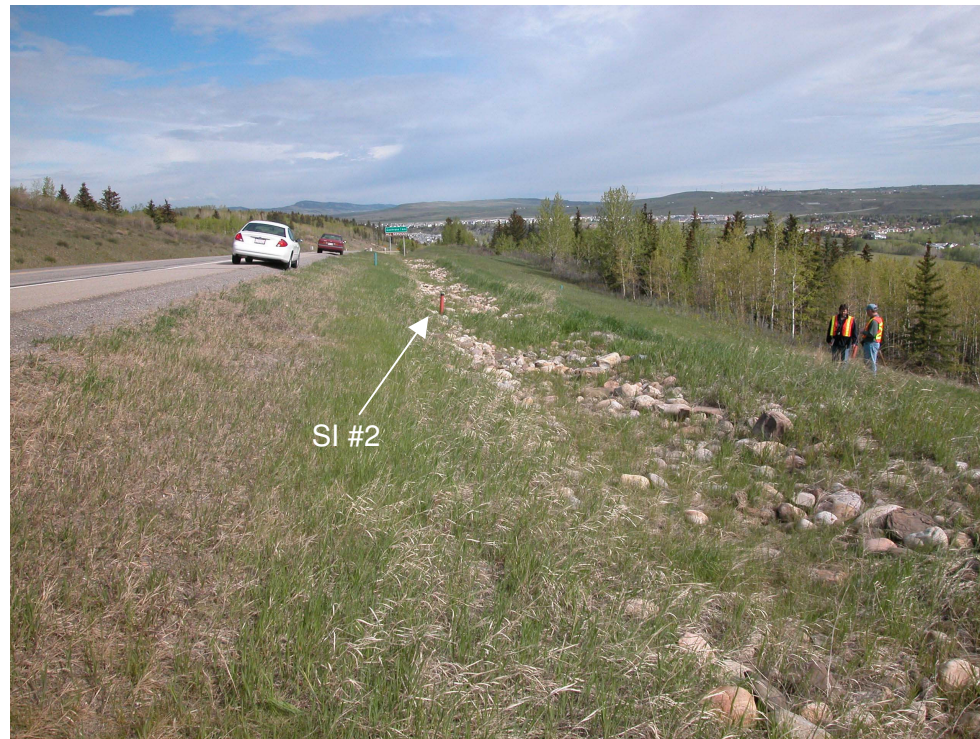
Photo S3-4 (upper left) – May 2004 – facing west along the north shoulder of the highway at S3 – Cochrane. The ditch appears to be functioning well although the low area in the downslope berm between SI #2 and SI #5 noted in previous inspections should be repaired to restore the overall ditch gradient and capacity and convey surface runoff away from this site.

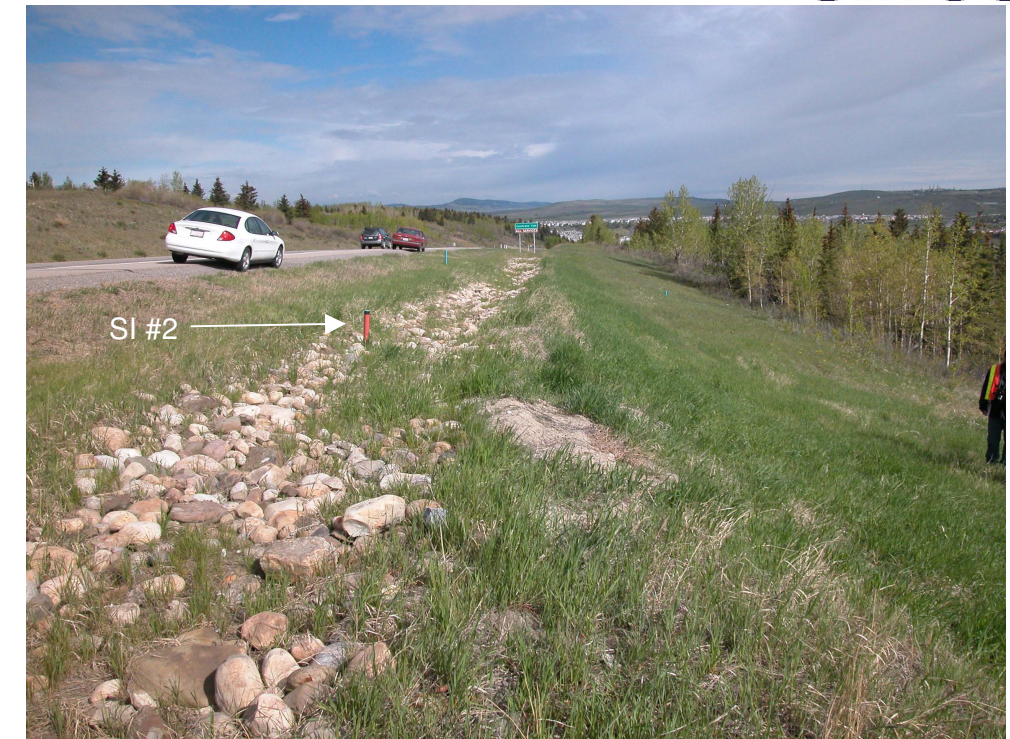
Photo S3-5 (upper right) – May 2004 – closer view of the ditch along the north shoulder of the highway around SI #2. The low areas in the berm along the downslope side of the ditch could potentially be overtopped by peak runoff and result in surface runoff further destabilizing the area around and downslope of SI #3. It is recommended that the berm be repaired.

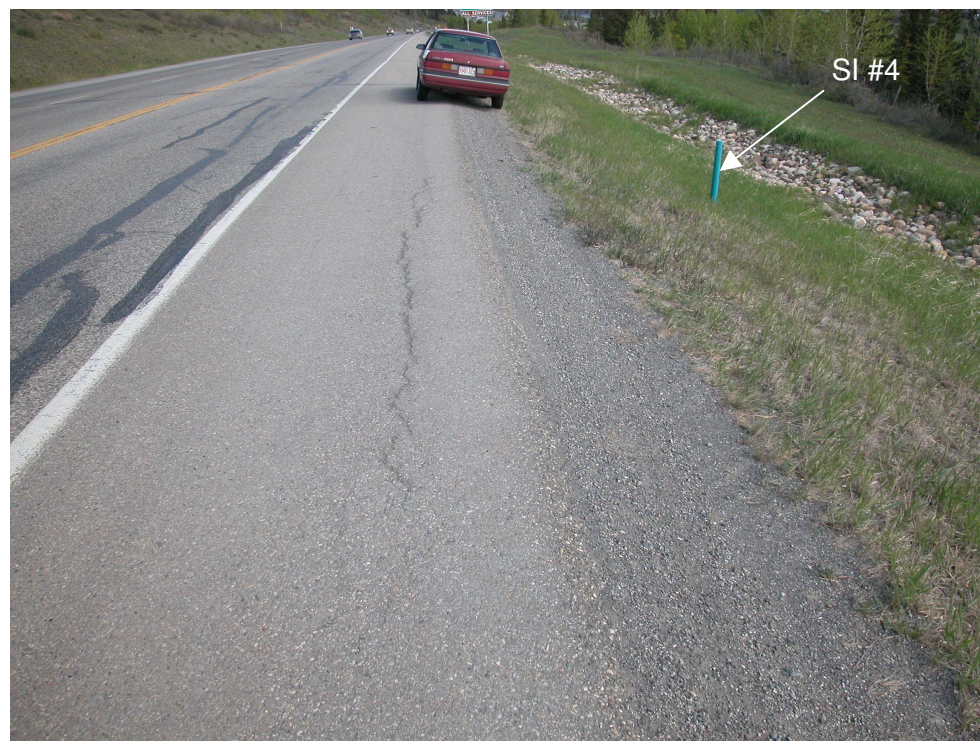
Photo S3-6 (lower left) – May 2004 – crack in the road near SI #4 – no significant change since the July 2003 inspection.

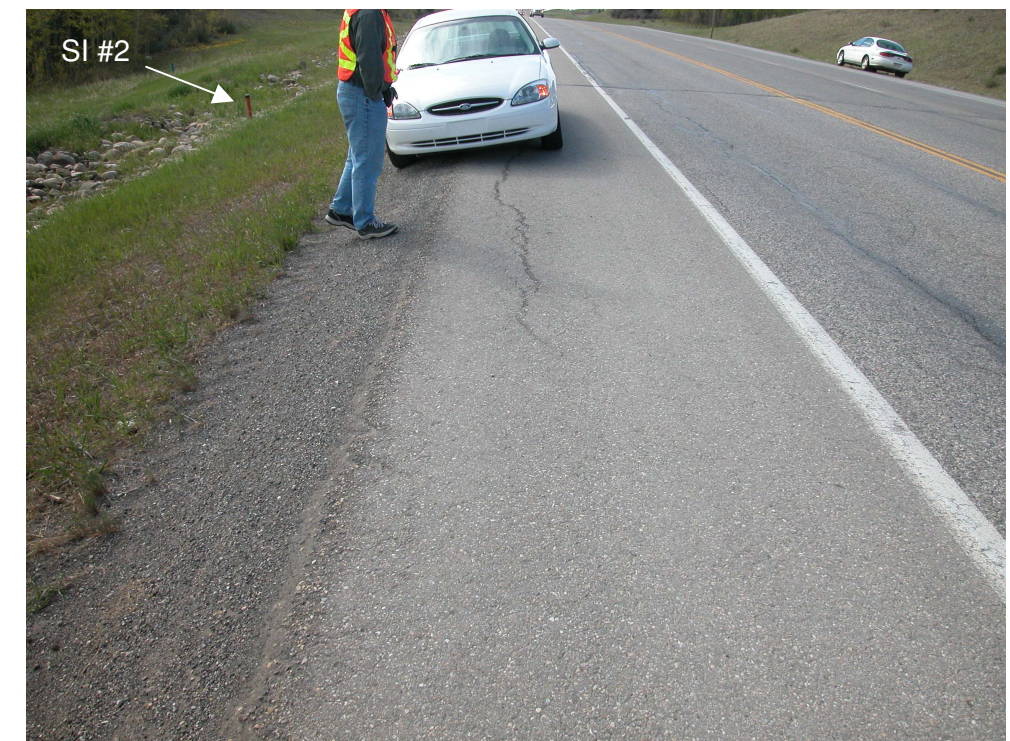
Photo S3-7 (lower right) – May 2004 – crack in the road near SI #2 – no significant change since the July 2003 inspection.
