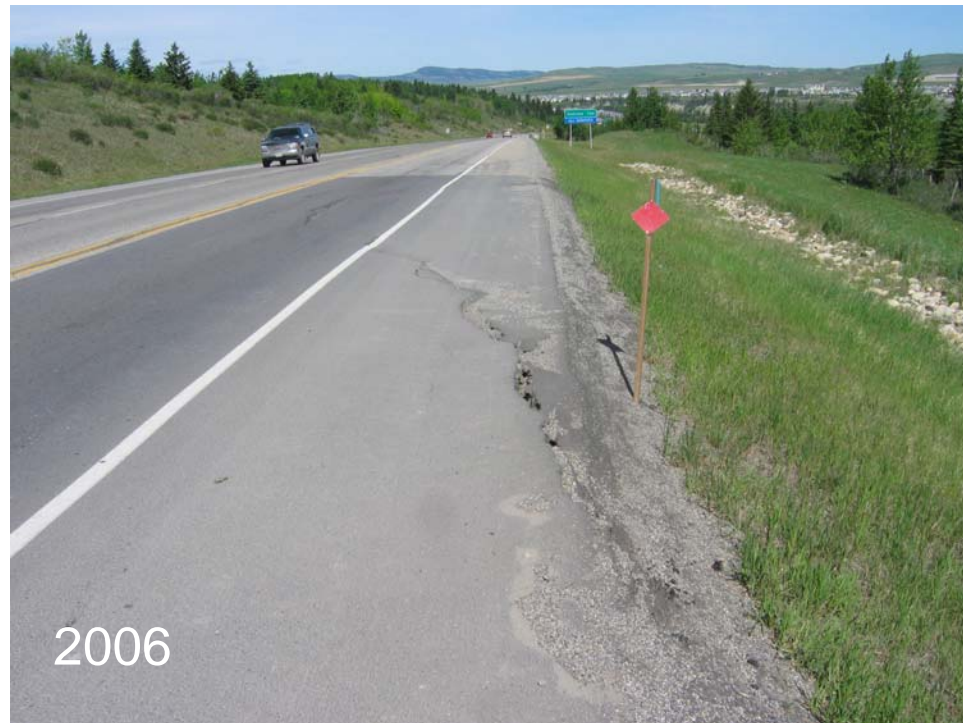
Photo S3-1 (upper left) – June 2006 – facing west along the road. Large cracks in the shoulder redeveloped after being repaired in the summer of 2005.

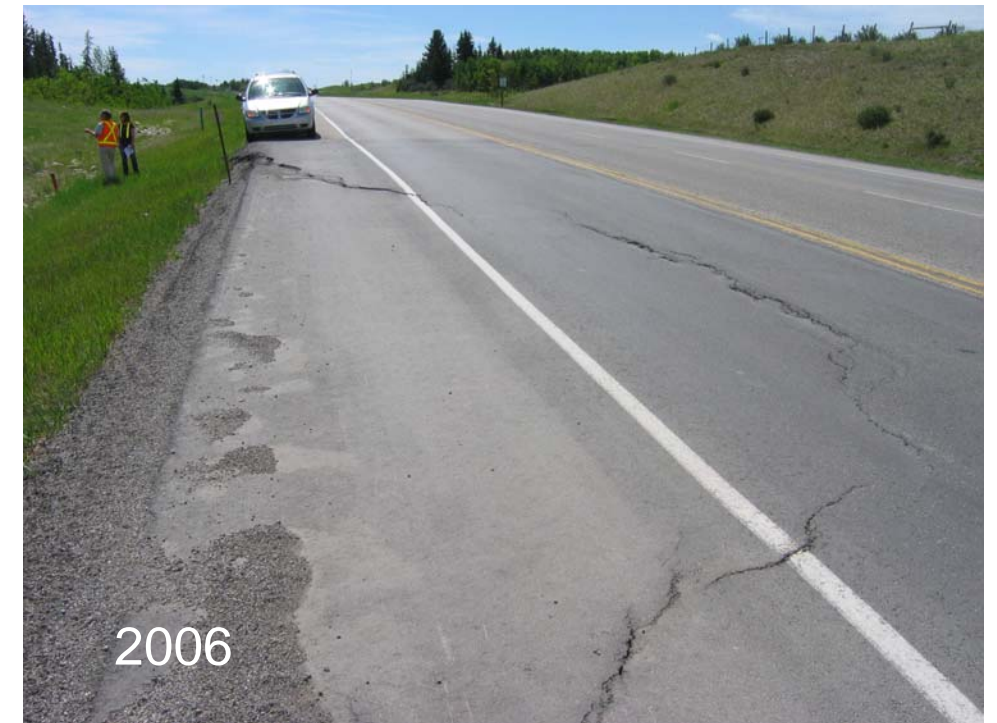
Photo S3-2 (upper right) – June 2006 – facing east along the road with semi-circular cracking visible in the westbound shoulder and lane. The pattern of cracking suggests a slump failure down towards the north (left). A similar cracking pattern was noted prior to 2005, however the magnitude of cracking has been greater from 2005 onwards. Compare with Photo S3-3 which shows the cracking as it appeared in 2005.

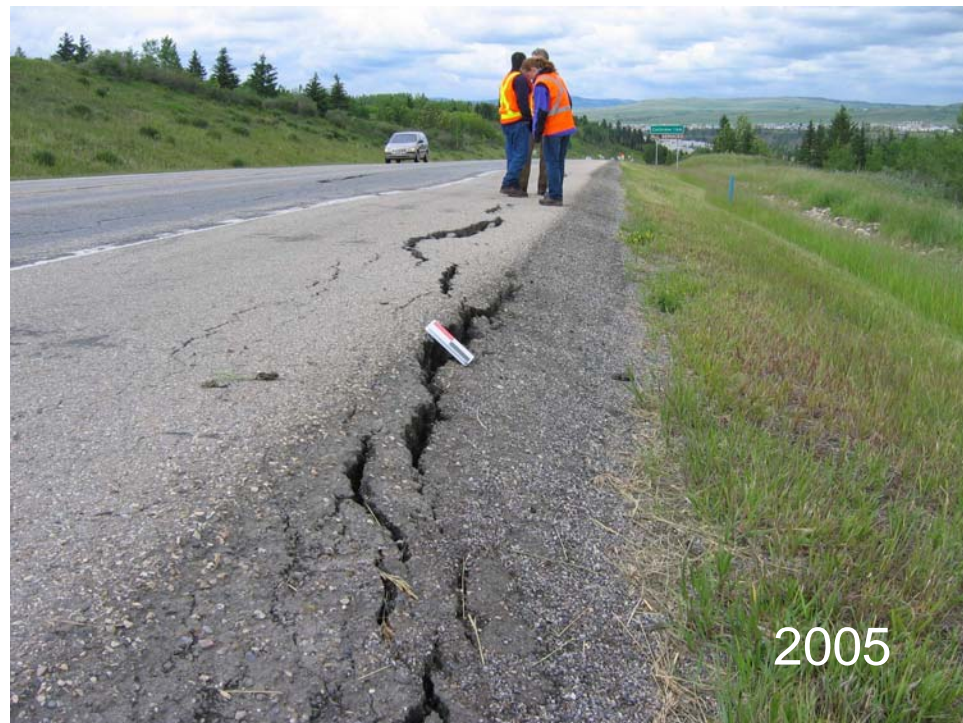
Photo S3-3 (lower left) – June 2005 – facing west along the road. Large cracks in the shoulder developed between the time May 2005 instrument readings and the late June 2005 annual site inspection.

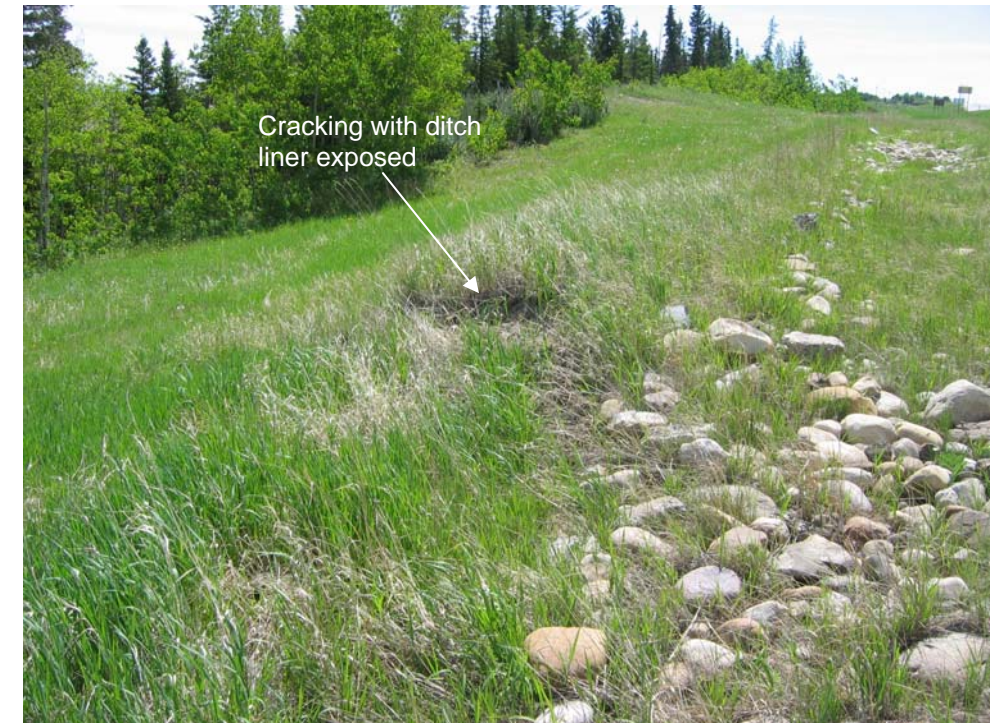
Photo S3-4 (lower right) – June 2006 – cracking along northern edge of ditch with the liner exposed. This is the first time that this cracking has been observed. The location and orientation of this cracking suggests that it is the eastern flank of the semi-circular cracking visible in the road surface (Photos S3-1 and S3-2).

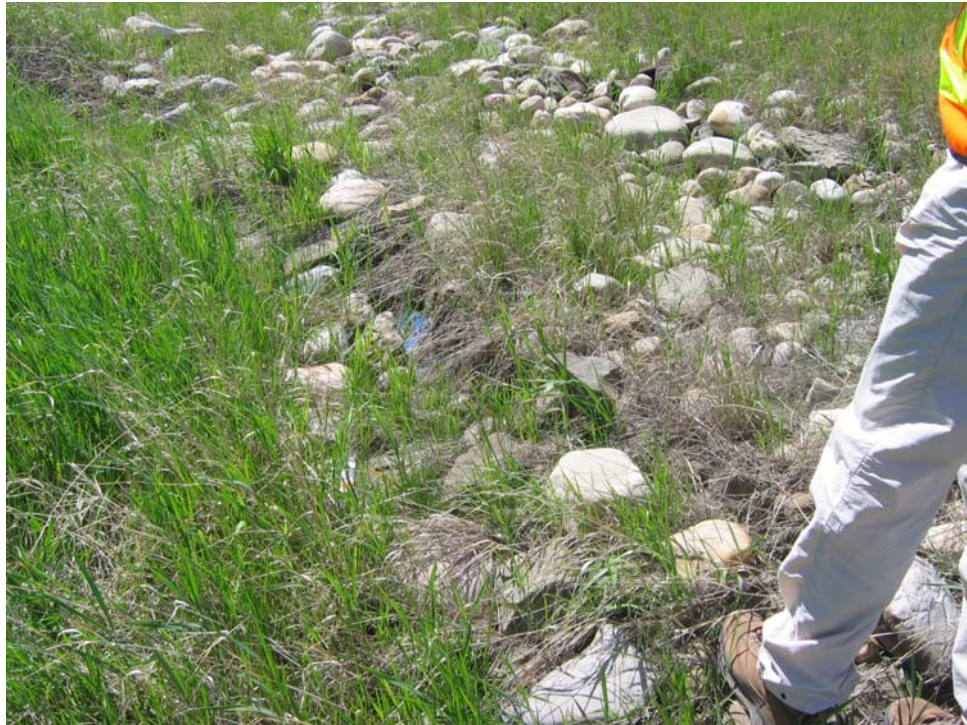
Photo S3-5 (upper left) – June 2006 – closer view of the cracking shown in Photo S3-4.

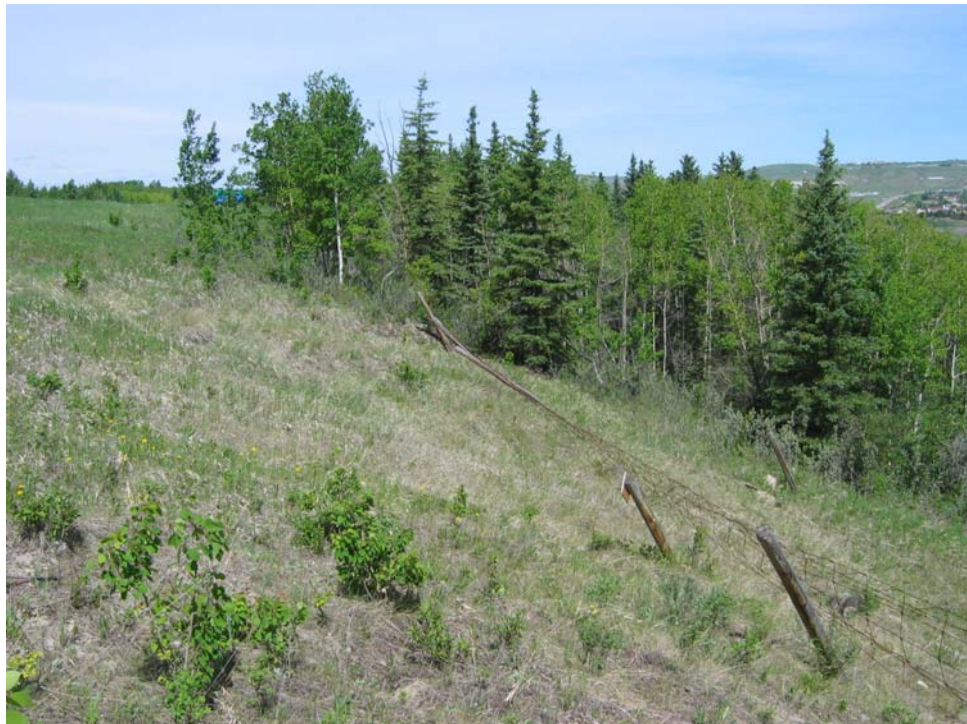
Photo S3-6 (lower left) – June 2006 – Facing across the S3 – Cochrane site. The fence line has been displaced and stretched tight as a result of ongoing slope movement. The visible headscarp cracking of this slope movement is approximately 1 m upslope of SI#3A, which is located just off the left edge of the photo.

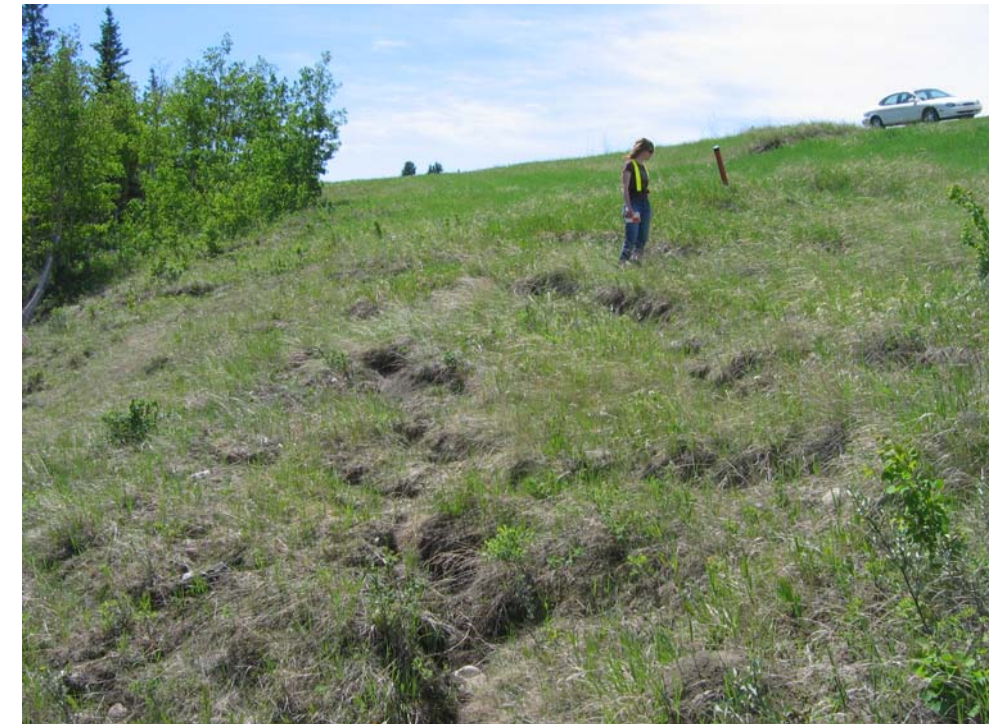
Photo S3-7 (lower right) – June 2006 – shallow sloughing on slope to the north of the road.
