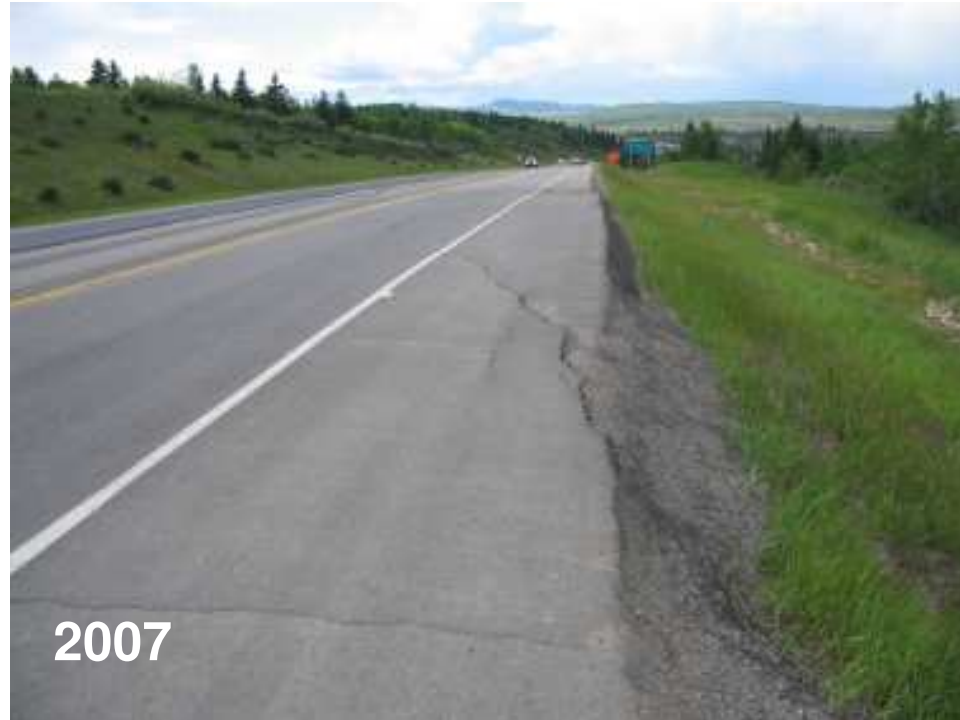
Photo S3-1 – June 2007 (upper left)
Facing west along the road with cracking and downdrop of the pavement along the shoulder and in the northbound lane visible. The pattern of the cracking appears to form a circular landslide headscarp that has retrogressed into the northbound lane of the highway.

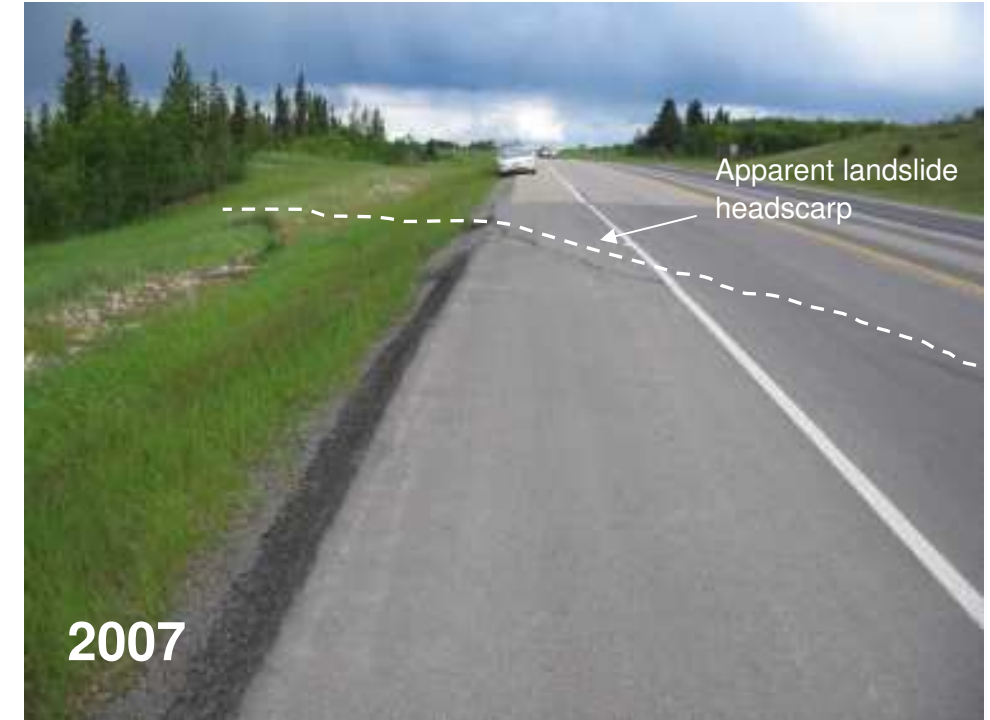
Photo S3-2 – June 2007 (upper right)
Facing east along the road with cracking and downdrop of the pavement along the shoulder and in the northbound lane visible. This damage has occurred since the 2006 overlay. Also note the visible landslide scarp across the ditch berm in the left background. This scarp appears to be an extension of the circular cracking pattern on the road and appears to form the south flank of an overall landslide headscarp. Compare this photo with Photo S3-3 showing the same area in 2006.

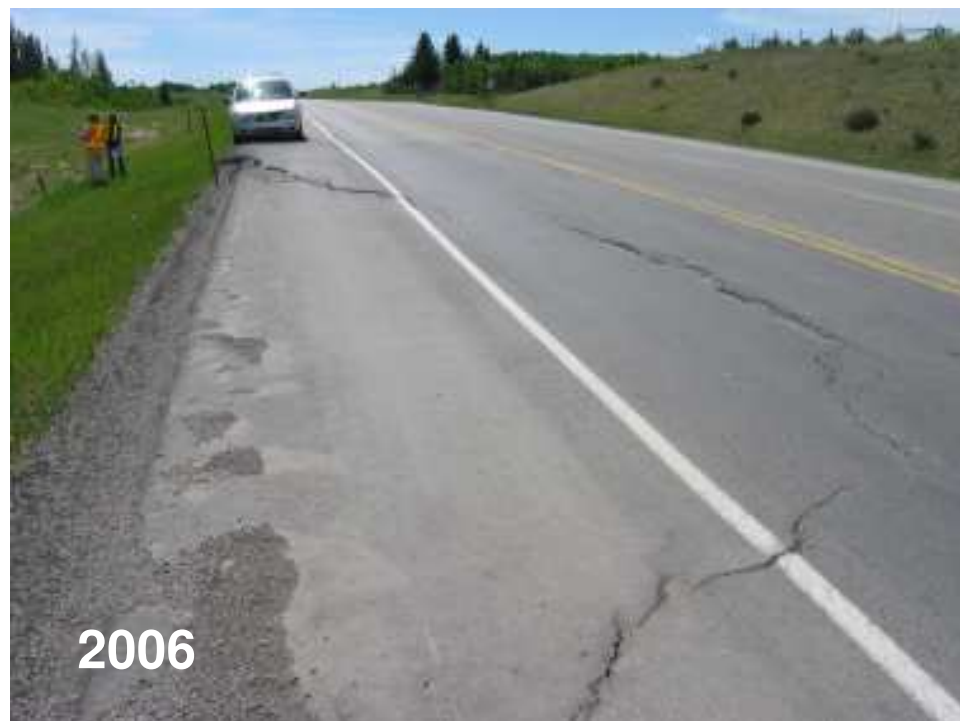
Photo S3-3 – June 2006 (lower left)
Cracking and downdrop of the road surface, as seen facing east along the road during the 2006 inspection. The damage to the road shown in this photo was subsequently patched/overlaid and re-formed to the condition shown in Photo S3-2 by June 2007.

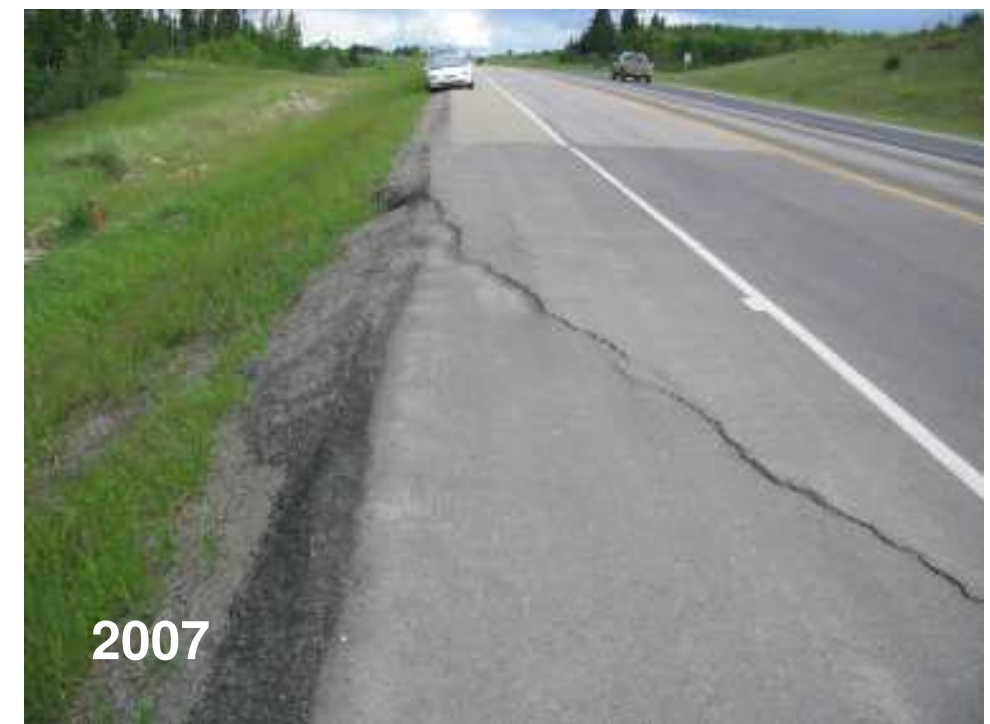
Photo S3-4 – June 2007 (lower right)
Closer view of the cracking and downdrop on the road surface and its position/pattern relative to the visible landslide scarp across the ditch berm in the left background.
