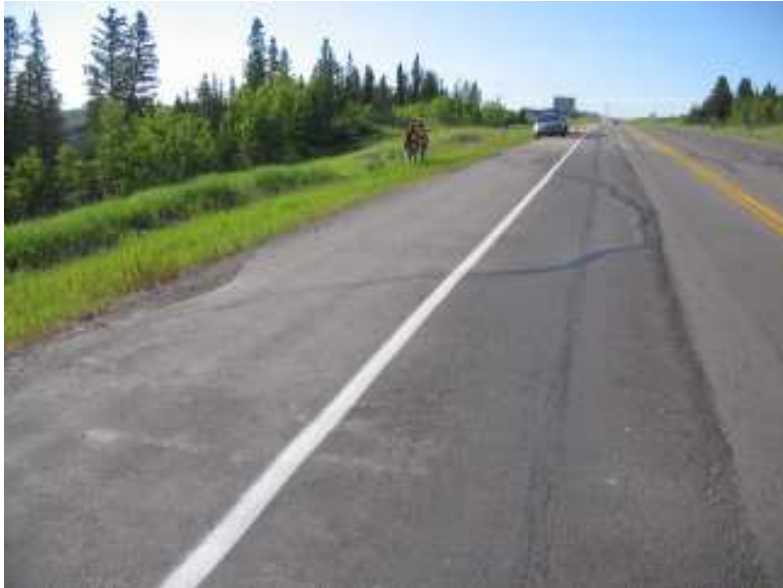
**Photo S3-1 – June 2008 (top)**  
Facing southeast across the site, with the apparent circular settlement/landslide headscarp visible encroaching into the northbound lane.

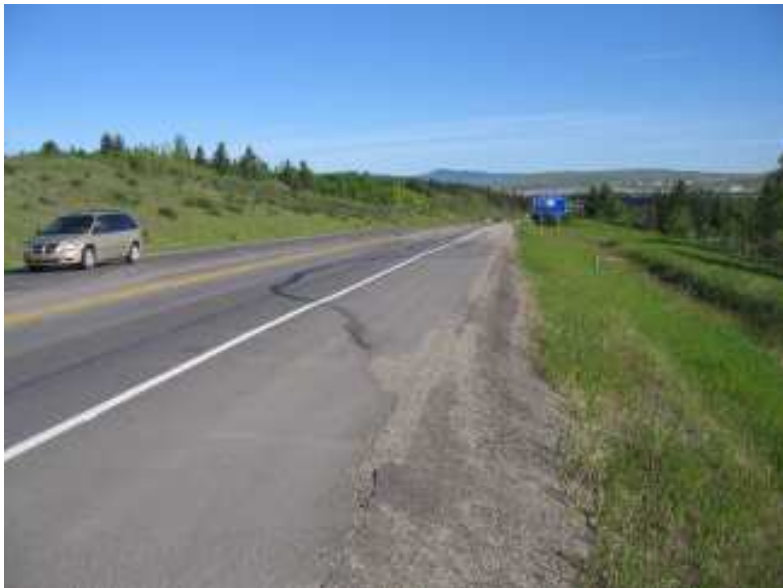
**Photo S3-2 – June 2008 (bottom)**  
Another view, facing northwest, of the settlement encroaching into the northbound lane.

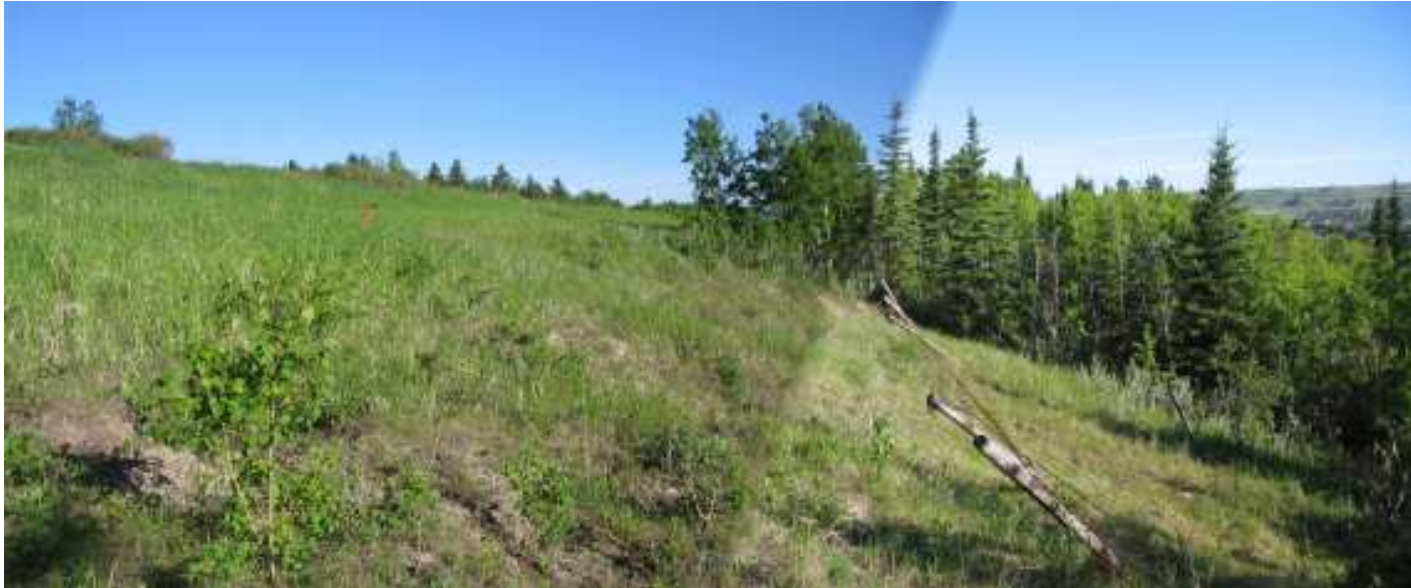
**Photo S3-3 – June 2008 (top)**

Facing northwest across the slumping visible in the slope below the highway. The red casing protector visible on the slope just above the uppermost open tension crack is SI #3A, which sheared off at 4 m depth in 1997. It is possible that active slumping in this area is leading to the settlement and cracking of the road surface as well as the apparent southeast flank of slumping visible across the ditch berm. SI 2007-1 that was installed just upslope of SI #3A has shown movement at approximately 3 m depth since installation in the spring of 2007, but this may indicate shallow sliding without a slump block forming or retrogressing upslope from the fenceline area.

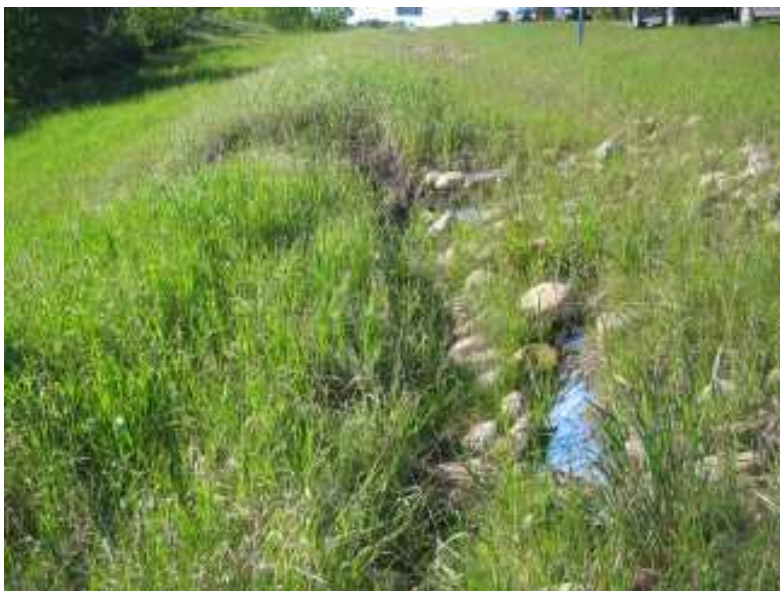
**Photo S3-4 – June 2008 (bottom)**

Apparent southeast flank of slumping that may connect to the circular headscarp visible across the northbound lane (see Photos S3-1 and S3-2). This flank cuts across the ditch berm and has exposed the ditch liner (blue geofabric visible in lower right of photo). This breach in the ditch berm allows water from within the ditch to flow directly into the slumping area below the highway.
