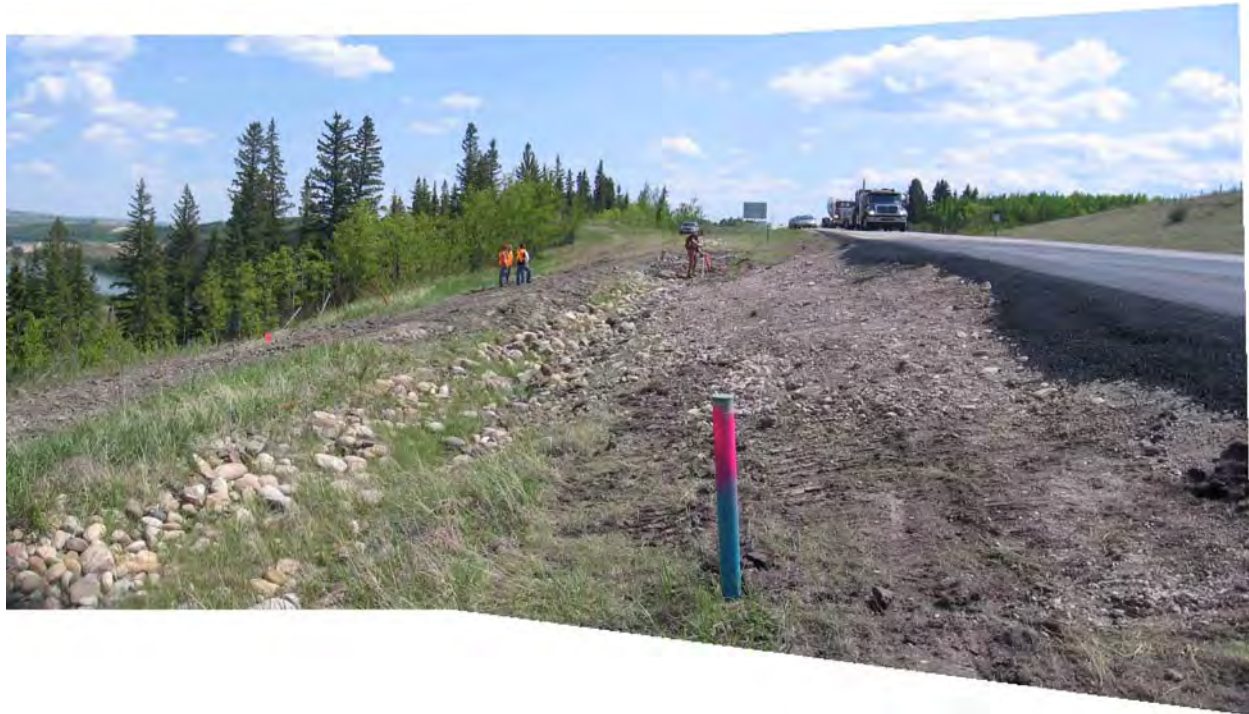
Photo S3-1 (top) – June 2009
Looking to the southeast with
the recent overlay and
repaired ditch visible and SI #4
in the foreground.

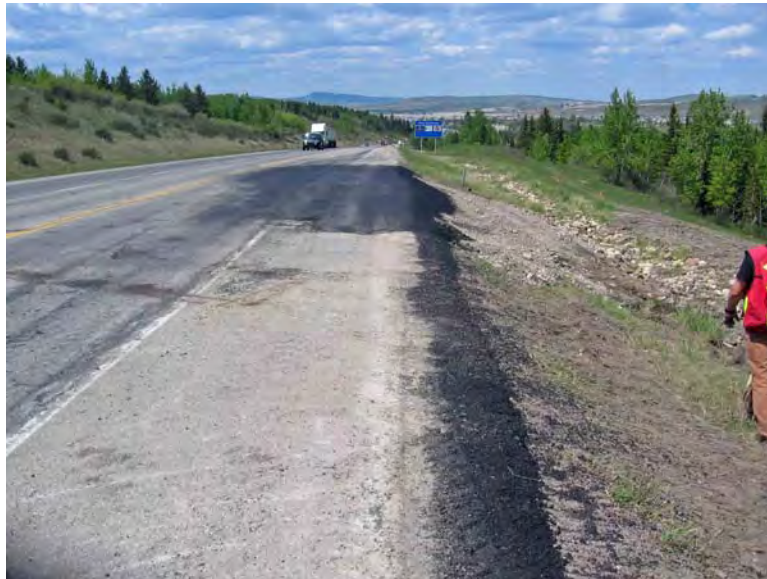
Photo S3-2 (left) – June 2009
Looking northwest towards the
recent overlay.

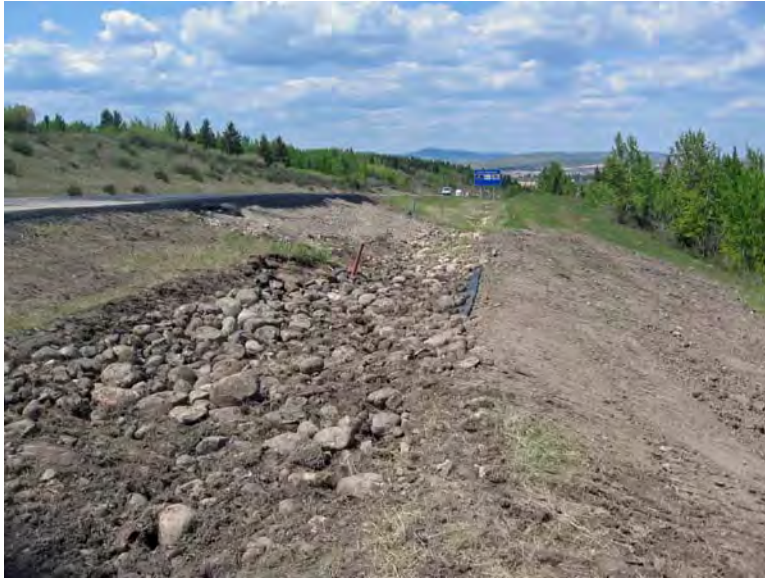
Photo S3-3 – June 2009
A closer view of the repaired ditch area. The 2008 inspection noted a scarp through the ditch berm that has been graded out by the recent repair. Vegetation needs to be established on the freshly graded fill.

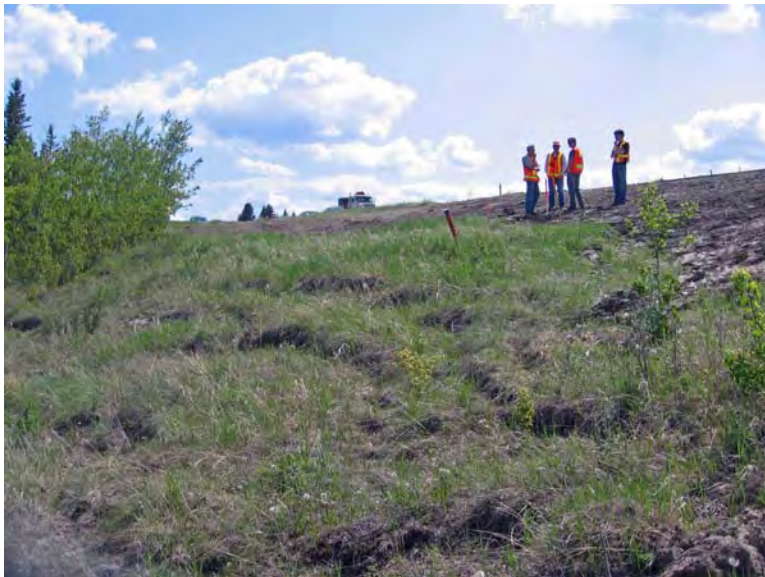
Photo S3-4 – June 2009
Looking towards the south with SI #5 visible. The small scarps appear to be in the same condition as was observed in 2008.

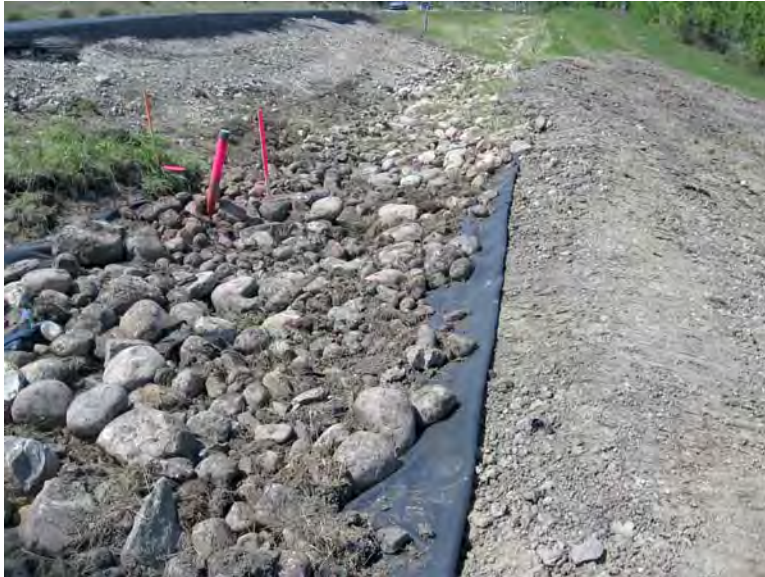
Photo S3-5 – June 2009
A close-up view of the ditch repair with the liner visible. SI #2 is painted on the upslope edge of the ditch.
