CG25132

Alberta Transportation
Southern Region Landslide Monitoring Program
Spring 2001 Assessment Report

Site S4 – Willow Creek

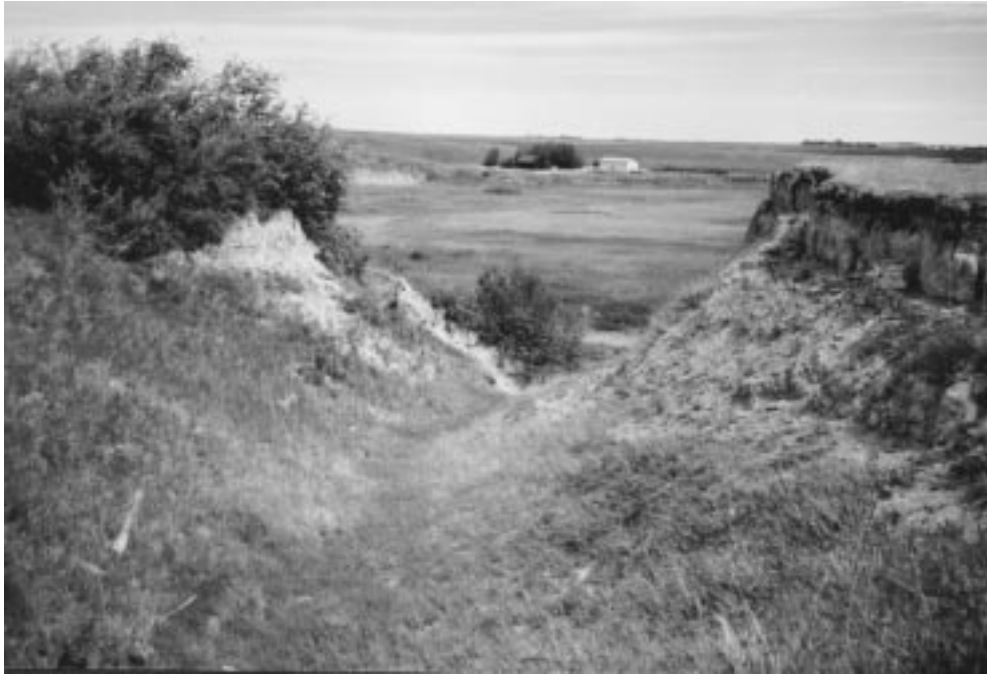
Photo 1 – Facing northeast down a gully in the southern portion of the slide area. May 2001 photo.

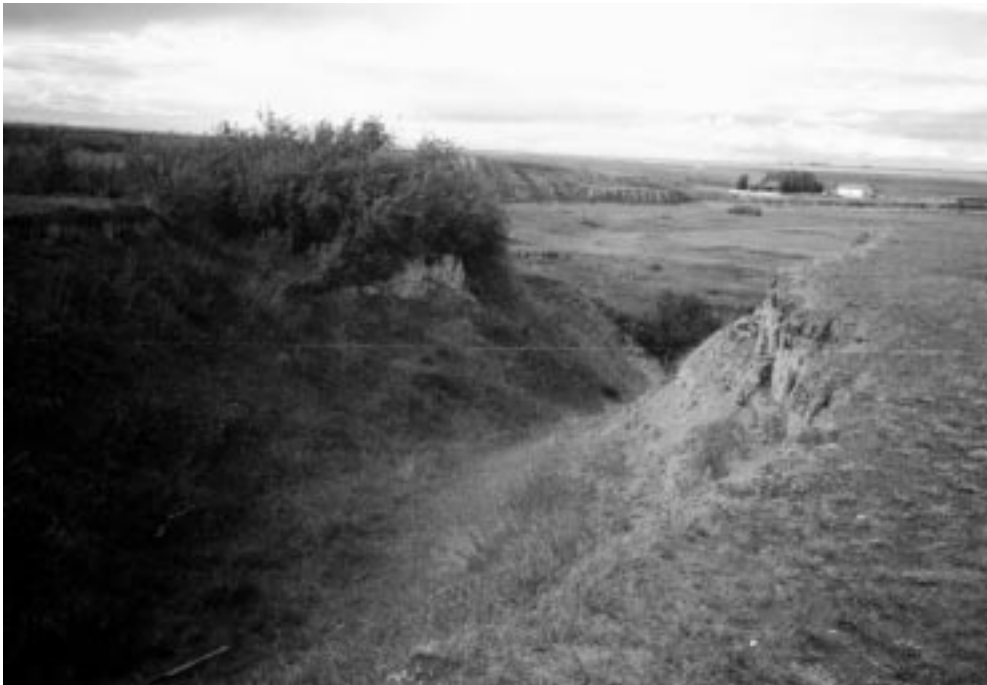
Photo 2 – Facing northeast down the same gully, June 2000 photo.

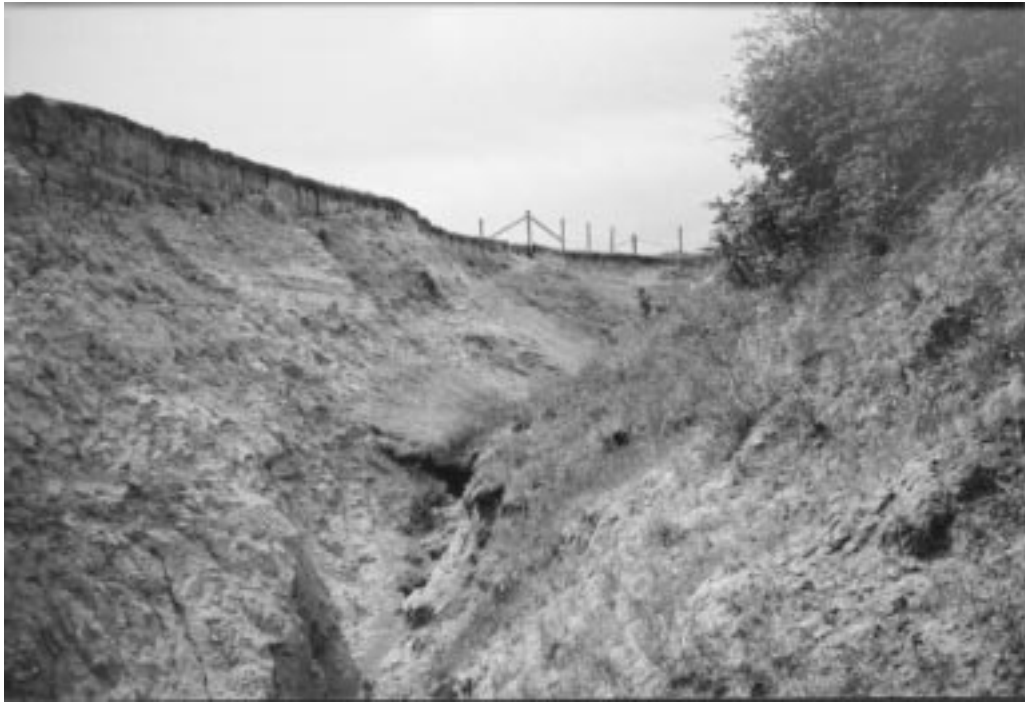
Photo 3 – Facing south up a gully in the southern portion of the slide area. May 2001 photo.

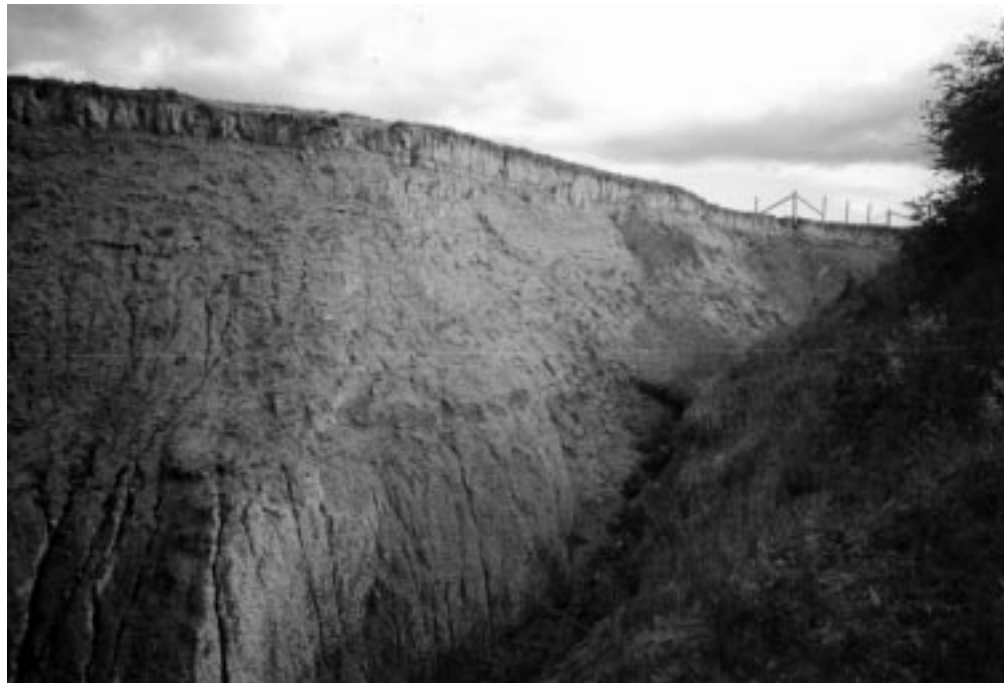
Photo 4 – Facing south up the same gully, June 2000 photo.

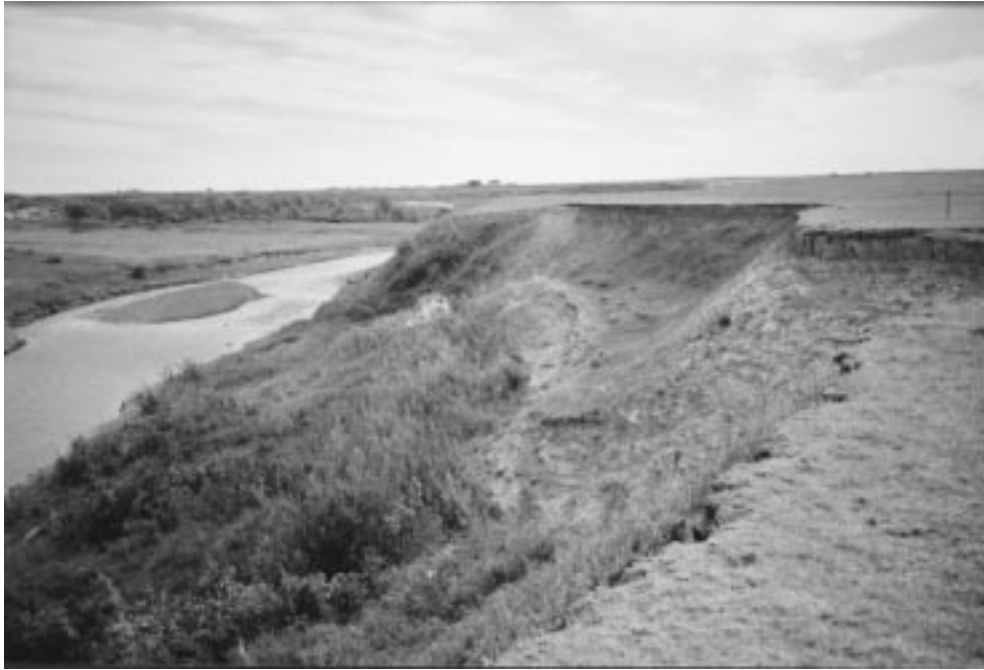
Photo 5 – Looking southeast across scarp and slide area.

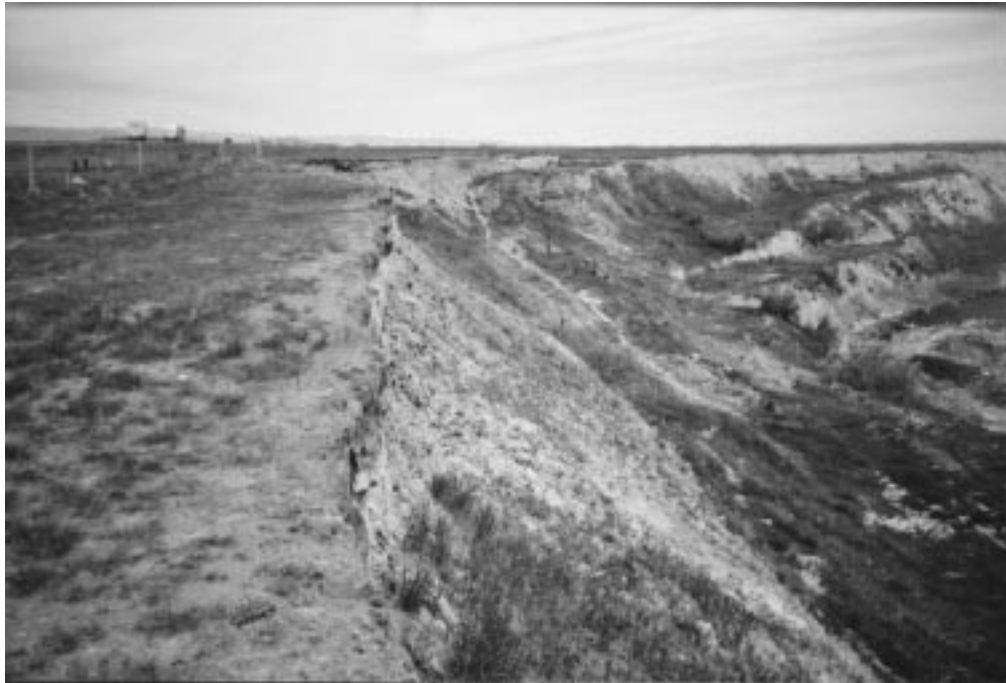
Photo 6 – Looking north across scarp and slide area.

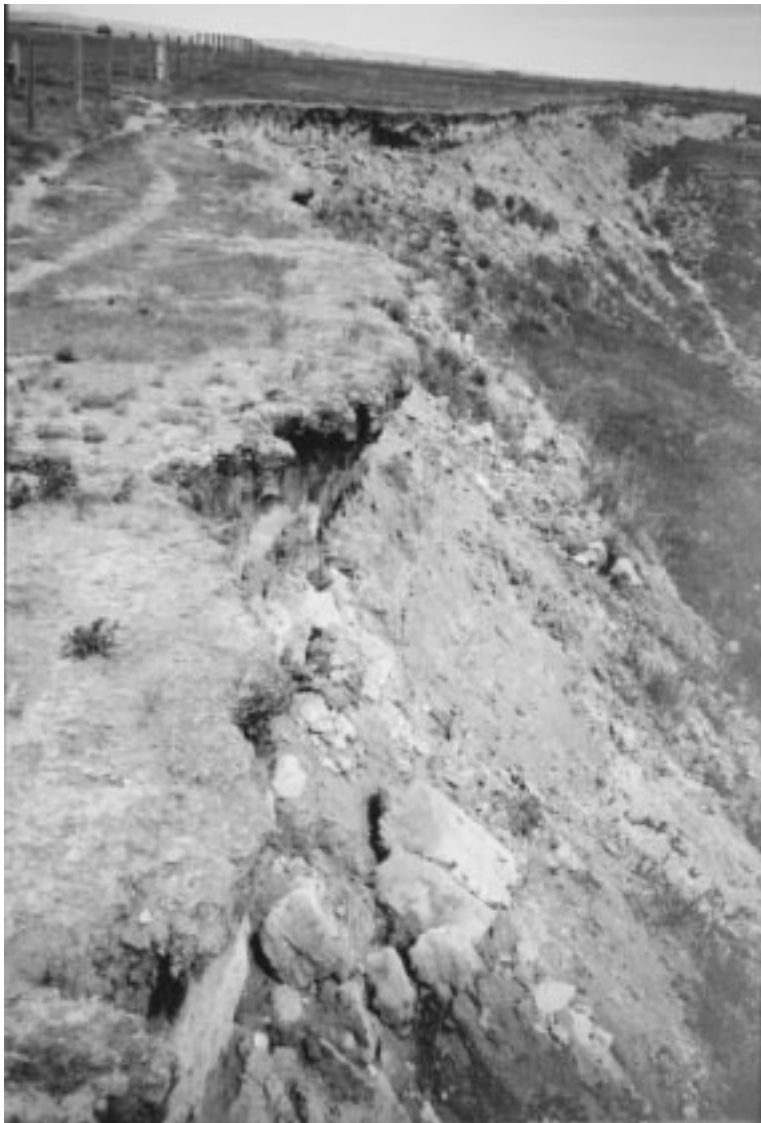
Photo 7 – Detail of scarp area showing ongoing oversteepening and toppling of portions of the crest.

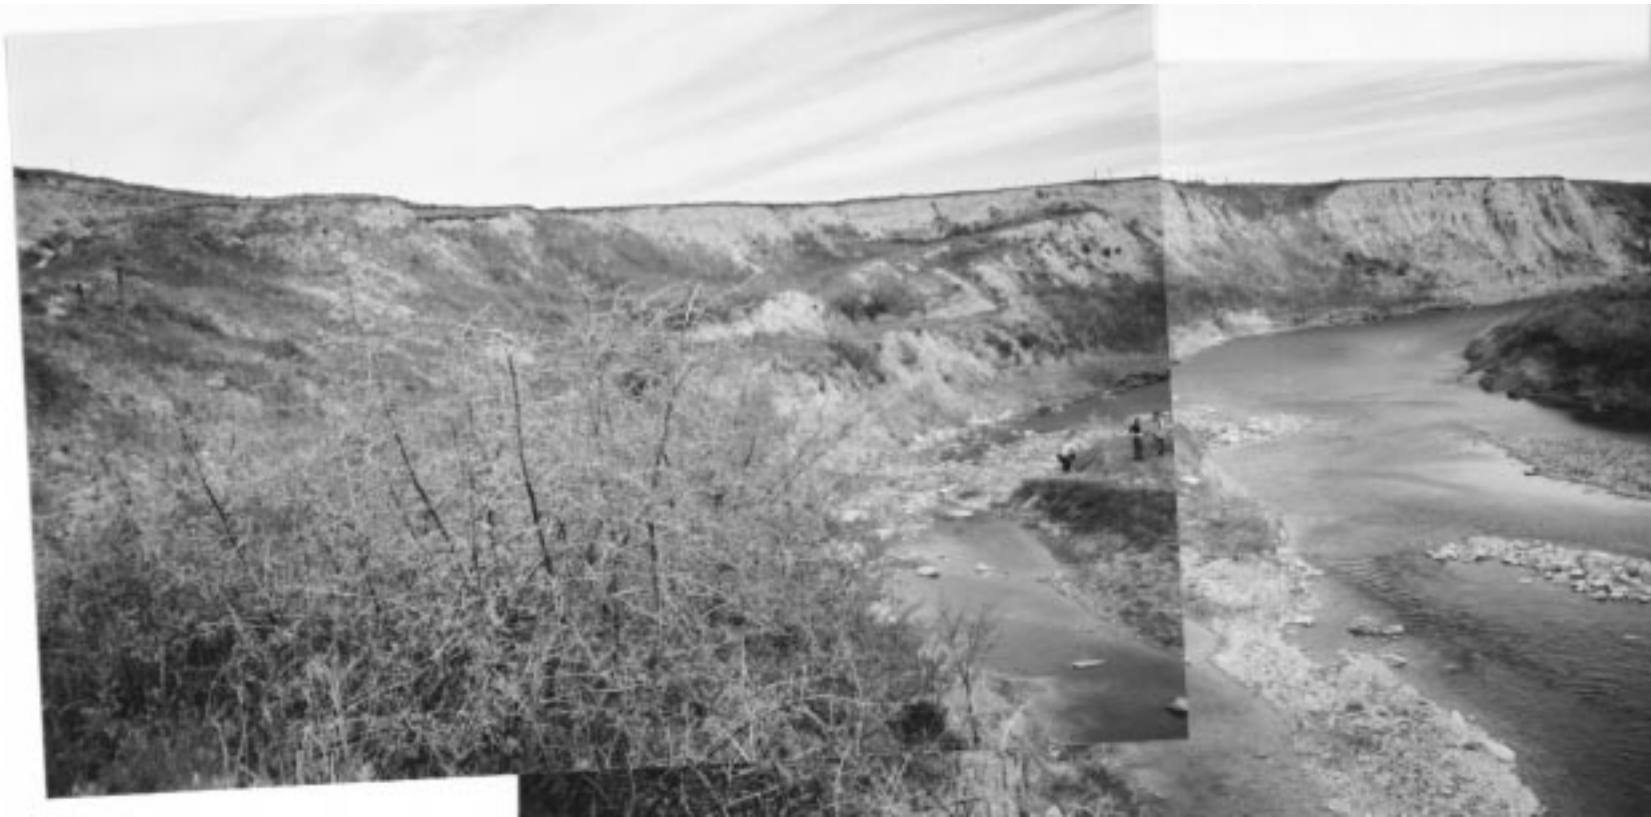
Photo 8 – Looking northwest at slide area from toe. Islands/bars in stream are possibly eroded remnants of previous landslide blocks and are protecting current toe from erosion.
