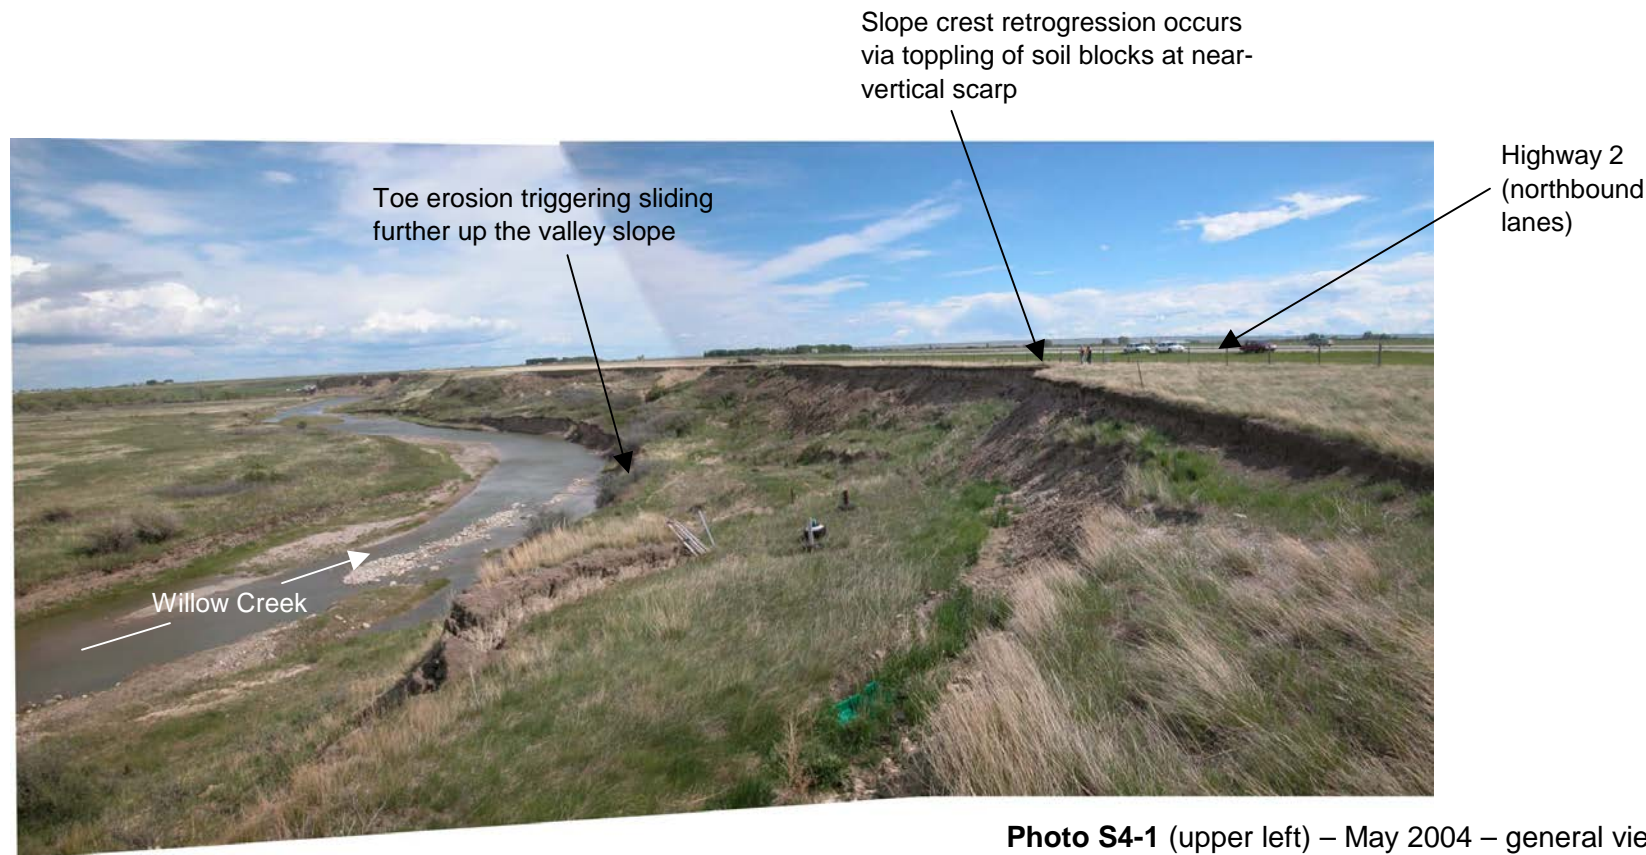
Photo S4-1 (upper left) – May 2004 – general view facing south across the S4 – Willow Creek site. The westward retrogression of the landslide towards the fenceline and highway is driven by creek erosion at the toe of the slope.

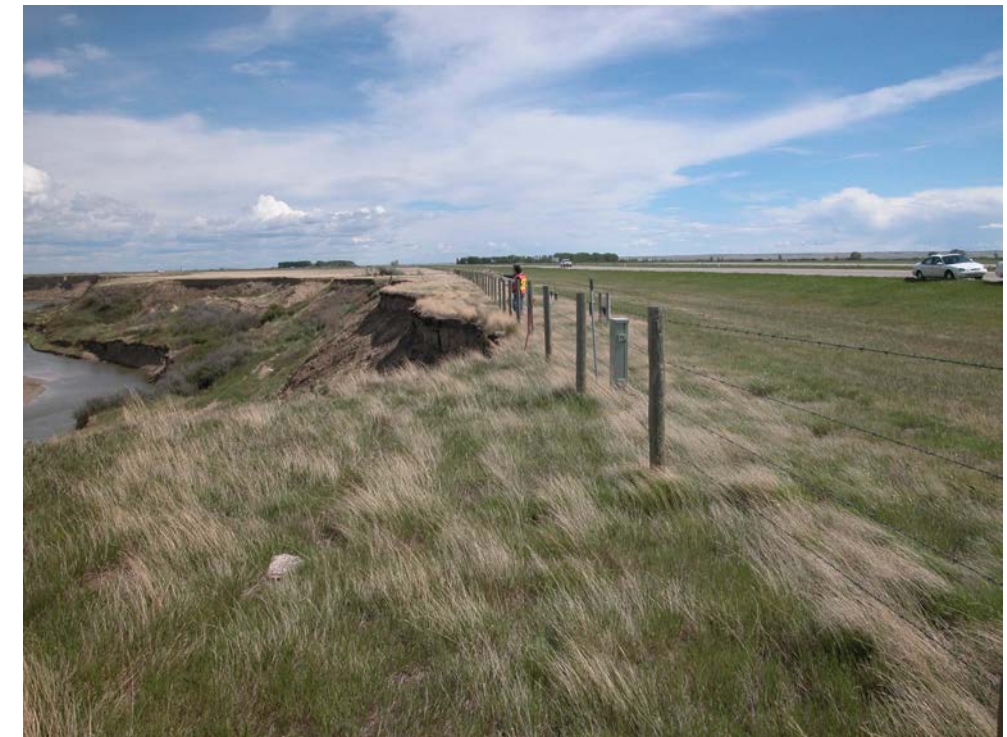
Photo S4-2 (upper right) – May 2004 – facing south towards the point of maximum crest retrogression relative to the fenceline.

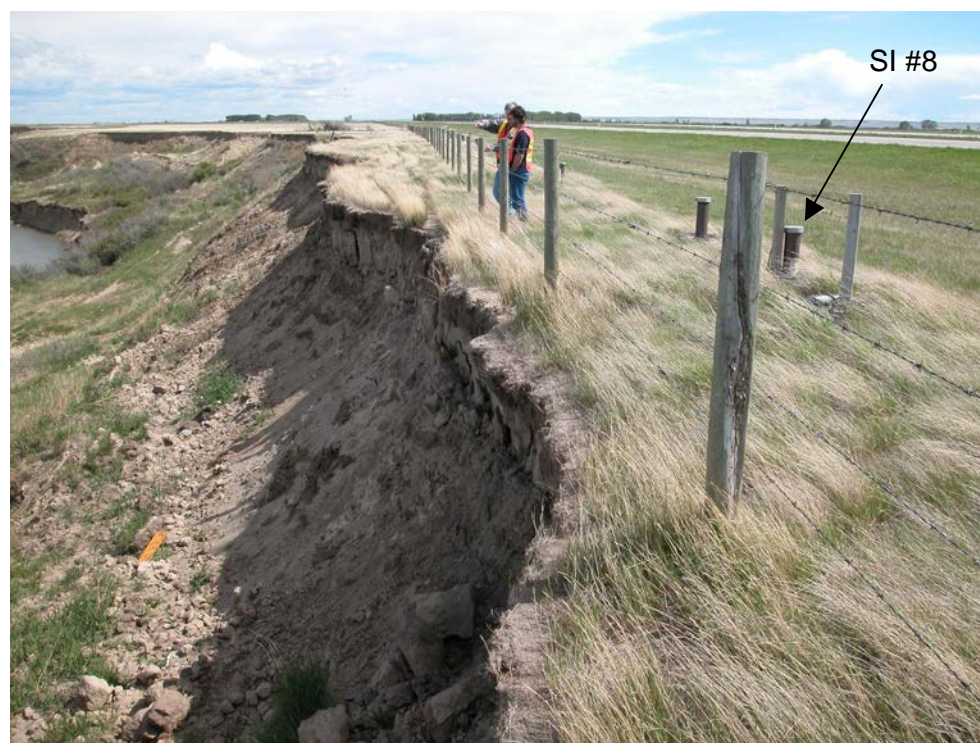
Photo S4-3 (lower left) – May 2004 – closer view of area shown in Photo S4-2. SI #8 is visible on the right hand side of the photo, just west of the fenceline. The scarp in this area retrogressed approximately 1 m between the October 2002 instrument readings and the July 2003 inspection. It does not appear that significant additional retrogression has occurred since July 2003. However, as noted in previous reports, the crest retrogression generally occurs in 0.5 to 1 m increments in response to toppling of soil blocks from the scarp, rather than a steady rate of retrogression.

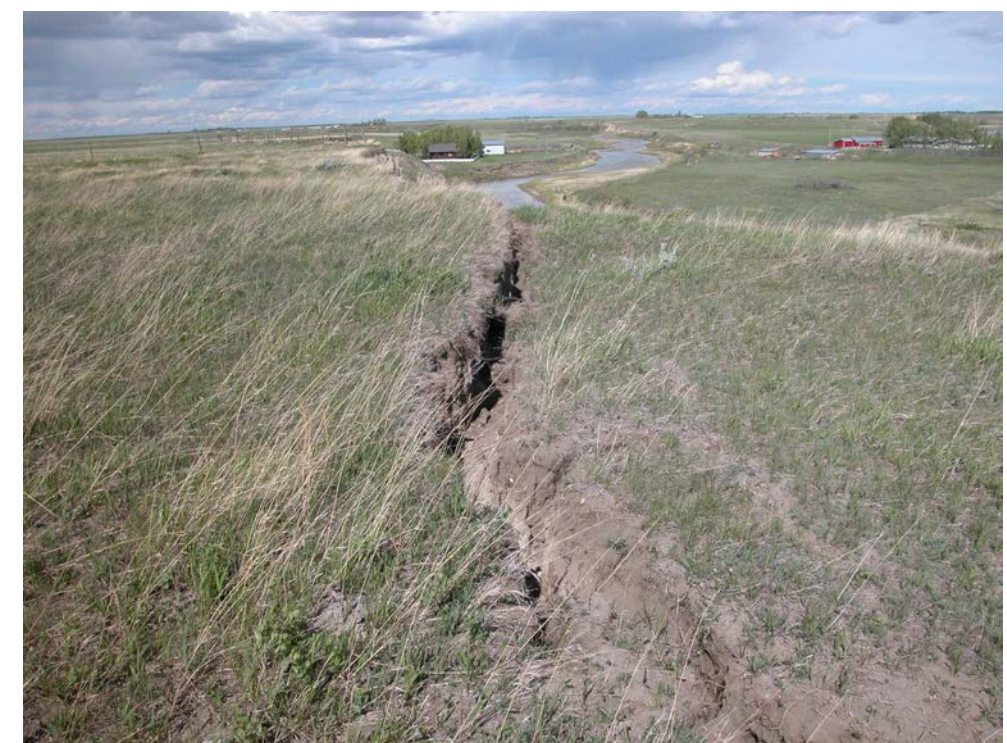
Photo S4-4 (lower right) – May 2004 – facing east along a tension crack at the scarp of a new landslide block developing to the northeast of SI #10. This tension crack was first noted in the summer of 2002, and since that time the lateral separation and vertical displacements have increased from negligible amounts to in the order of 0.5 to 1 m.
