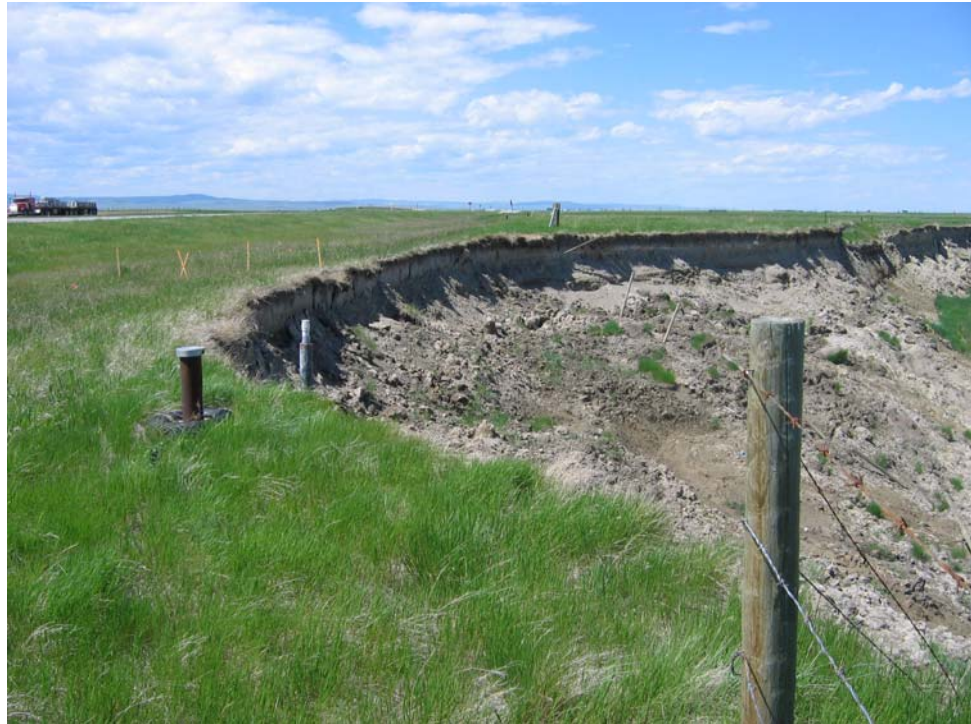
Photo S4-1 (upper left) – May 2006 – facing north across the area where the landslide scarp has retrogressed further past the fenceline and towards the road since the 2005 inspection.

Compare with Photo S4-3 which shows the same area as it appeared in June 2005.

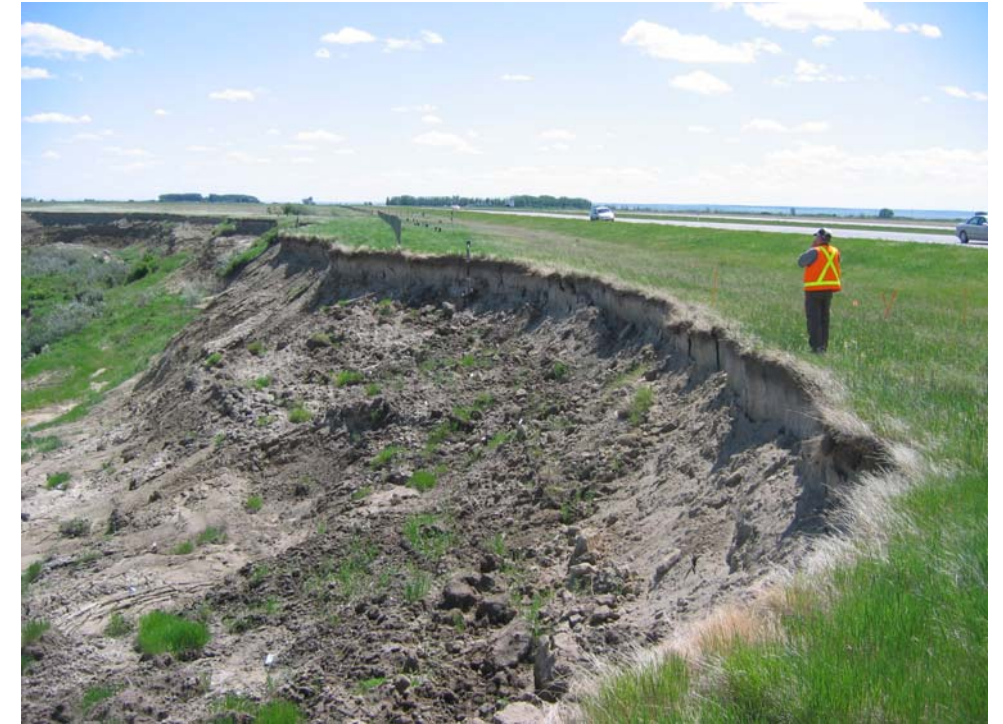
Photo S4-2 (upper right) – May 2006 – facing south across the area where the landslide scarp has retrogressed further past the fenceline and towards the road since the 2005 inspection.

Compare with Photo S4-3 which shows the same area as it appeared in June 2005.

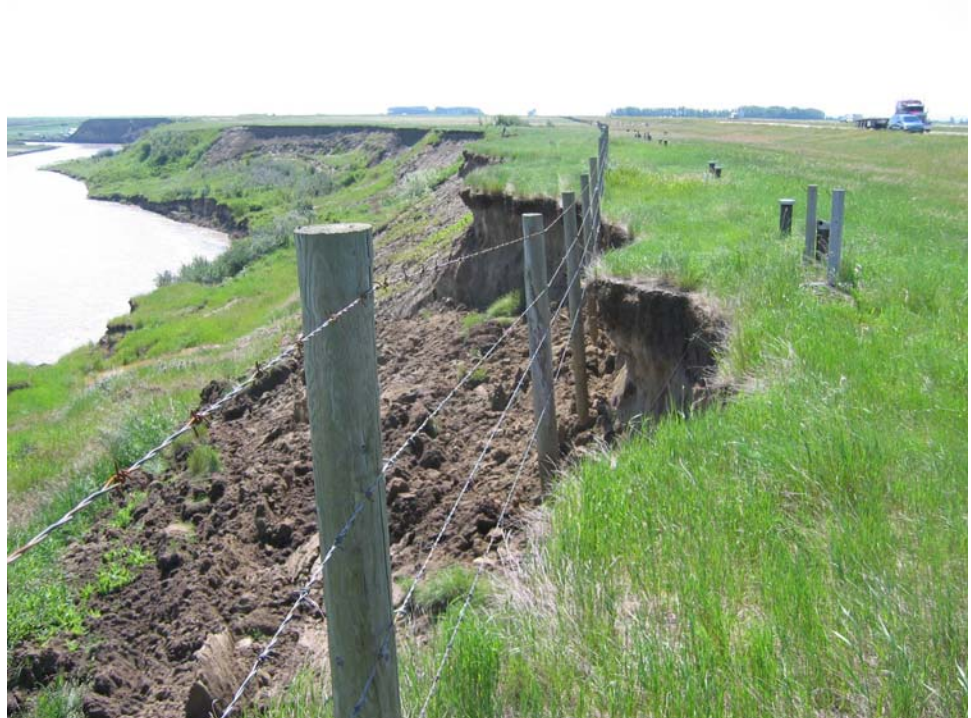
Photo S4-3 (lower left) – June 2005 – point of maximum slope crest retrogression towards the road as of June 2005.

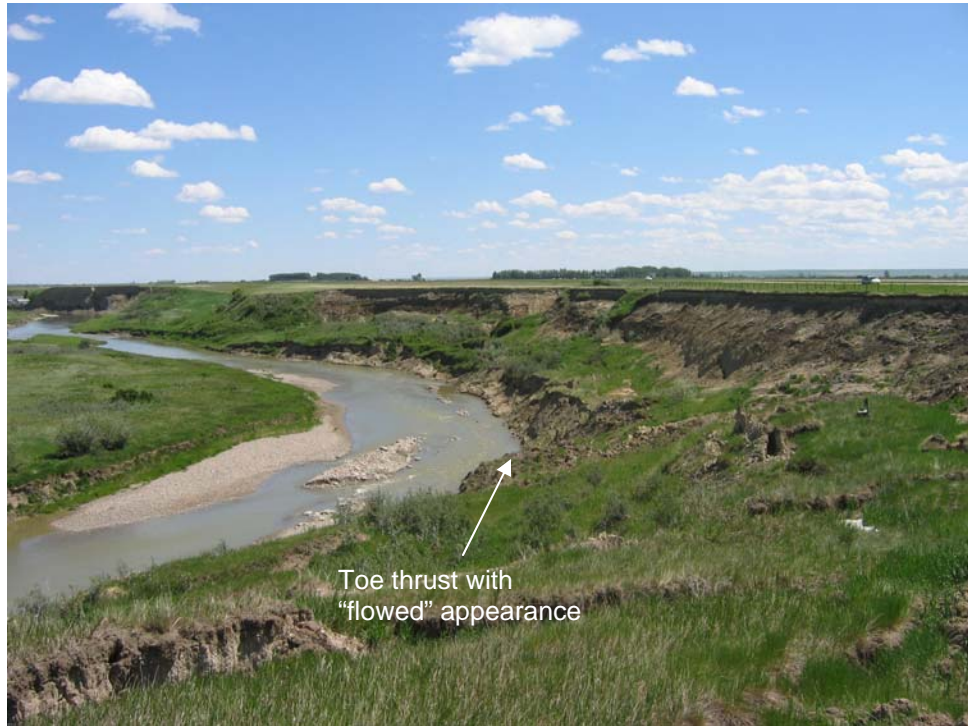
Photo S4-4 (upper left) – May 2006 – facing south across the landslide area. Note the portion of the toe of the landslide that thrust outwards into the creek channel. The material that was thrust into the creek channel had a “flowed” appearance.

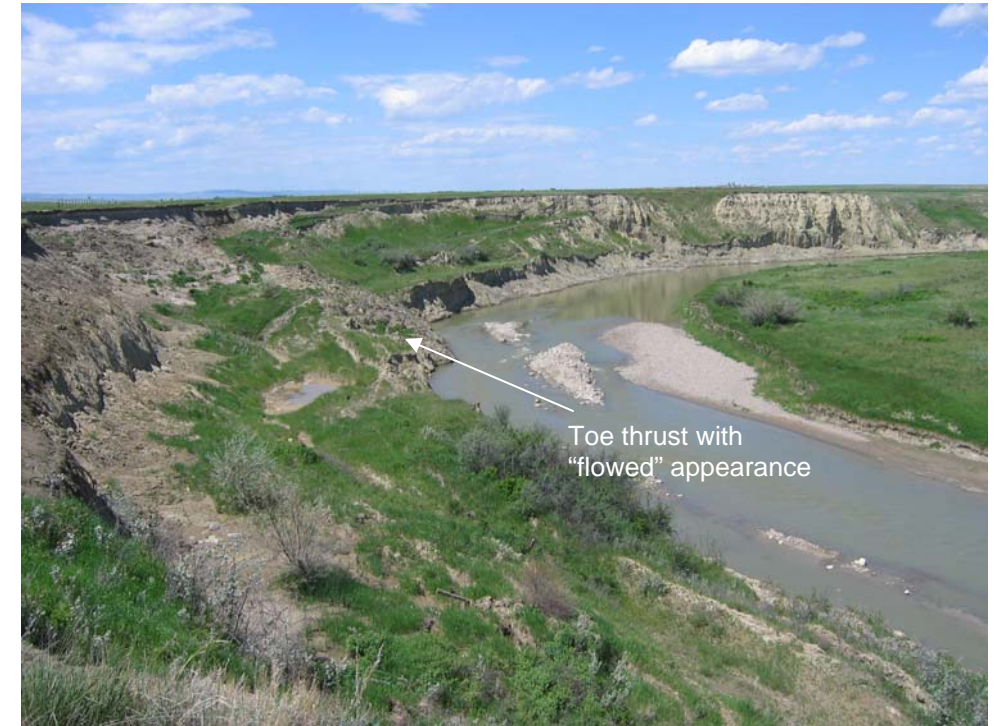
Photo S4-5 (upper right) – May 2006 – facing south across the landslide area.
