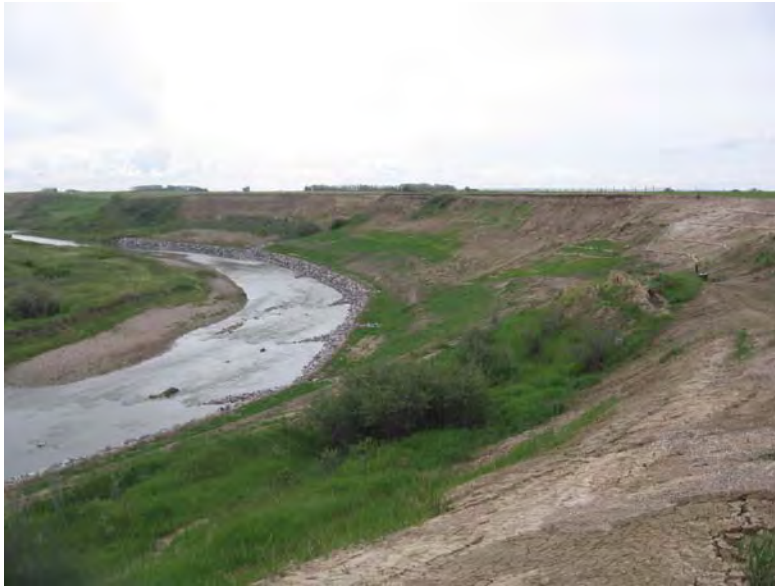
Photo S4-1 (top) – June 2009
General view facing southwards across the site.

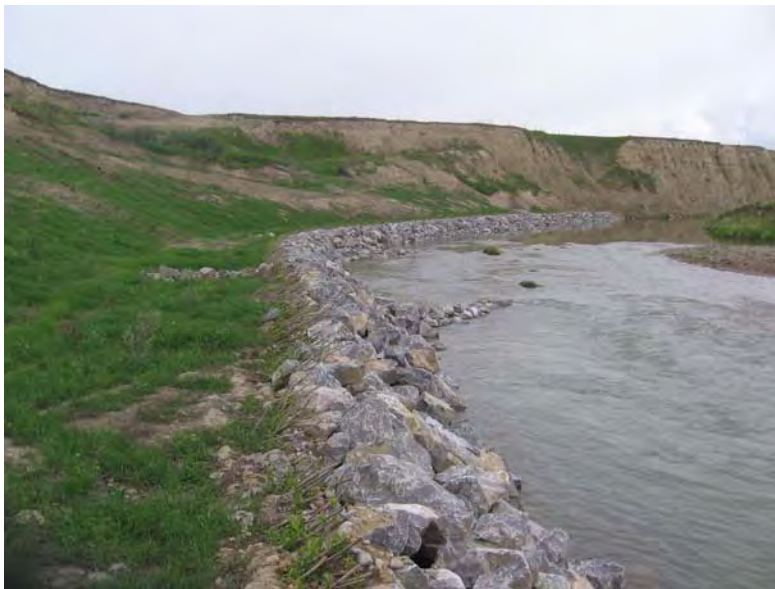
Photo S4-2 (bottom) – June 2009
Facing upstream along the LPSTP along the right creek bank, with the rocks vanes angling into the channel visible.

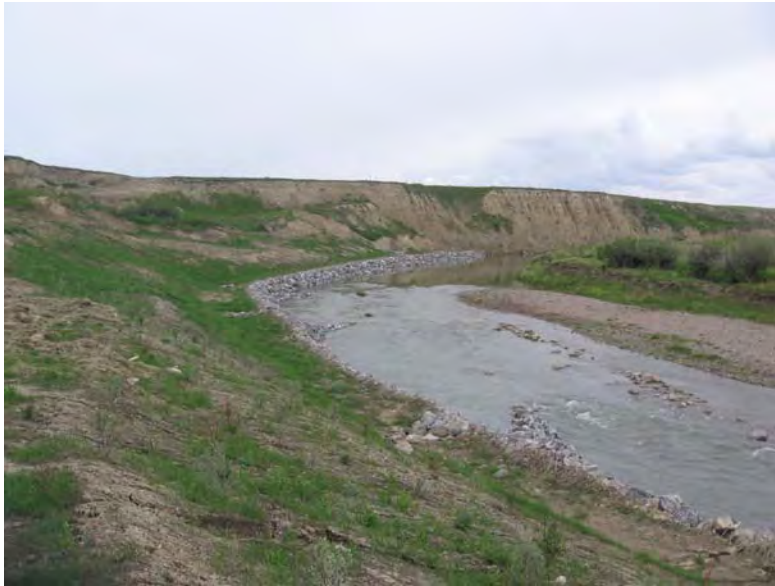
Photo S4-3 (top) – June 2009
Wider view, facing upstream along the LPSTP along the right creek bank with the rocks vanes angling into the channel visible.

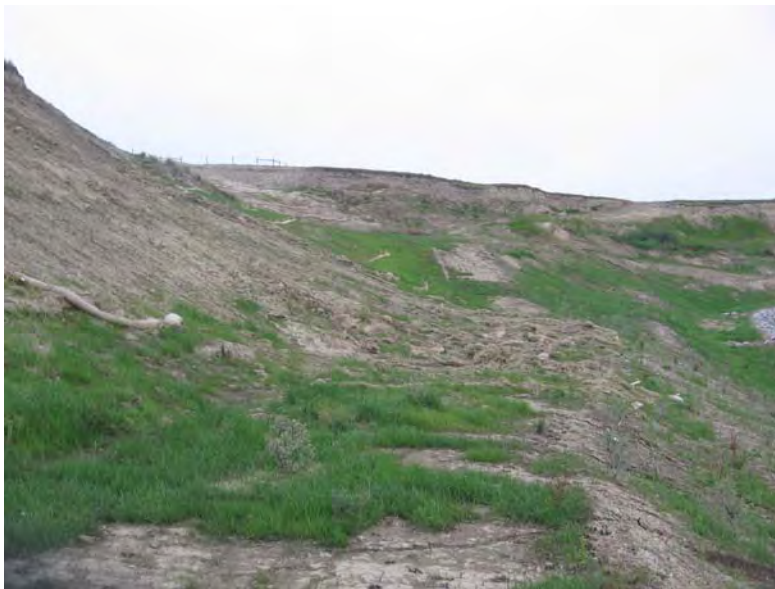
Photo S4-4 (bottom) – June 2009
Fiber rolls that were staked into the upper slope in this portion of the soil disposal area have detached and slid downwards.

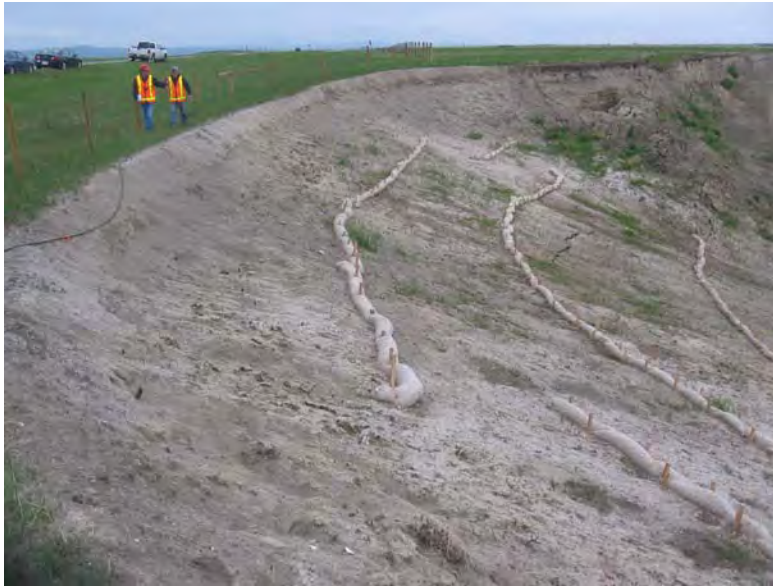
Photo S4-5 (top) – June 2009

This segment of the slope crest was regraded and stabilized with launched soil nails during the 2008 repair. The slope face below the crest was also regraded to prevent ponding of water and sprayed flexible growth medium (FGM) was applied along with fiber rolls staked into the regraded slope. There has been very little vegetation growth in the FGM area, possibly due to windy conditions during application that blew away at least some of the sprayed material.

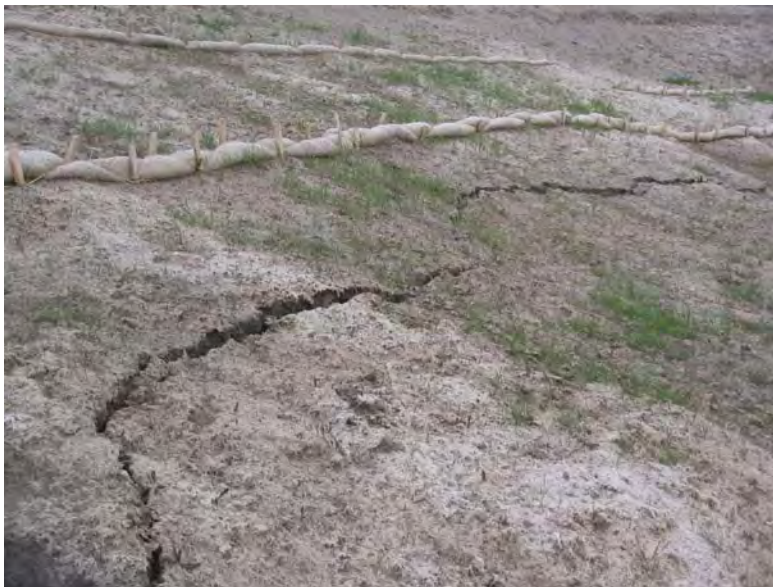
Photo S4-6 (bottom) – June 2009

Tension cracking in the regraded slope face below the soil nailing area.

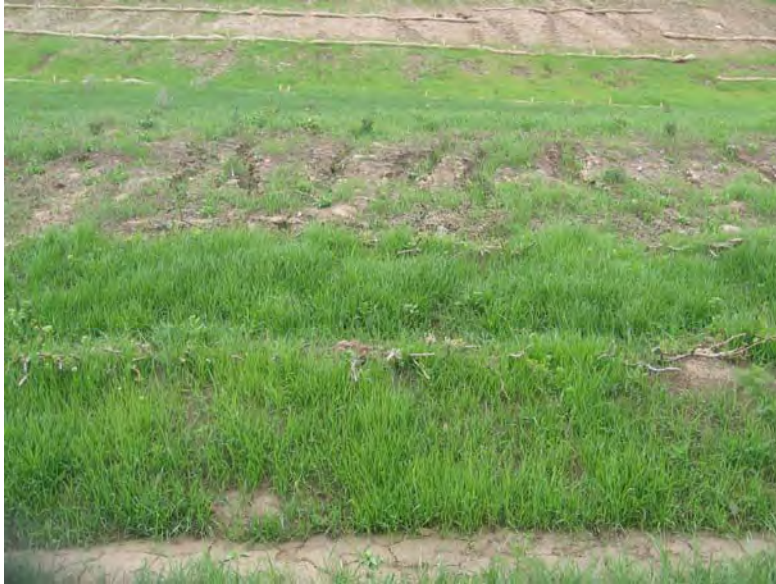
Photo S4-7 (top) – June 2009

Gullying in the slope face across the lower portion of the soil disposal area. This area was erosion-protected with soil flaps and live brush layering, which appears to have confined the gully to the uppermost portion of the slope only (i.e. above the uppermost soil flap).

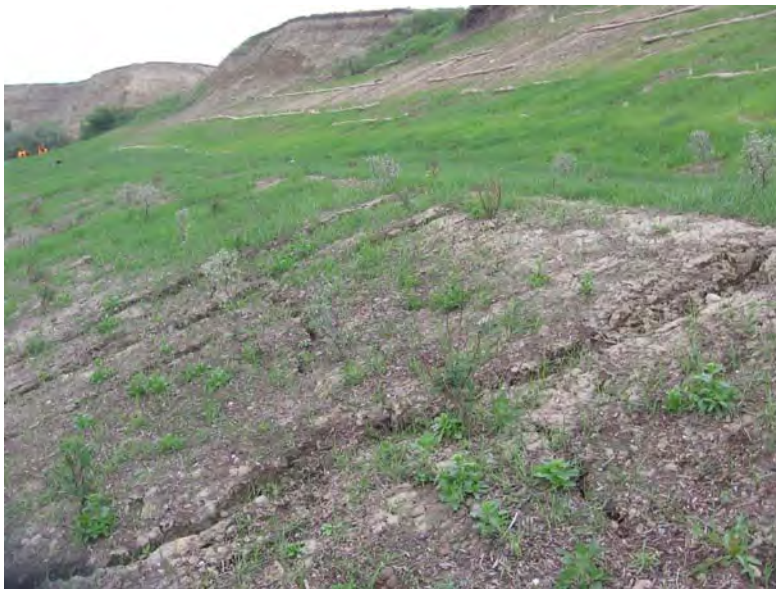
Photo S4-8 (bottom) – June 2009

Gullying in the slope face across the lower portion of the soil disposal area. This area was erosion-protected with live plantings and blown compost blanket. These measures appear to have been less effective to date than the soil flaps and live brush layering area visible in the left background and also shown in Photo S4-7.

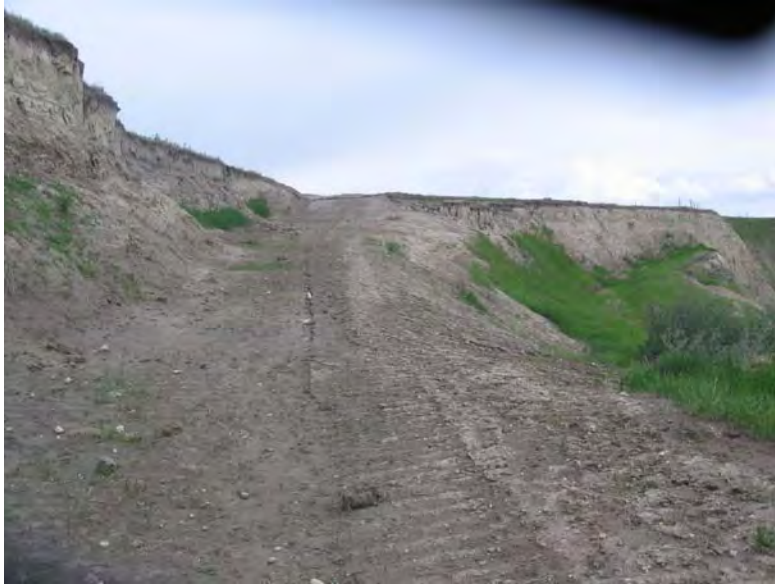
Photo S4-9 (top) – June 2009

Facing upslope along the equipment access trail between the upland area and the right creek bank. Some surface erosion and the early stages of erosion gully development is visible along the trail.

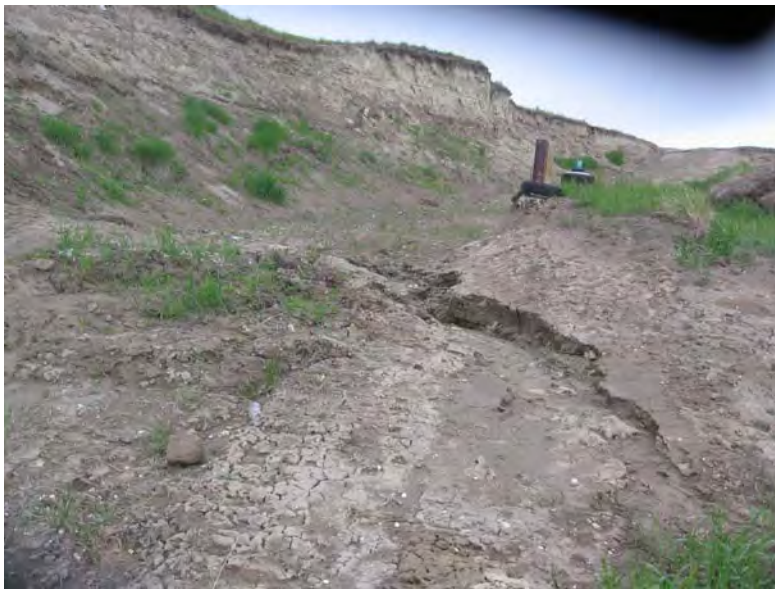
Photo S4-10 (bottom) – June 2009

Another view of surface erosion and erosion gully development along the access trail.

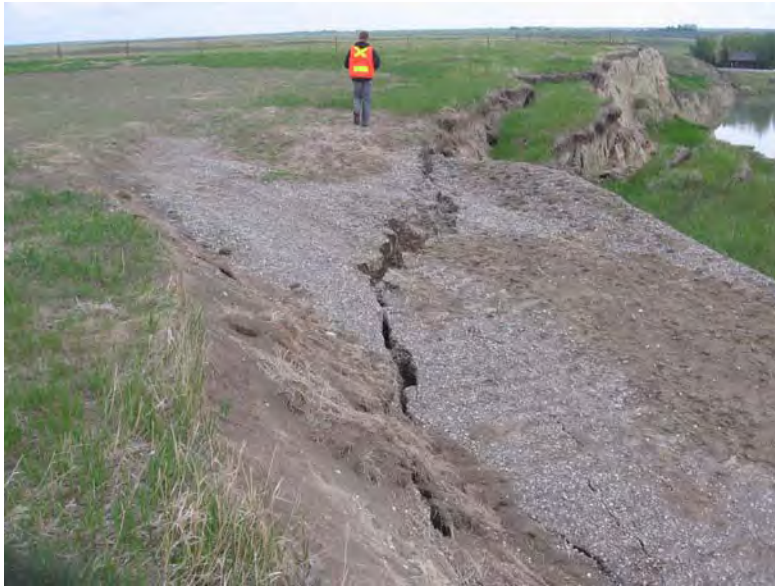
Photo S4-11 (top) – June 2009
Landslide headscarp that has reformed since November 2008 across the uppermost portion of the equipment access trail.
