Alberta Transportation Southern Region Geohazard Assessment 2012 Annual Inspection Report Site S4: Highway 2:08, Willow Creek November 2012 Page 8

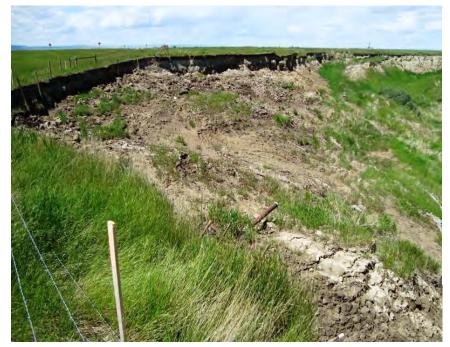
## Photo S4-1 (June 2011) -

Facing north across the soil nail repair area in 2011, for comparison with 2012 conditions (refer to Photo S4-2).

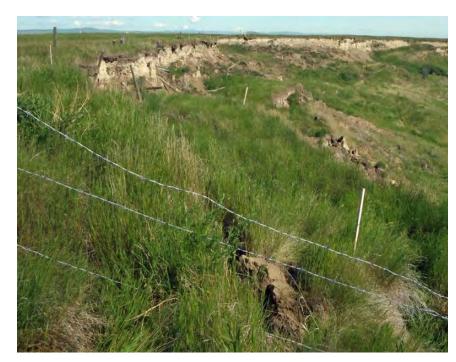
## Photo S4-2 (June 2012) -Taken from near the same location as Photo S4-1. Note the displacement of the stake visible in the foreground of the photos, which indicates a retrogression. Continued retrogression at the slope crest, as well as disturbance of the vegetation by soil flows has occurred. Overall the slope appears more vegetated and stable than previous years.

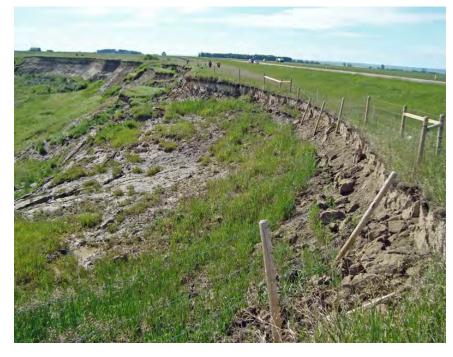
Photo S4-3 (June 2012) – Facing south at the slide area. The instabilities in the upper, steeper portions of the slope are mostly unchanged from 2011 apart from settlement of the larger blocks. Retrogression of the slide continues to occur with large blocks sliding down and adding to the slide mass although at a seemingly slower rate than observed previously. Alberta Transportation Southern Region Geohazard Assessment 2012 Annual Inspection Report Site S4: Highway 2:08, Willow Creek November 2012 Page 10

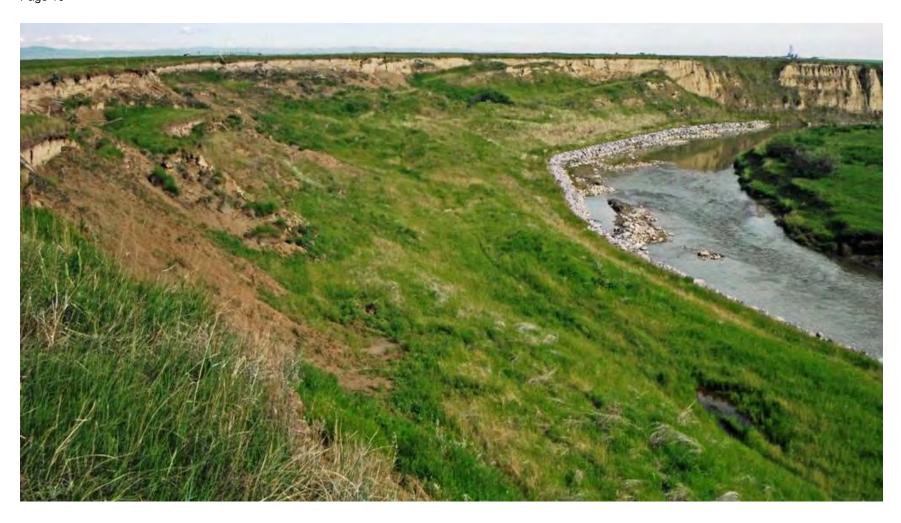
## Photo S4-4 (June 2012) -

Facing north at the slide area with a view of the lower slope and river bank. Note the vane damage and the improved vegetation cover.
